<b>sabena</b> <b>B707</b>	Module: GENERAL	A/C Reg :	Check :

<b>01F3000001</b>
	Oper. : RT-MP LC			
	Type : STRUCT-INSP	Issuer : A59513	Cert.St.: 50516	
Spec. : MECH. INSP	Release Date: 18.05.2011		Page 1 of 25

**BS600K & BS820 TERMINAL FITTING INSPECTION**

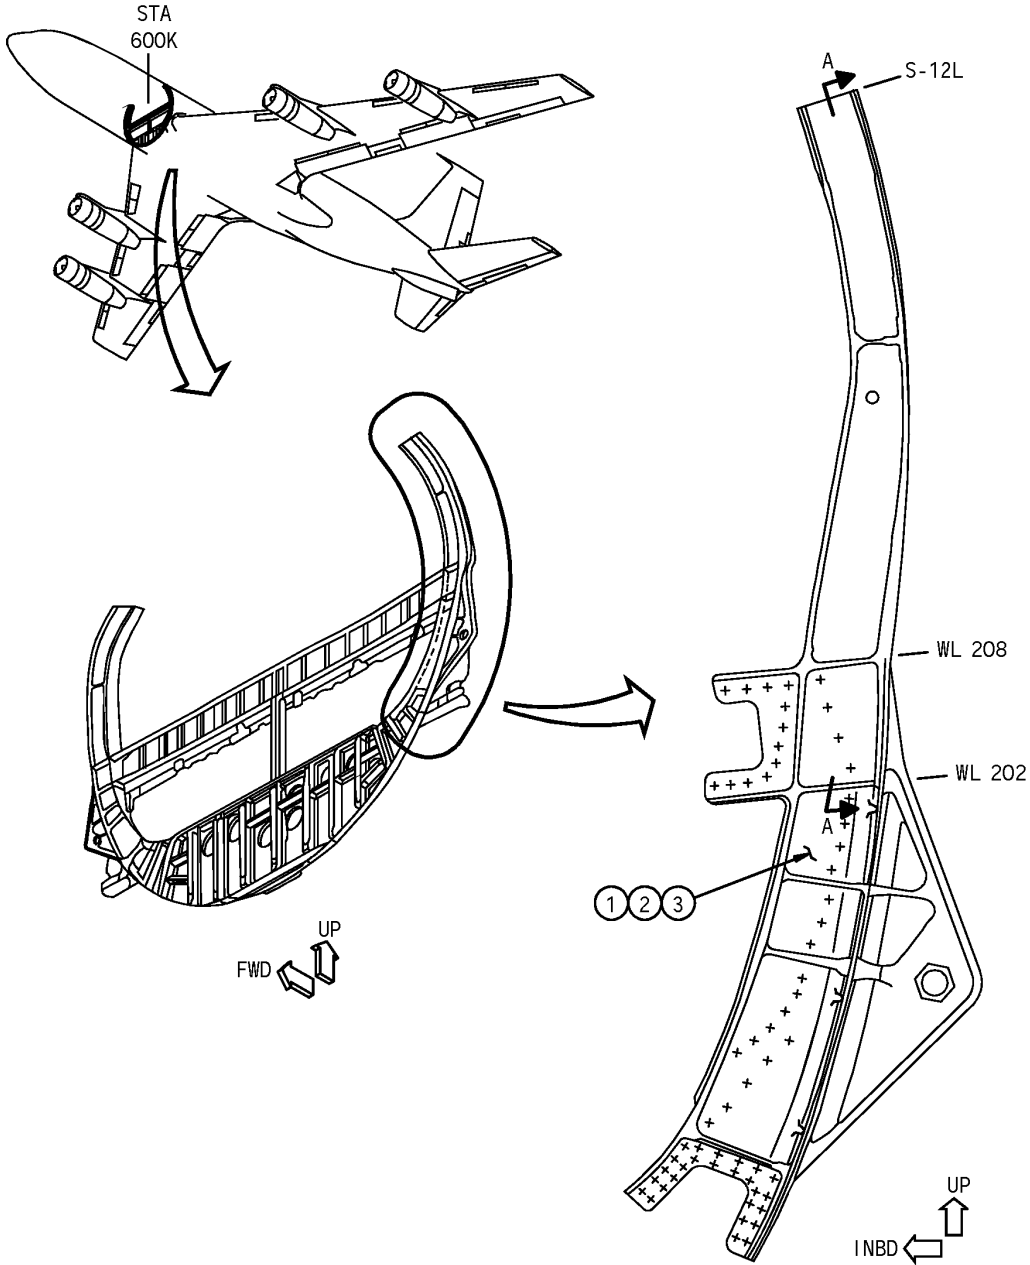
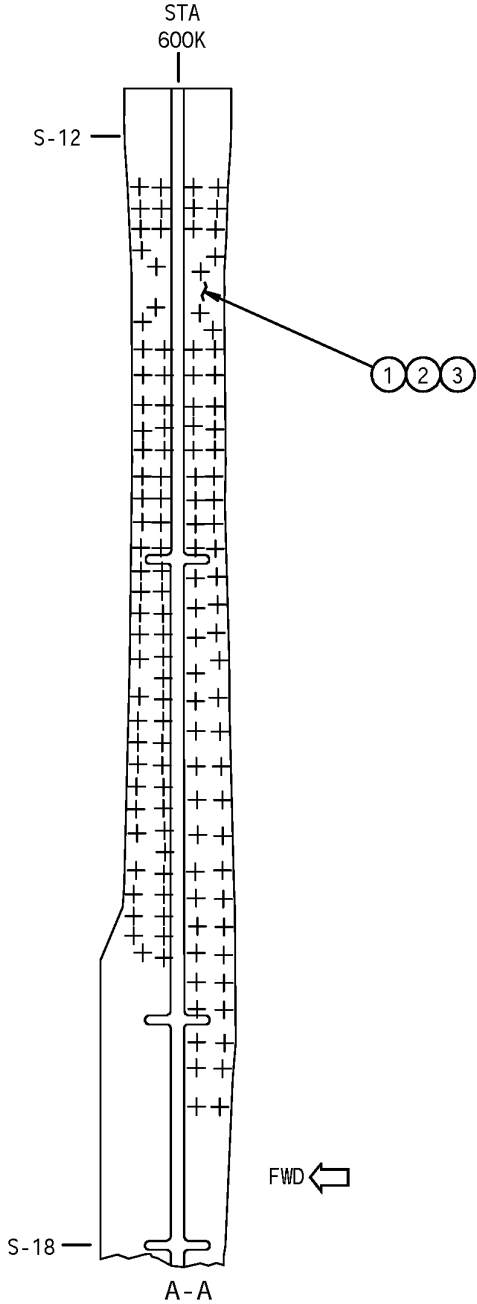
**FIGURE 3: GROUP 2 - LEFT BODY TERMINAL FITTING INSPECTION - BODY STATION 600K.**  
(SHEET 1 OF 3)

3. Do a detailed inspection of the left body terminal fitting at STA 600K as given in Figure 3.
  - a) If any crack or corrosion is found, contact Boeing for repair instructions or for instructions to replace the body terminal fitting with a body terminal fitting made from 7075-T73 material. Provide a detailed description of any crack or corrosion to Boeing when requesting repair instructions.

(a) Pay particular attention to fastener locations. Removal of fasteners or structure is not required.

- b) If there is an existing repair, inspect the repair for any crack or corrosion.
    - 1) If no crack or corrosion is found, it is not necessary to remove the repair.

- 2) If any crack or corrosion is found, remove the repair & do a detailed inspection of the fitting in the area covered by the repair. Send a detailed description of any crack or corrosion to Boeing & request repair instructions.

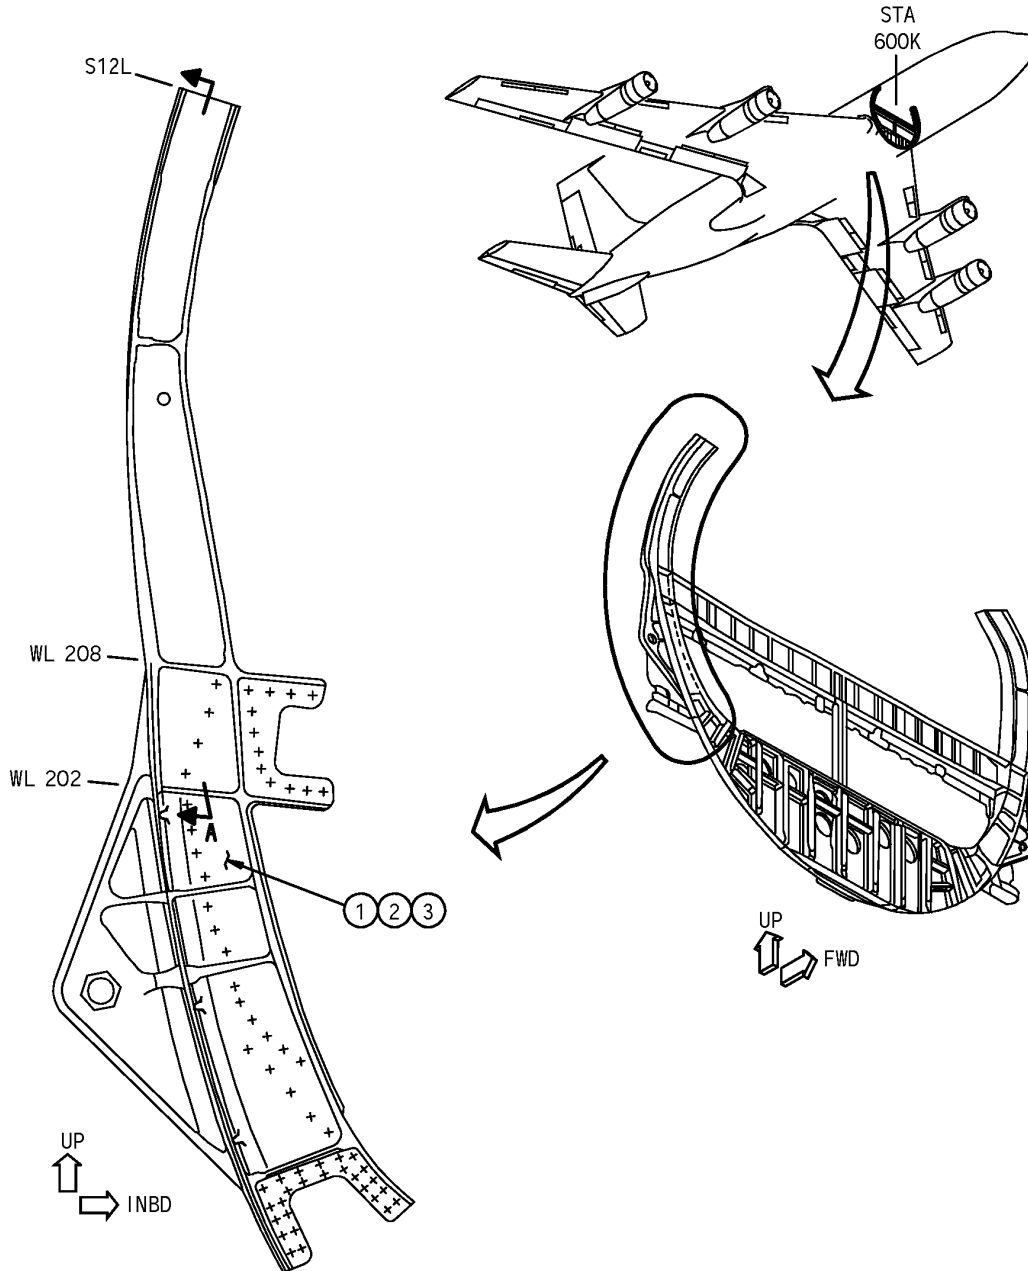
**FIGURE 4: GROUP 2 - RIGHT BODY TERMINAL FITTING INSPECTION - BODY STATION 600K.**  
(SHEET 1 OF 3)

4. Do a detailed inspection of the right body terminal fitting at STA 600K as given in Figure 4.
  - a) If any crack or corrosion is found, contact Boeing for repair instructions or for instructions to replace the body terminal fitting with a body terminal fitting made from 7075-T73 material. Provide a detailed description of any crack or corrosion to Boeing when requesting repair instructions.

(a) Pay particular attention to fastener locations. Removal of fasteners or structure is not required.

- b) If there is an existing repair, inspect the repair for any crack or corrosion.
    - 1) If no crack or corrosion is found, it is not necessary to remove the repair.

- 2) If any crack or corrosion is found, remove the repair & do a detailed inspection of the fitting in the area covered by the repair. Send a detailed description of any crack or corrosion to Boeing & request repair instructions.

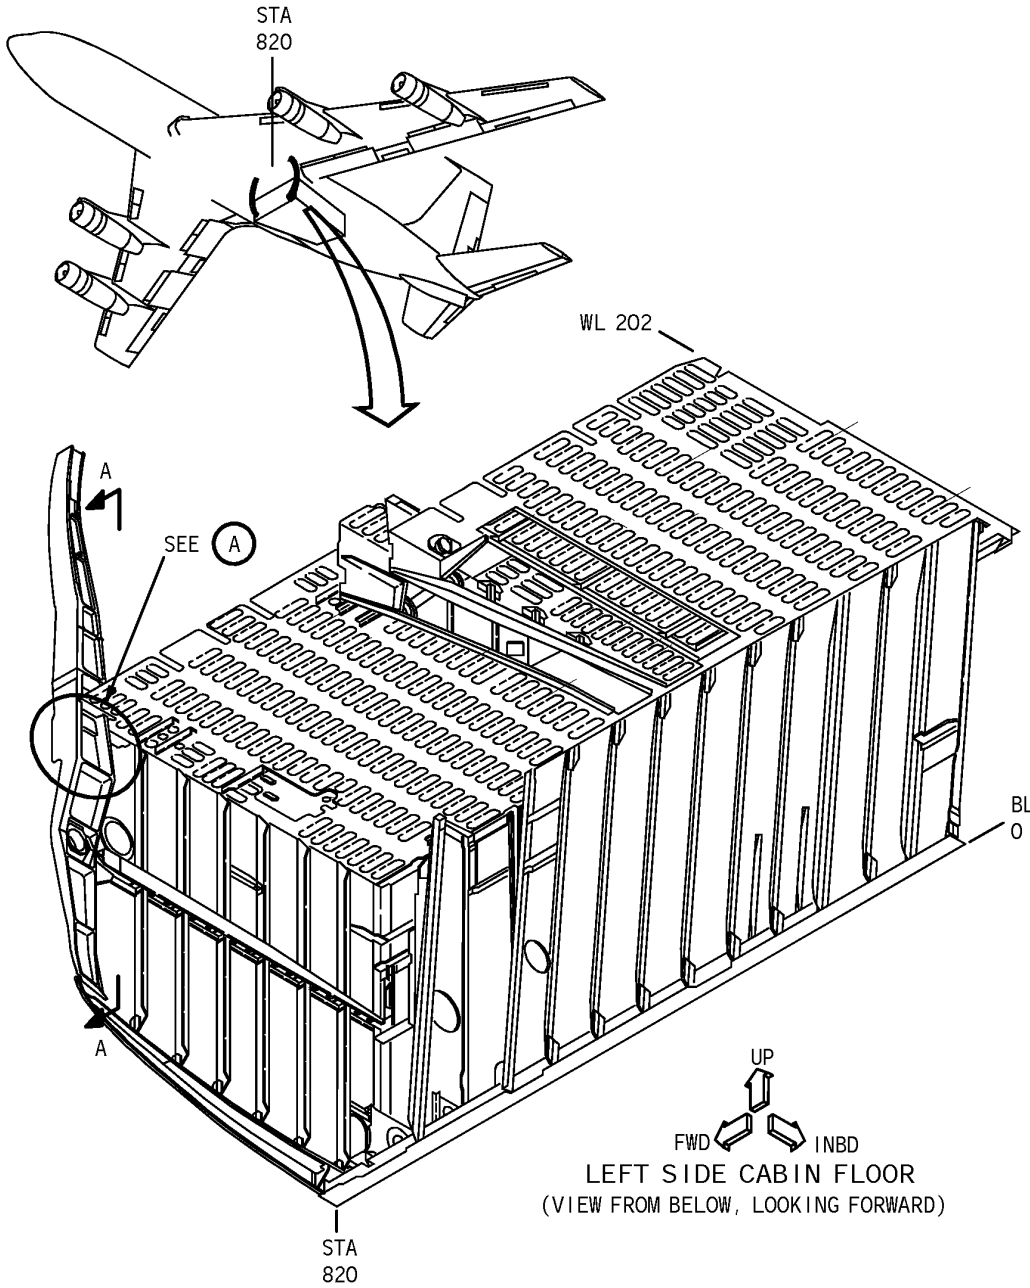
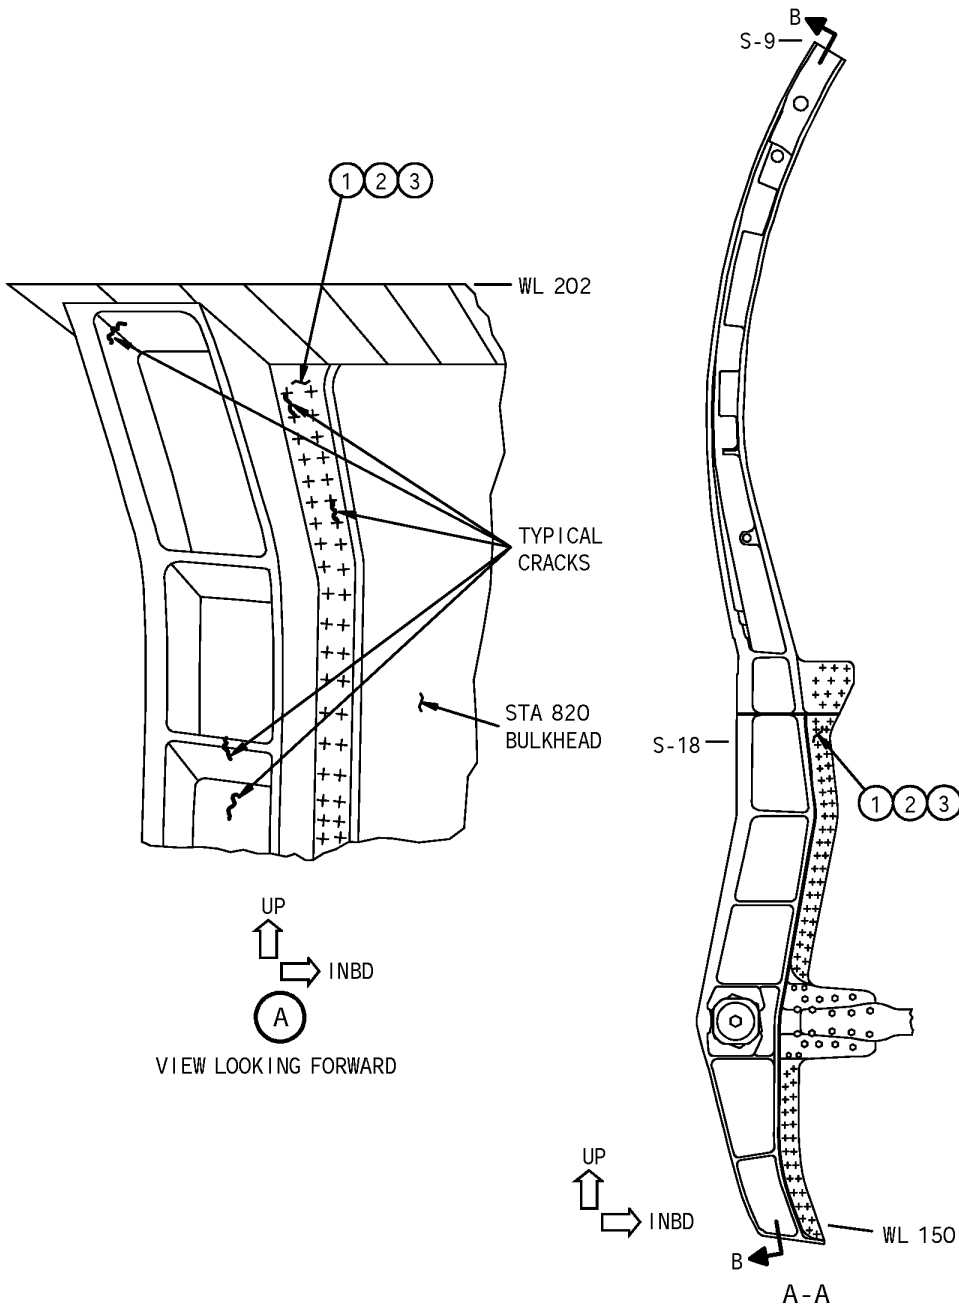
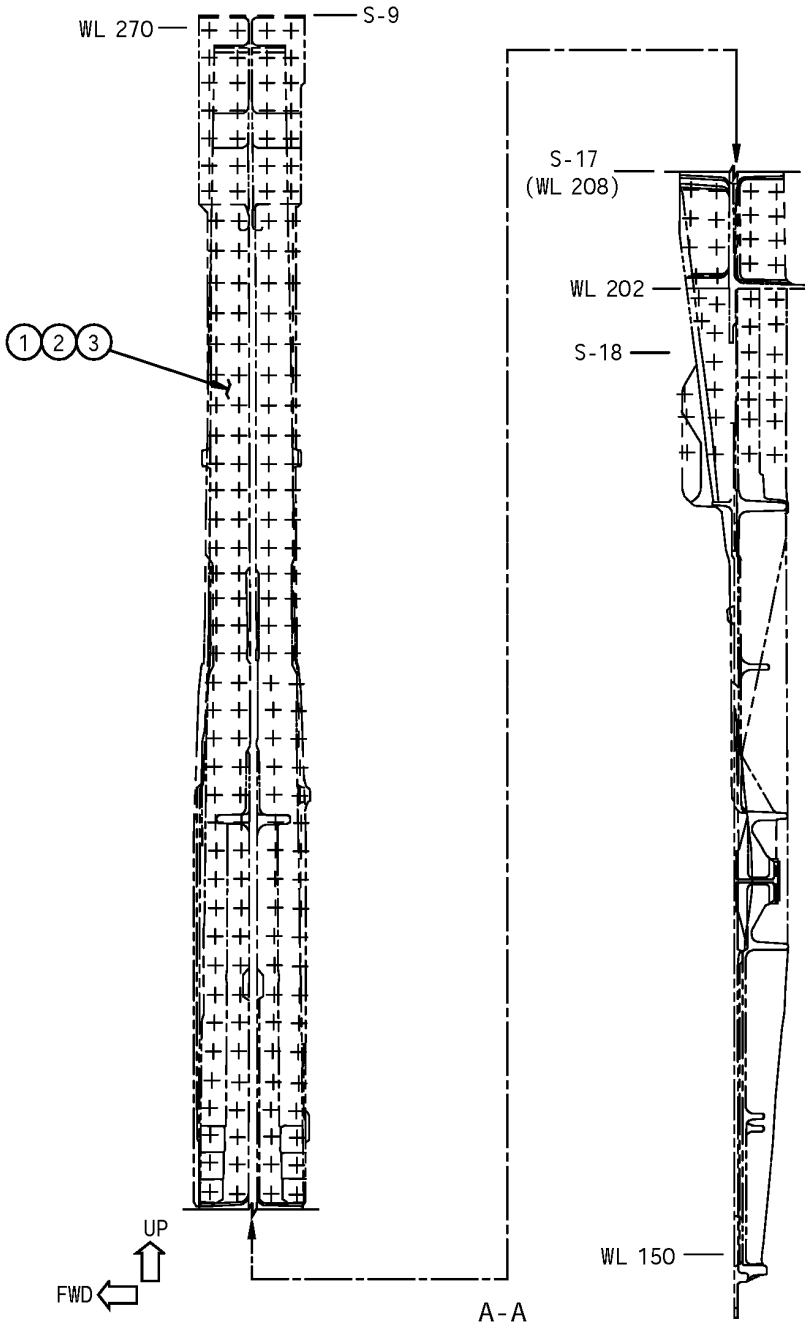
**FIGURE 5: GROUPS 1 & 2 - LEFT BODY TERMINAL FITTING INSPECTION - BODY STATION 820.**  
(SHEET 1 OF 4)

3. Do a detailed inspection of the left body terminal fitting on the STA 820 bulkhead as given in Figure 5.		
a) If any crack or corrosion is found, contact Boeing for repair instructions or for instructions to replace the body terminal fitting with a body terminal fitting made from 7075–T73 material. Provide a detailed description of any crack or corrosion to Boeing when requesting repair instructions.

(a) If there are existing repairs, do a Detailed Inspection of the repairs on the fitting for any crack or corrosion. Pay particular attention to fastener locations.

b) If there is an existing repair, inspect the repair for any crack or corrosion.		
1) If no crack or corrosion is found, it is not necessary to remove the repair.

2) If any crack or corrosion is found, remove the repair & do a detailed inspection of the fitting in the area covered by the repair. Send a detailed description of any crack or corrosion to Boeing & request repair instructions.

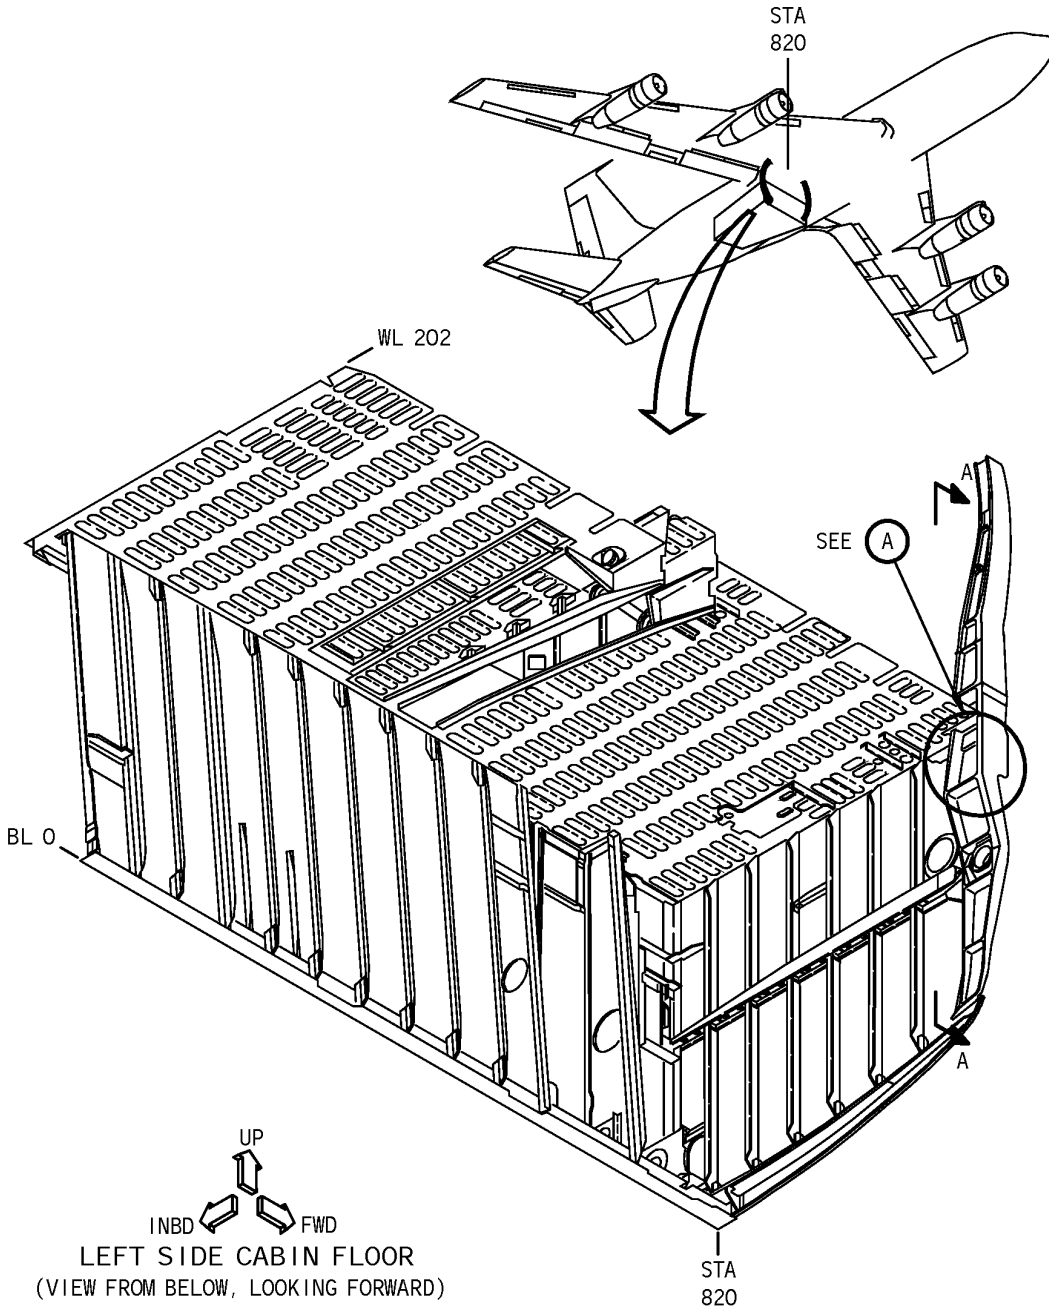
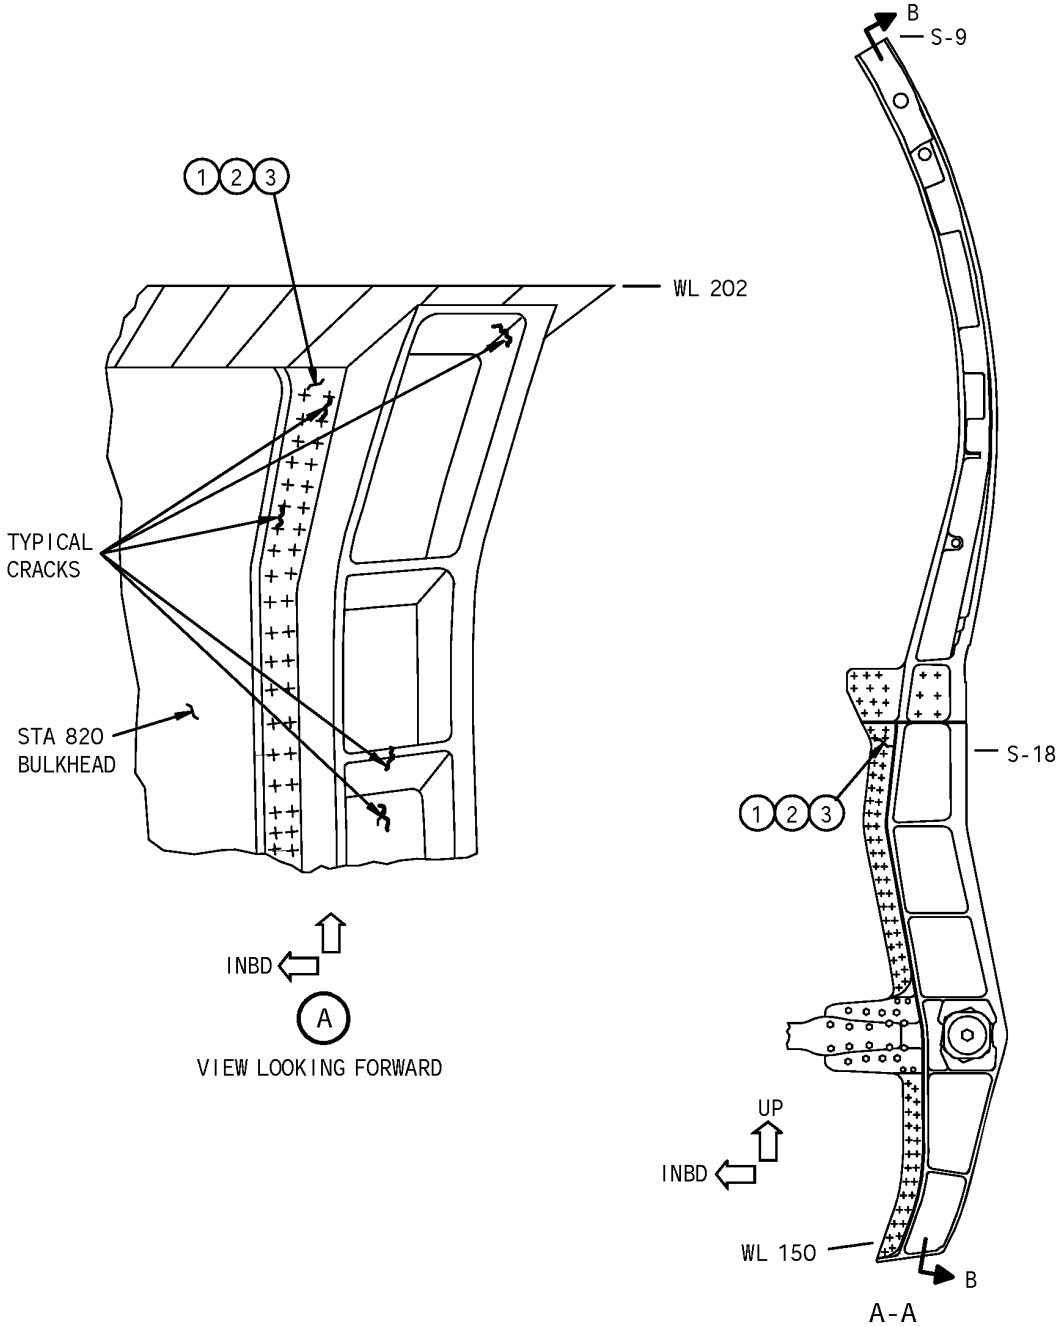
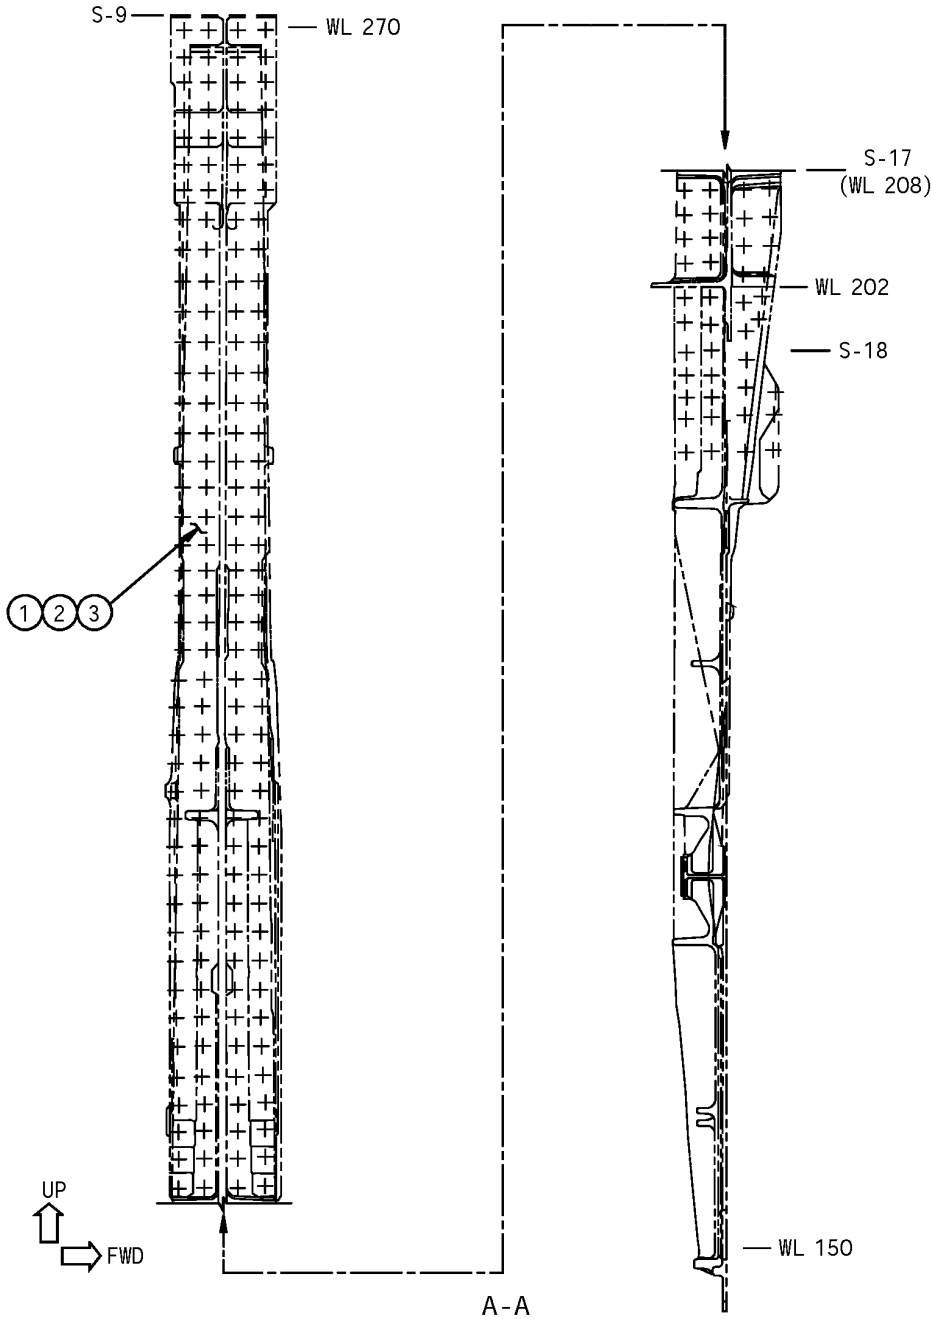
**FIGURE 6: GROUPS 1 & 2 - RIGHT BODY TERMINAL FITTING INSPECTION - BODY STATION 820.  
(SHEET 1 OF 4)**

4. Do a detailed inspection of the right body terminal fitting on the STA 820 bulkhead as given in Figure 6.		
a) If any crack or corrosion is found, contact Boeing for repair instructions or for instructions to replace the body terminal fitting with a body terminal fitting made from 7075–T73 material. Provide a detailed description of any crack or corrosion to Boeing when requesting repair instructions.

(a) If there are existing repairs, do a Detailed Inspection of the repairs on the fitting for any crack or corrosion. Pay particular attention to fastener locations.

b) If there is an existing repair, inspect the repair for any crack or corrosion.		
1) If no crack or corrosion is found, it is not necessary to remove the repair.

2) If any crack or corrosion is found, remove the repair & do a detailed inspection of the fitting in the area covered by the repair. Send a detailed description of any crack or corrosion to Boeing & request repair instructions.

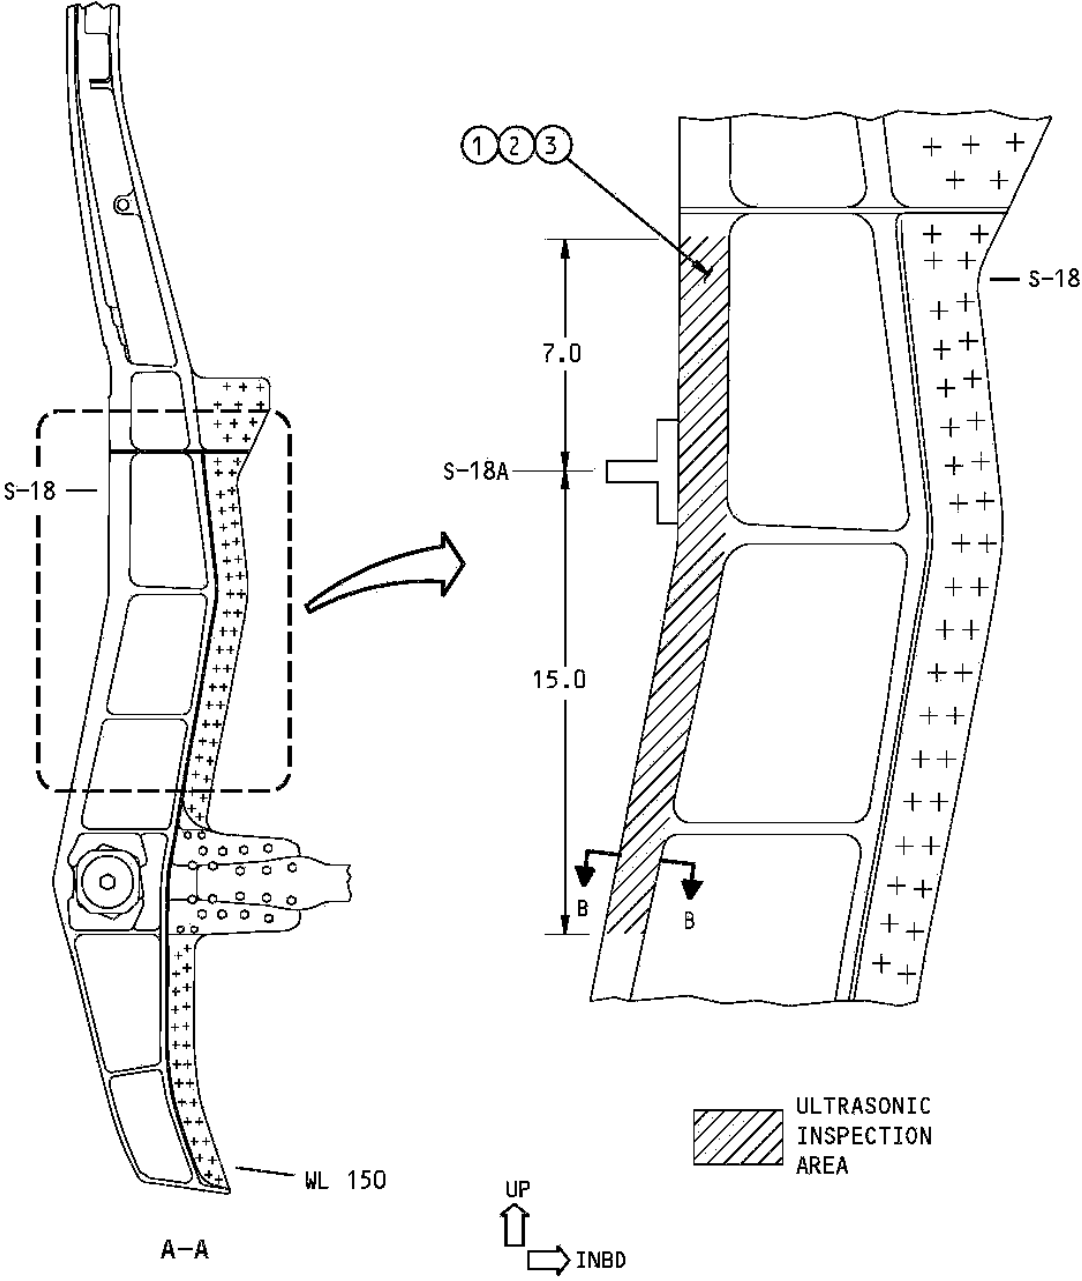
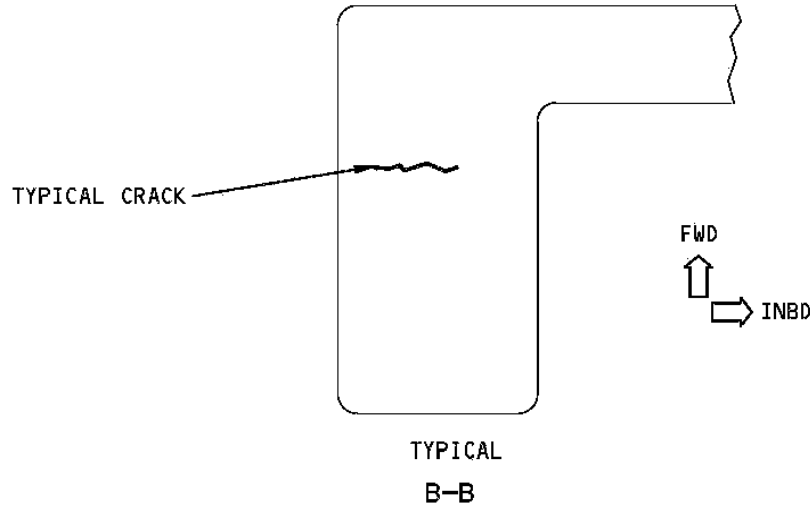
<p><b>FIGURE 9: LEFT BODY TERMINAL FITTING ULTRASONIC INSPECTION - BODY STATION 820. (SHEET 2 OF 3)</b></p>

(a) Do the inspection as given in 707, 720 NDT Part 4, 53-10-07 Figure 1.

(b) 707, 720 NDT Part 4, 53-10-07 Figure 1 was intended for use in monitoring crack propagation, but can also be used for crack detection.

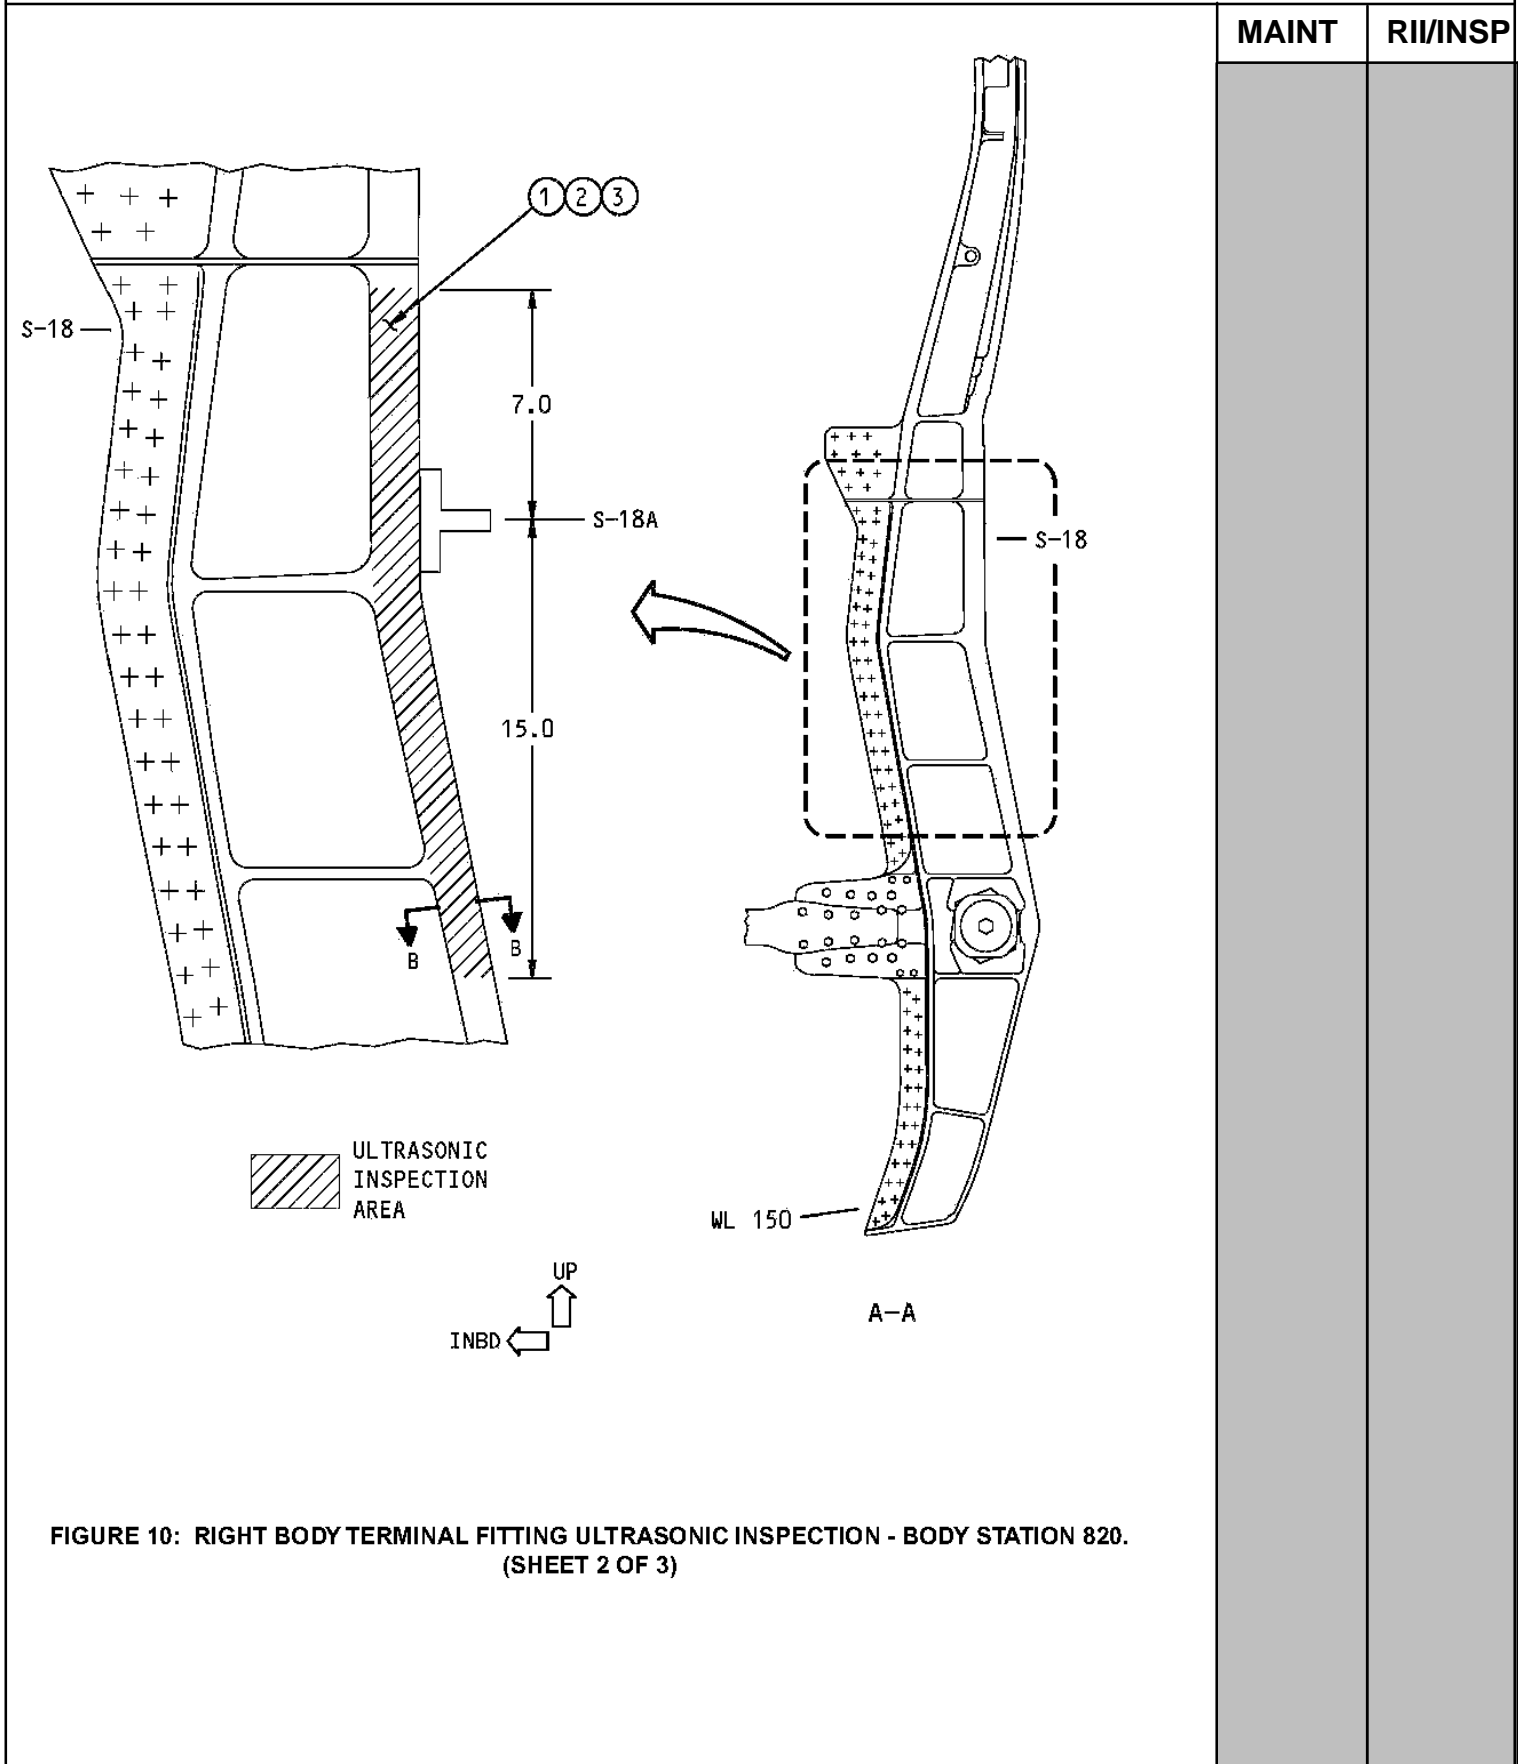
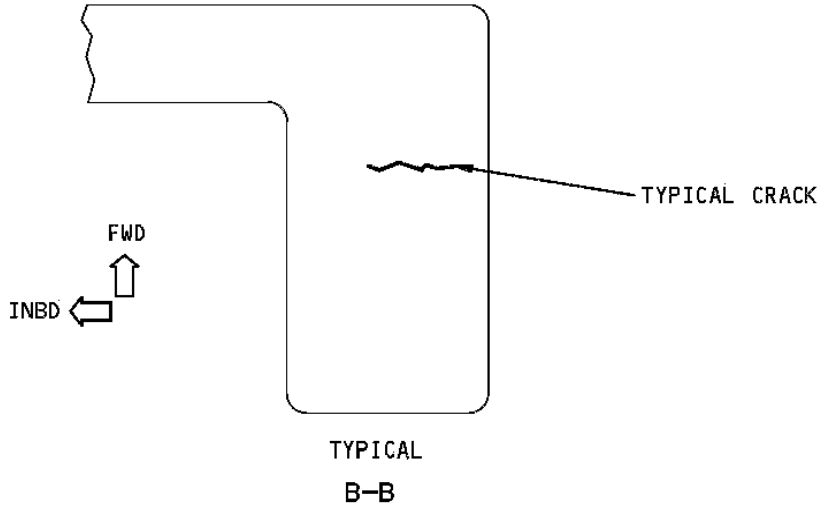
<p style="text-align: center;"> <b>LEFT SIDE CABIN FLOOR</b>  (VIEW FROM BELOW, LOOKING FORWARD) </p>		
<b>FIGURE 10: RIGHT BODY TERMINAL FITTING ULTRASONIC INSPECTION - BODY STATION 820.</b> (SHEET 1 OF 3)

MAINT	RII/INSP
<p>(3) Do an ultrasonic inspection for any internal crack of the right body terminal fitting on the STA 820 bulkhead as given in Figure 10.</p> <p>(a) If no crack is found:</p> <p>1) If the modification is not in accordance with Boeing Service Bulletin 707-2912 R01 Accomplishment Instructions, PART II. PREVENTIVE MODIFICATION DATA, remove the modification, contact Boeing for repair instructions and do the work instructed by Boeing.</p> <p>2) If the modification is in accordance with Boeing Service Bulletin 707-2912 R01 Accomplishment Instructions, PART II. PREVENTIVE MODIFICATION DATA, no more work is necessary.</p> <p>(b) If any crack is found:</p> <p>1) If the modification or repair was installed as given in Boeing Service Bulletin 707-2912 R01, inspect the crack to verify that the modification or repair still meets the requirements of Boeing Service Bulletin 707-2912 R01.</p> <p>a) If the crack is within the repair limits of the modification or repair as given in Boeing Service Bulletin 707-2912 R01, no more work is necessary.</p> <p>b) If the crack has grown beyond the repair limits of the modification or repair as given in Boeing Service Bulletin 707-2912 R01, but is still within the repair limits of Boeing Service Bulletin 707-2912 R01, Accomplishment Instructions, PART III. REPAIR DATA, repair the crack as given in Boeing Service Bulletin 707-2912 R01, Accomplishment Instructions, PART III. REPAIR DATA.</p> <p>c) If the crack has grown beyond the repair limits of Boeing Service Bulletin 707-2912 R01, contact Boeing for new repair instructions and do the work instructed by Boeing.</p> <p>2) If the modification or repair was not installed as given in Boeing Service Bulletin 707-2912 R01, remove the modification or repair and do the ultrasonic inspection. Contact Boeing for new repair instructions and do the work instructed by Boeing.</p>

(a) Do the inspection as given in 707, 720 NDT Part 4, 53-10-07 Figure 1.					
(b) 707, 720 NDT Part 4, 53-10-07 Figure 1 was intended for use in monitoring crack propagation, but can also be used for crack detection.
