<b>sabena</b> <sup>®</sup> <b>B707</b>	Module: GENERAL	A/C Reg :	Check :

<b>02F3000001</b>
	Oper. : RT-MP HT			
	Type : STRUCT-INSP	Issuer : A62165	Cert.St.: 50516	
Spec. : MECH. INSP	Release Date: 21.05.2010		Page 1 of 25

**AD 2009-18-10      BS600K & BS820 TERMINAL FITTING INSPECTION**

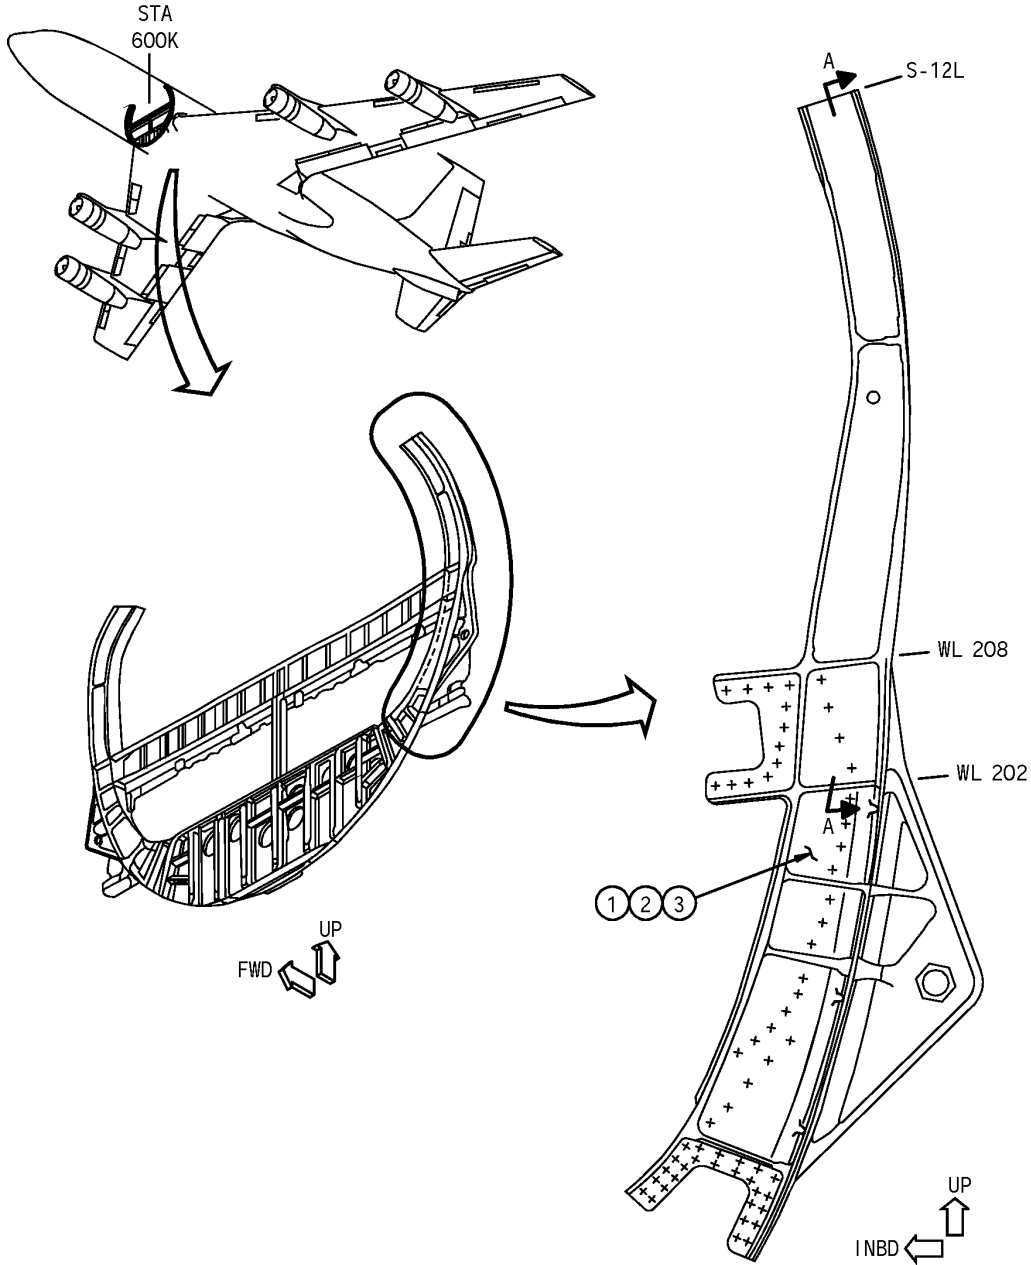
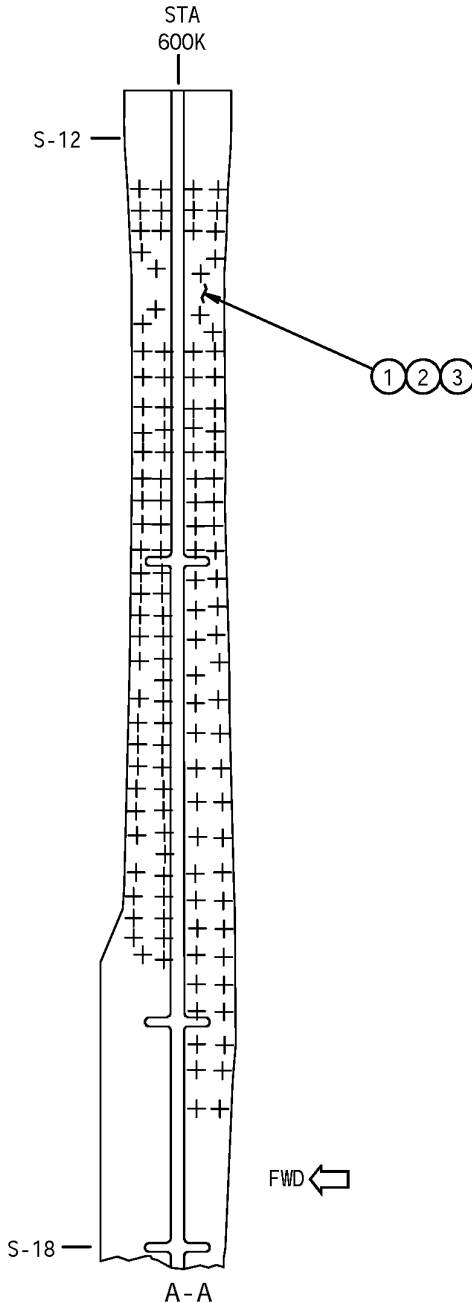
FIGURE 3: GROUP 2 - LEFT BODY TERMINAL FITTING INSPECTION - BODY STATION 600K.  
(SHEET 1 OF 3)

3. Do a detailed inspection of the left body terminal fitting at STA 600K as given in Figure 3.
  - a) If any crack or corrosion is found, contact Boeing for repair instructions or for instructions to replace the body terminal fitting with a body terminal fitting made from 7075-T73 material. Provide a detailed description of any crack or corrosion to Boeing when requesting repair instructions.

- b) If there is an existing repair, inspect the repair for any crack or corrosion.
    - 1) If no crack or corrosion is found, it is not necessary to remove the repair.

- 2) If any crack or corrosion is found, remove the repair & do a detailed inspection of the fitting in the area covered by the repair. Send a detailed description of any crack or corrosion to Boeing & request repair instructions.

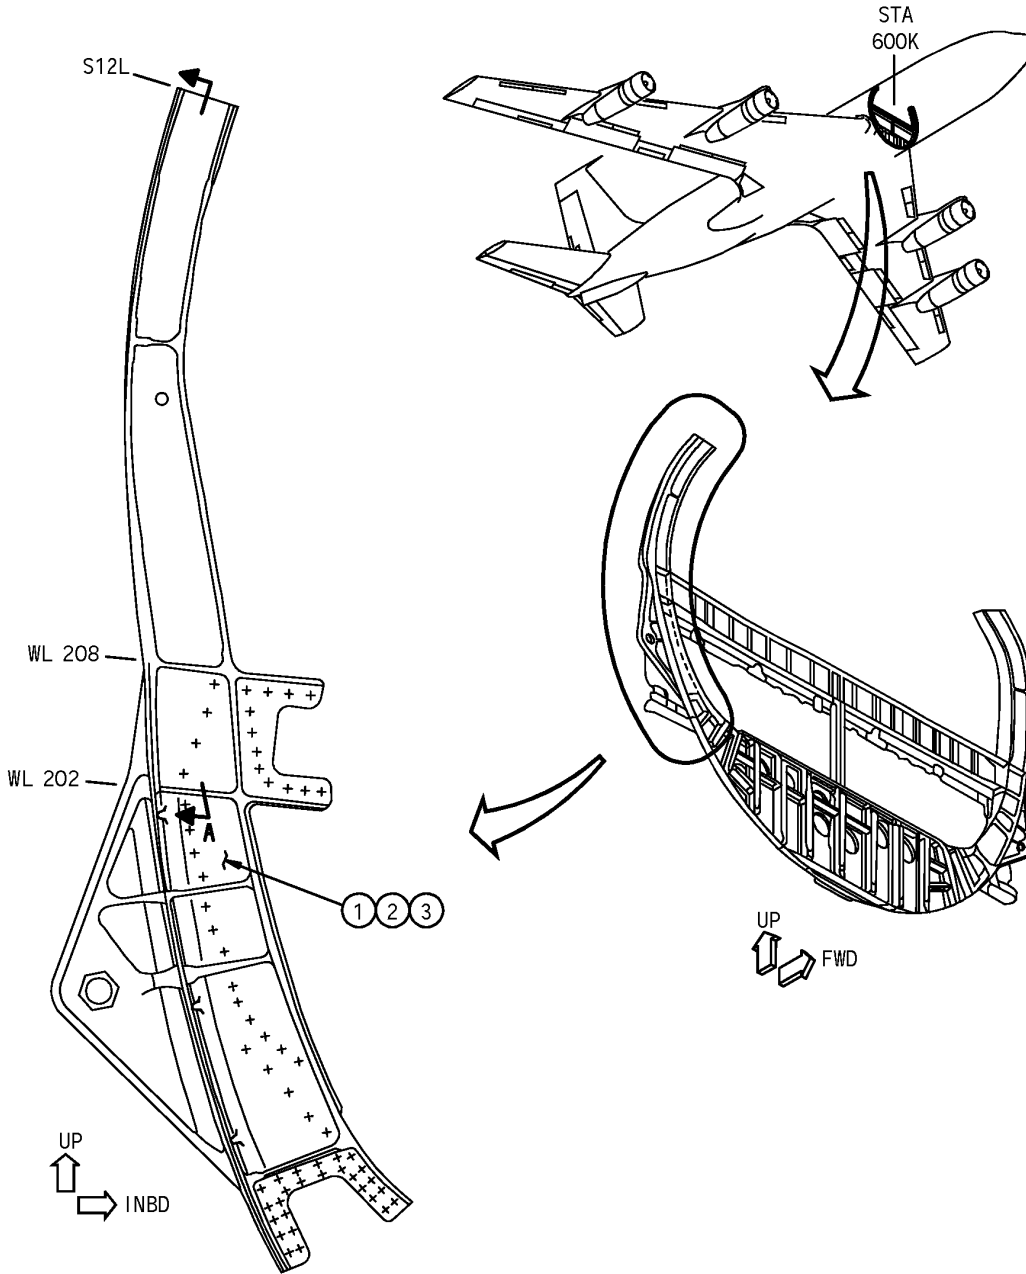
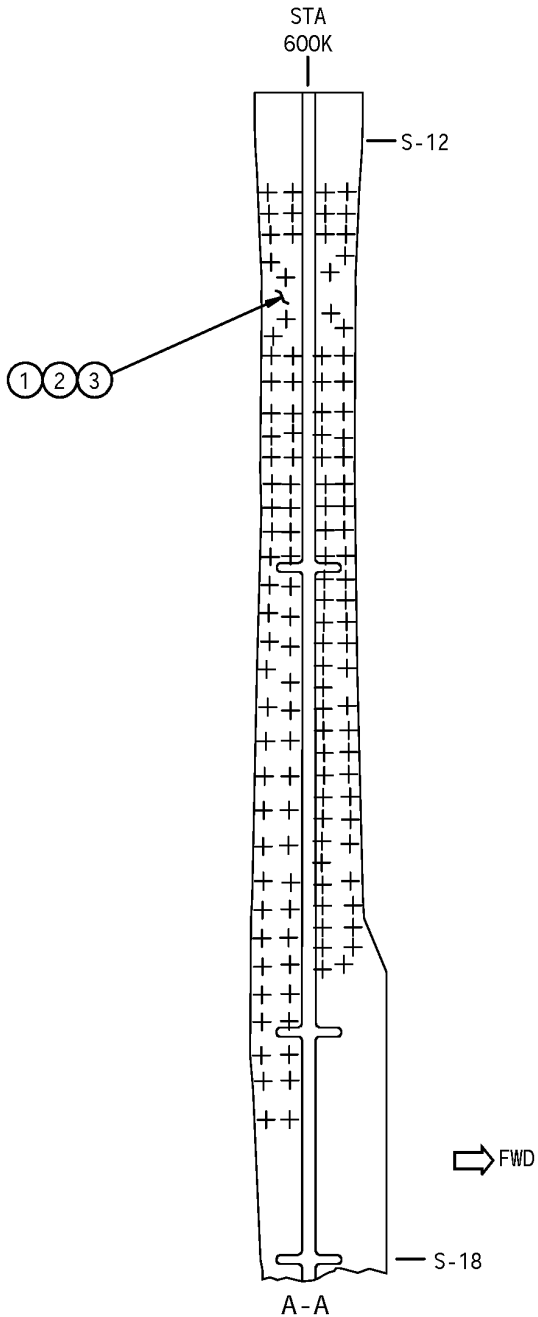
**FIGURE 4: GROUP 2 - RIGHT BODY TERMINAL FITTING INSPECTION - BODY STATION 600K.**  
(SHEET 1 OF 3)

4. Do a detailed inspection of the right body terminal fitting at STA 600K as given in Figure 4.
  - a) If any crack or corrosion is found, contact Boeing for repair instructions or for instructions to replace the body terminal fitting with a body terminal fitting made from 7075-T73 material. Provide a detailed description of any crack or corrosion to Boeing when requesting repair instructions.

- b) If there is an existing repair, inspect the repair for any crack or corrosion.
    - 1) If no crack or corrosion is found, it is not necessary to remove the repair.

- 2) If any crack or corrosion is found, remove the repair & do a detailed inspection of the fitting in the area covered by the repair. Send a detailed description of any crack or corrosion to Boeing & request repair instructions.

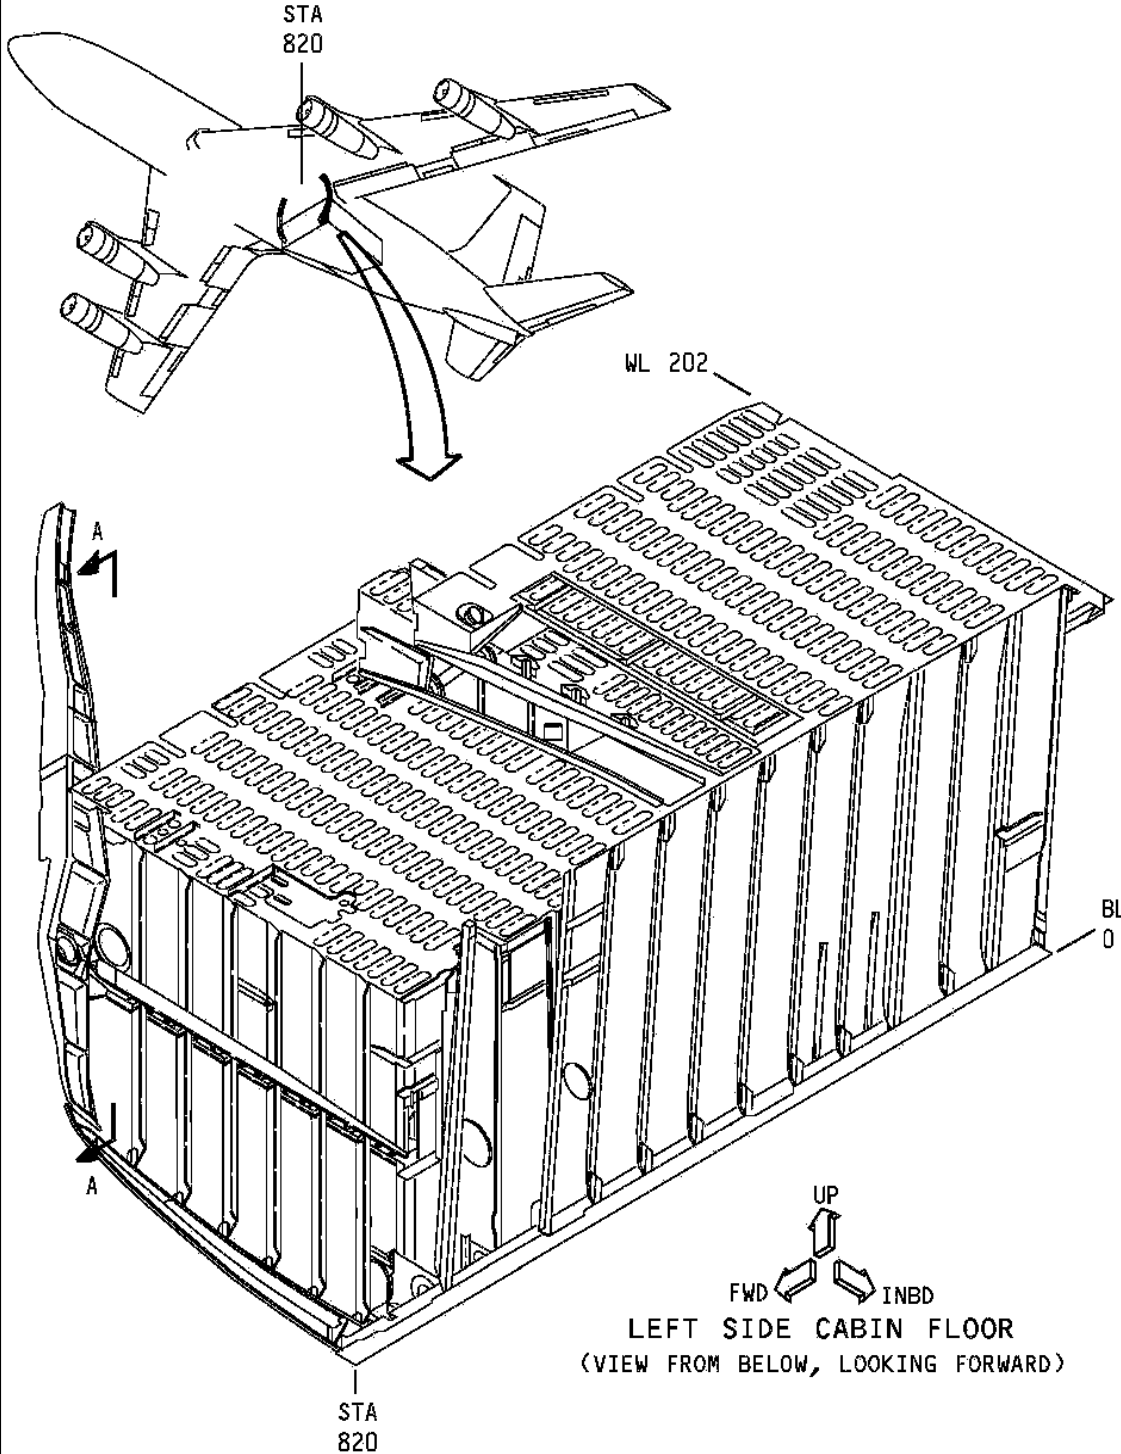
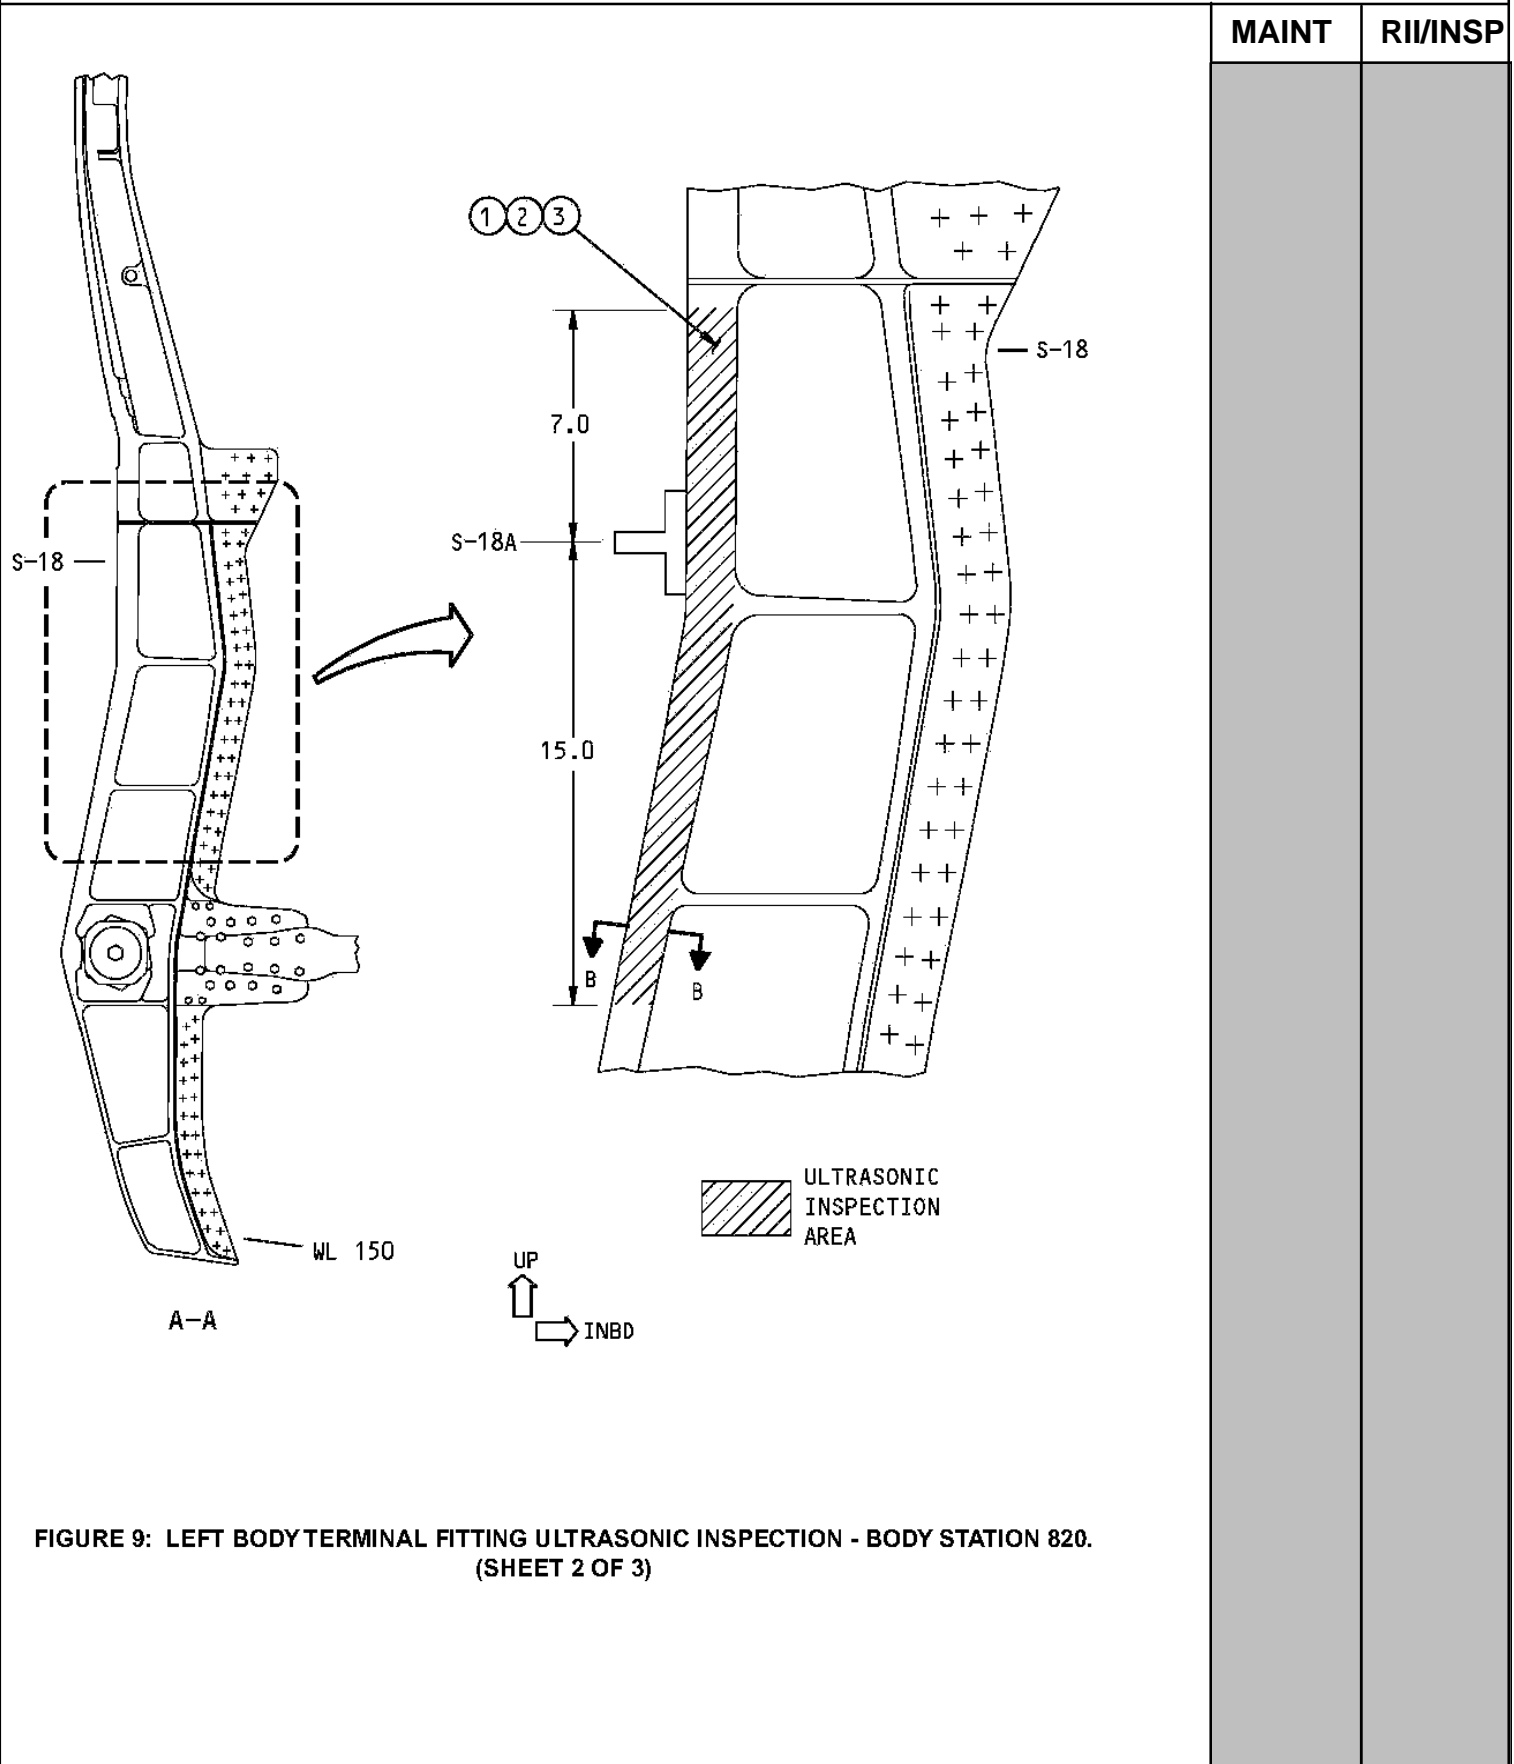
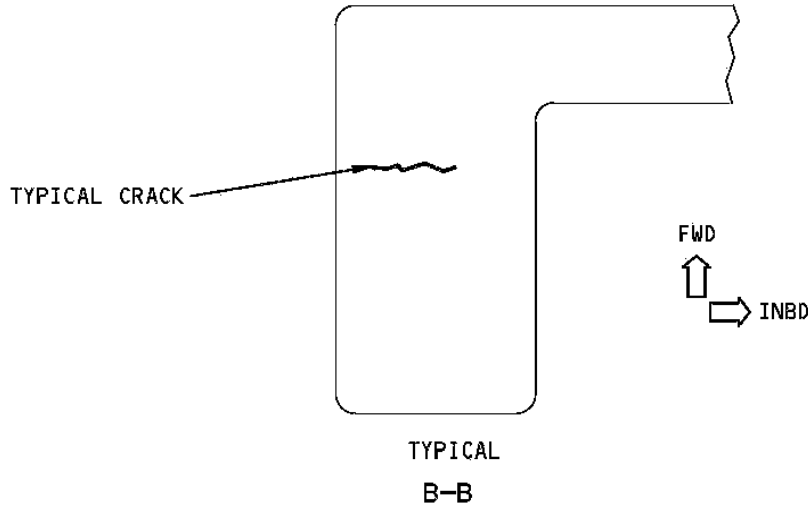
<p style="text-align: center;"> <b>FIGURE 9: LEFT BODY TERMINAL FITTING ULTRASONIC INSPECTION - BODY STATION 820.</b>  <b>(SHEET 1 OF 3)</b> </p>

- (1) Get access to the body terminal fittings at STA 820 below the cabin floor level through the main landing gear wheel well.
  - (2) Do an ultrasonic inspection for any internal crack in the left body terminal fitting on the STA 820 bulkhead as given in Figure 9.

- (a) If no crack is found:
      - 1) If the modification is not in accordance with Boeing Service Bulletin 707-2912 R01 Accomplishment Instructions, PART II. PREVENTIVE MODIFICATION DATA, remove the modification, contact Boeing for repair instructions and do the work instructed by Boeing.

- 2) If the modification is in accordance with Boeing Service Bulletin 707-2912 R01 Accomplishment Instructions, PART II. PREVENTIVE MODIFICATION DATA, no more work is necessary.

- (b) If any crack is found:
      - 1) If the modification or repair was installed as given in Boeing Service Bulletin 707-2912 R01, inspect the crack to verify that the modification or repair still meets the requirements of Boeing Service Bulletin 707-2912 R01.

- a) If the crack is within the repair limits of the modification or repair as given in Boeing Service Bulletin 707-2912 R01, no more work is necessary.

- b) If the crack has grown beyond the repair limits of the modification or repair as given in Boeing Service Bulletin 707-2912 R01, but is still within the repair limits of Boeing Service Bulletin 707-2912 R01, Accomplishment Instructions, PART III. REPAIR DATA, repair the crack as given in Boeing Service Bulletin 707-2912 R01, Accomplishment Instructions, PART III. REPAIR DATA.

- c) If the crack has grown beyond the repair limits of Boeing Service Bulletin 707-2912 R01, contact Boeing for new repair instructions and do the work instructed by Boeing.

- 2) If the modification or repair was not installed as given in Boeing Service Bulletin 707-2912 R01, remove the modification or repair and do the ultrasonic inspection. Contact Boeing for new repair instructions and do the work instructed by Boeing.

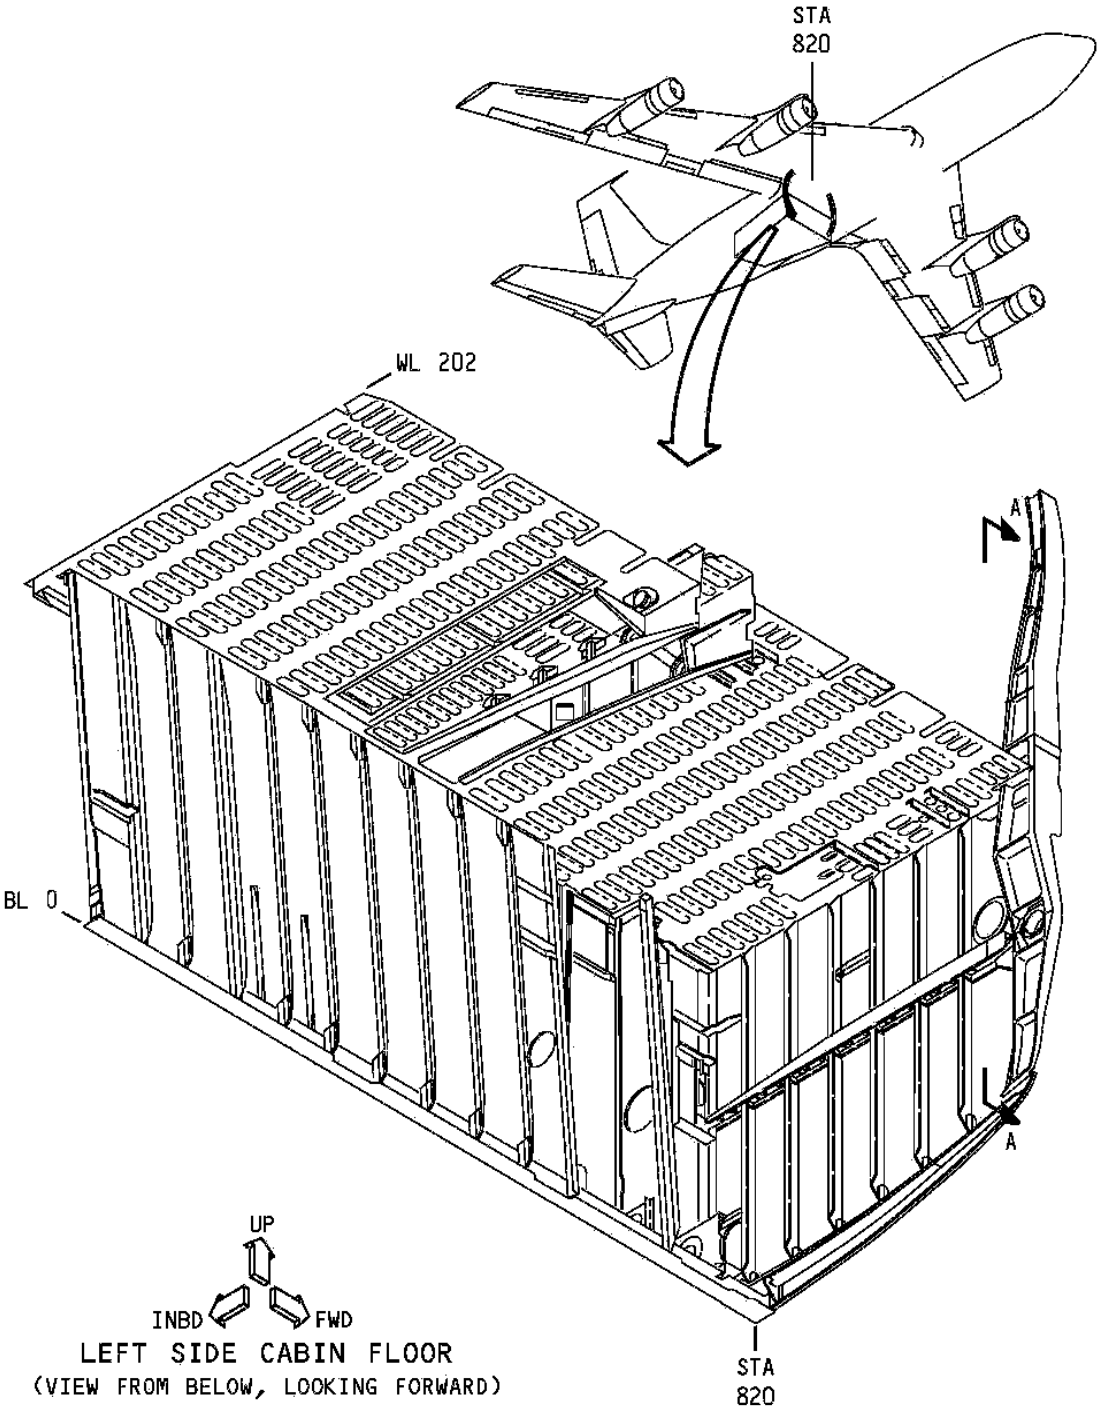
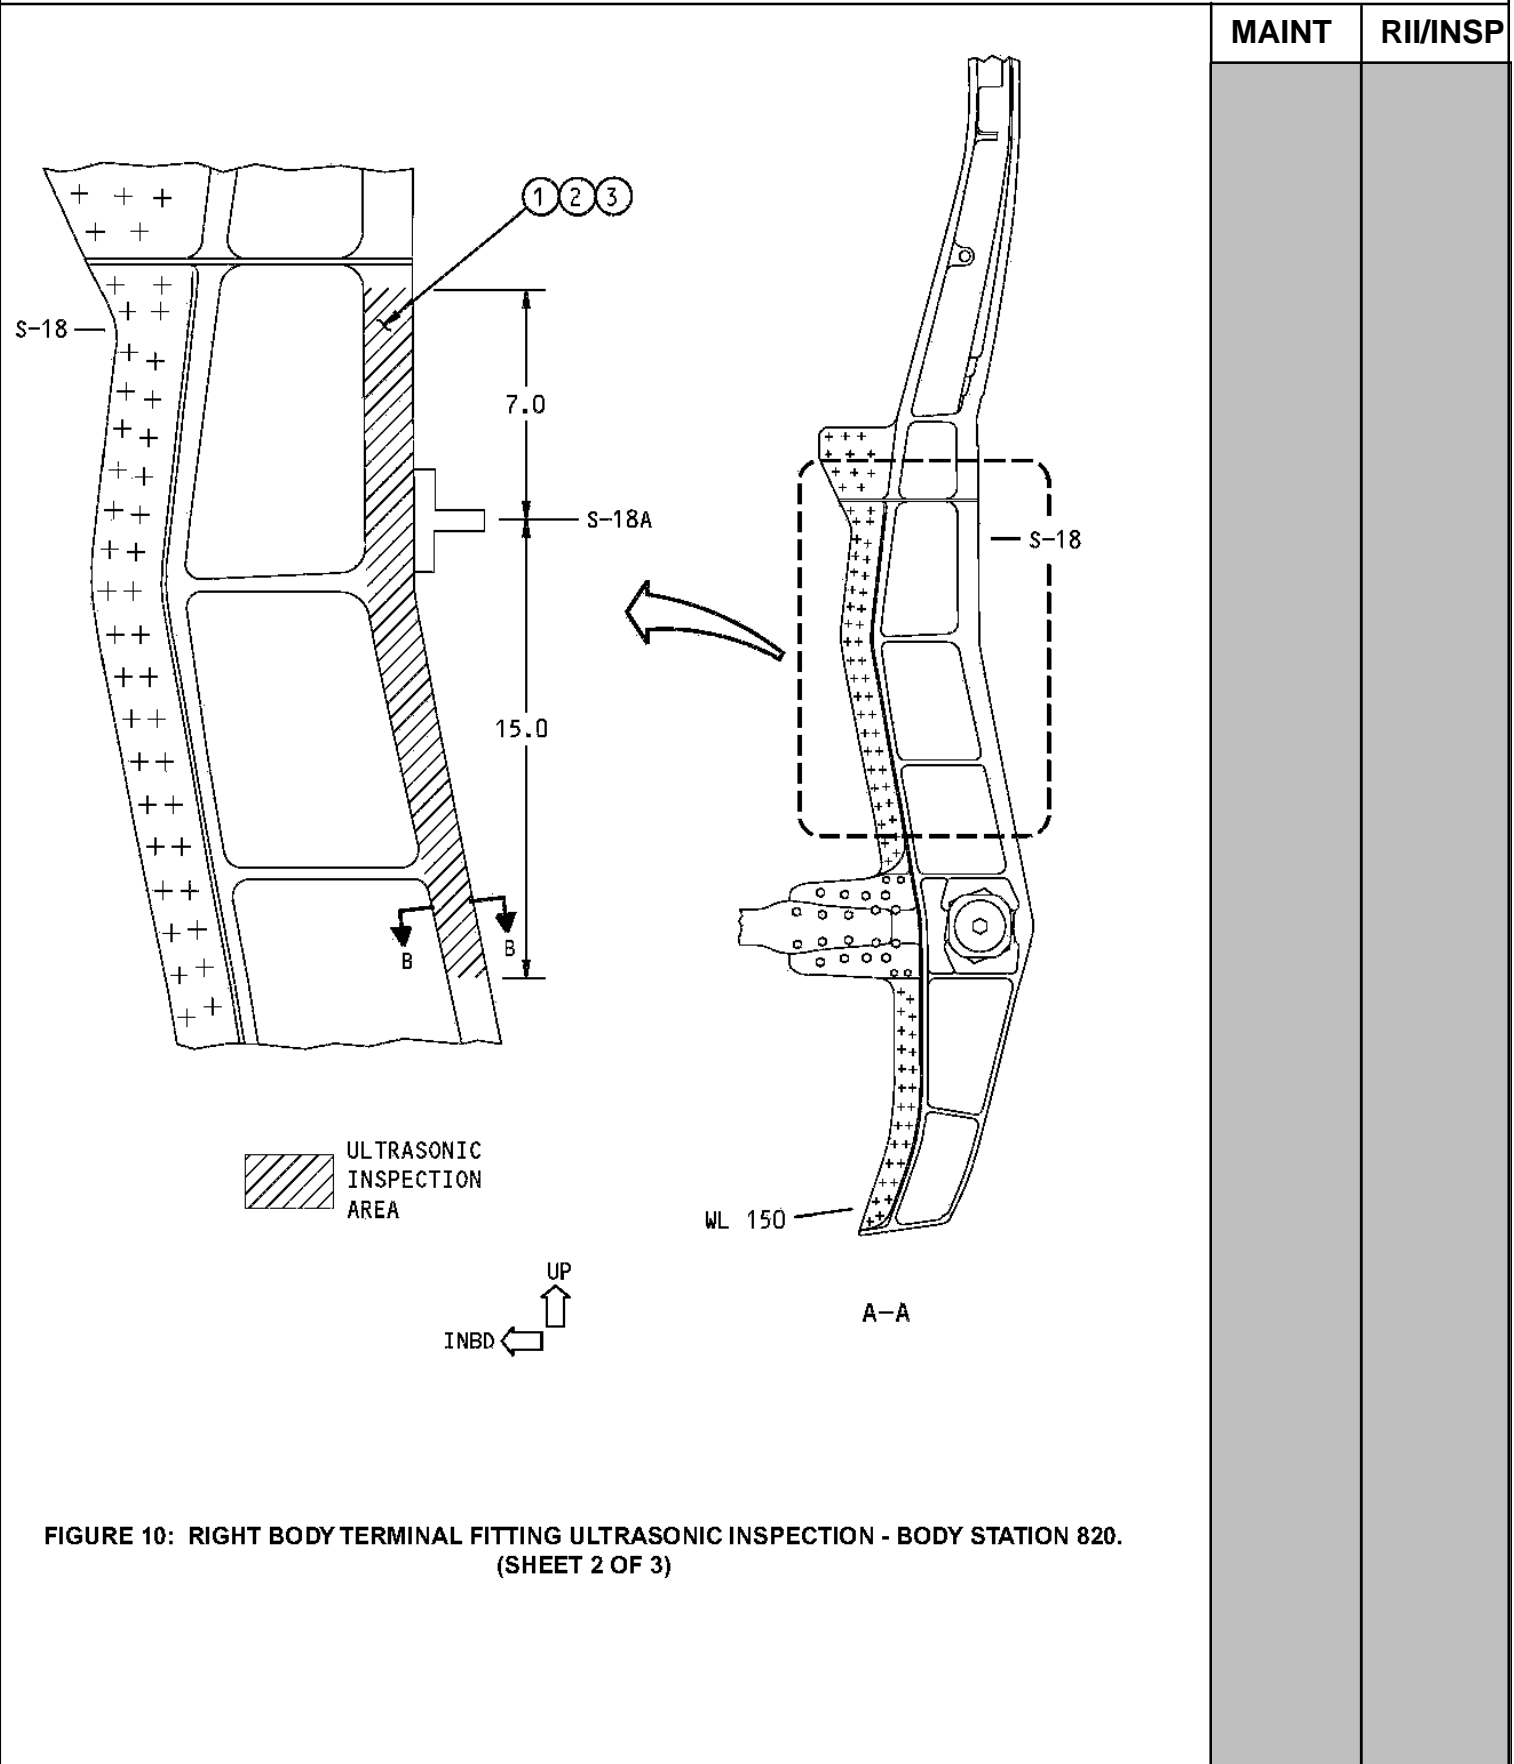
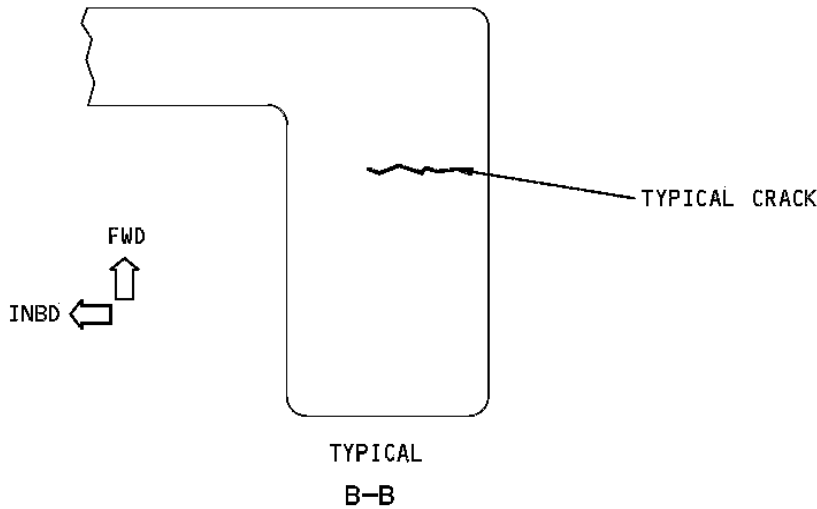
<p style="text-align: center;"> <b>LEFT SIDE CABIN FLOOR</b>  (VIEW FROM BELOW, LOOKING FORWARD) </p>		
<b>FIGURE 10: RIGHT BODY TERMINAL FITTING ULTRASONIC INSPECTION - BODY STATION 820.</b> (SHEET 1 OF 3)

MAINT	RII/INSP
<p>(3) Do an ultrasonic inspection for any internal crack of the right body terminal fitting on the STA 820 bulkhead as given in Figure 10.</p> <p>(a) If no crack is found:</p> <p>1) If the modification is not in accordance with Boeing Service Bulletin 707-2912 R01 Accomplishment Instructions, PART II. PREVENTIVE MODIFICATION DATA, remove the modification, contact Boeing for repair instructions and do the work instructed by Boeing.</p> <p>2) If the modification is in accordance with Boeing Service Bulletin 707-2912 R01 Accomplishment Instructions, PART II. PREVENTIVE MODIFICATION DATA, no more work is necessary.</p> <p>(b) If any crack is found:</p> <p>1) If the modification or repair was installed as given in Boeing Service Bulletin 707-2912 R01, inspect the crack to verify that the modification or repair still meets the requirements of Boeing Service Bulletin 707-2912 R01.</p> <p>a) If the crack is within the repair limits of the modification or repair as given in Boeing Service Bulletin 707-2912 R01, no more work is necessary.</p> <p>b) If the crack has grown beyond the repair limits of the modification or repair as given in Boeing Service Bulletin 707-2912 R01, but is still within the repair limits of Boeing Service Bulletin 707-2912 R01, Accomplishment Instructions, PART III. REPAIR DATA, repair the crack as given in Boeing Service Bulletin 707-2912 R01, Accomplishment Instructions, PART III. REPAIR DATA.</p> <p>c) If the crack has grown beyond the repair limits of Boeing Service Bulletin 707-2912 R01, contact Boeing for new repair instructions and do the work instructed by Boeing.</p> <p>2) If the modification or repair was not installed as given in Boeing Service Bulletin 707-2912 R01, remove the modification or repair and do the ultrasonic inspection. Contact Boeing for new repair instructions and do the work instructed by Boeing.</p>
