<b>sabena</b> <sup>®</sup> <b>B707</b>	Module: LWR FUS / EMPENA	A/C Reg :	Check :

<b>21E0000506</b>
	Oper. : RT-MP LC			
	Type : * ZONAL INSP*	Issuer : A43710	Cert.St.: 24828	<b>Page 1 of 2</b>
Spec. : MECHANIC	Release Date: 11.10.2001

AD 91-07-07 rev 6943                      CENTER SECT FRONT SPAR UP LUG INSP

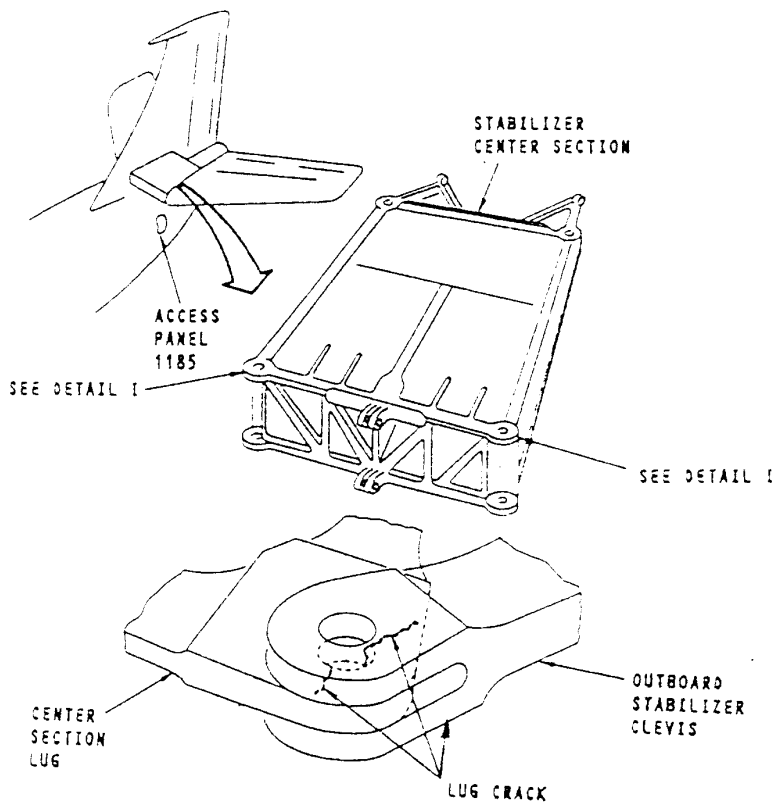
FIGURE 2. CENTER SECTION LUG INSPECTION

1. Close visual inspection of the lugs for cracks with special attention to the fwd inb and aft outb areas of the lugs (fig 2).
2. If no cracks are found: Ultrasonic inspection (Doc. D6-48023 P4, Subj 55-10-07, Fig 1&2).
3. Apply BMS 3-23.
