sabena [®] B707	Module: HOR STAB + FL CT	A/C Reg :	Check :

LH LWR HOR STAB FRONT SPAR SPLICE & CHORD INSP

MAINT	RII/INSP
Nr.	Hardtime	Task	Spec.	Related Documents		
1.		E3 E4	MEC	AD 94-10-06 rev 8913 MMS-328 551140 01002 rev 15/05/01 SB 55-3145 rev .		
Check: C						
Zones: 391						
Access:						
<u>LH HORIZONTAL STABILIZER LOWER FRONT SPAR SPLICE & CHORD STA. 11.55 INSPECTION.</u>

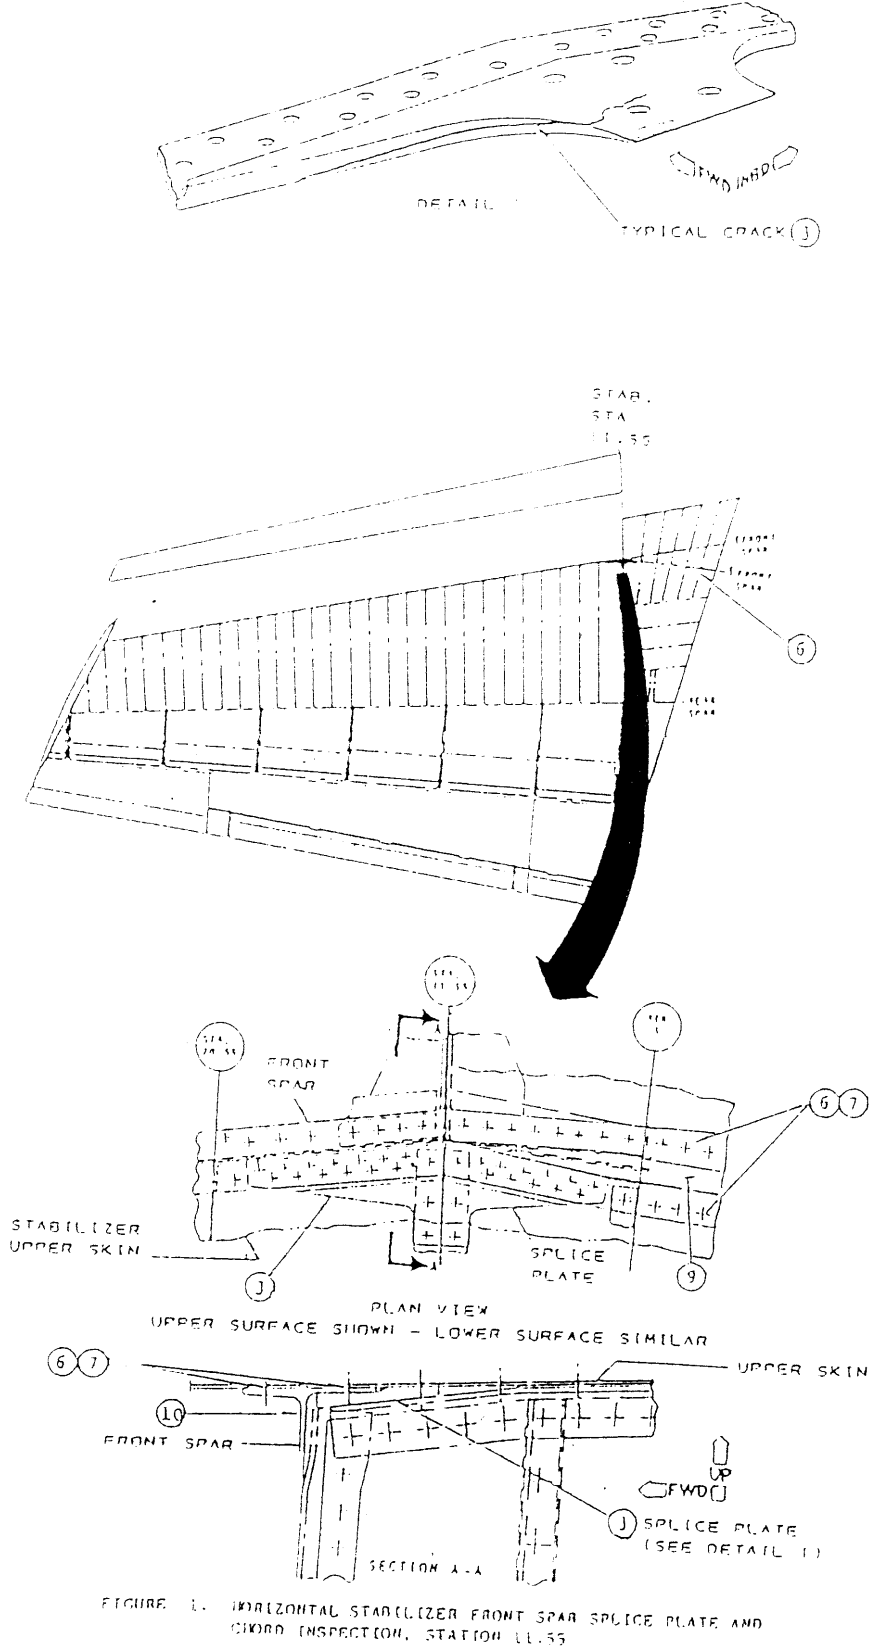
1. Visually inspect both the upper and lower front spar chord splice plate for corrosion and cracking. Typical cracks reported are shown in det. 1. The outboard leg of the splice is the only area easily accessible. The inboard leg can be viewed through an access opening in the stabilizer lower skin immediately aft of the inboard end of the front spar (3).

2. Between st. 11.55 and the inboard end of the front spar, visually inspect for skin bulges around and between the fasteners attaching the skin to the upper and lower spar chord forward and aft flanges. Bulges are indicative of corrosion and laminar cracks in the flange (6).

3. If no bulges are found, do a LOW FREQUENCY EDDY CURRENT inspection of the front spar upper chord fwd flange and the lower chord forward and aft flanges per Boeing NTM D6-48023 p6. sub 55-10-07 fig 8. The inspection will detect corrosion and cracks that have not developed enough to cause bulging (7).

4. In addition to the foregoing inspections, inspect the raised portion of the chord between the fwd edge of the interspar skins and the aft edges of the leading edge of skin (9).

5. Inspect for surface cracks at the fwd and aft edges, using a HIGH FREQUENCY EDDY CURRENT inspection surface probe per D6-48023 p6, sub 51-00-00 fig 4 and ultrasonically inspect for laminar cracks per D6-48023 p4, sub 57-10-07 fig 12 (9).

6. Visually inspect the front surface and the exposed area of the aft surface of the vertical flange of the upper and lower chord for cracks and corrosion. Also check the spar web for bulges at and between the fasteners attaching the web to the vertical flanges (10).

7. If no corrosion or cracking is found, or minor surface corrosion is cleaned up, apply a liberal coating of water inhibiting compound AV 30 to the plates. See structural repair manual subject 51-8-0.
