DFW B707-56-001 rev 22/11/2007

COCKPIT - WINDOW NR 3 INITIAL INSPECTION

Component / Equipment Type: Windows - Flight Deck Number 3 Window**Accomplishment Report****Note:**

Subject: Control Cabin Windows - Fixed Windows - Window number 3 - Inspection and Replacement**Model:** TCA - B707**Accomplished at (Tailnumber):****Date of Accomplishment:****Description of Deviations:****Findings:****Carry Overs:****SOR Statements:****Executed/performed by:****SOR Engineering Representative:****SOR Quality Assurance:**

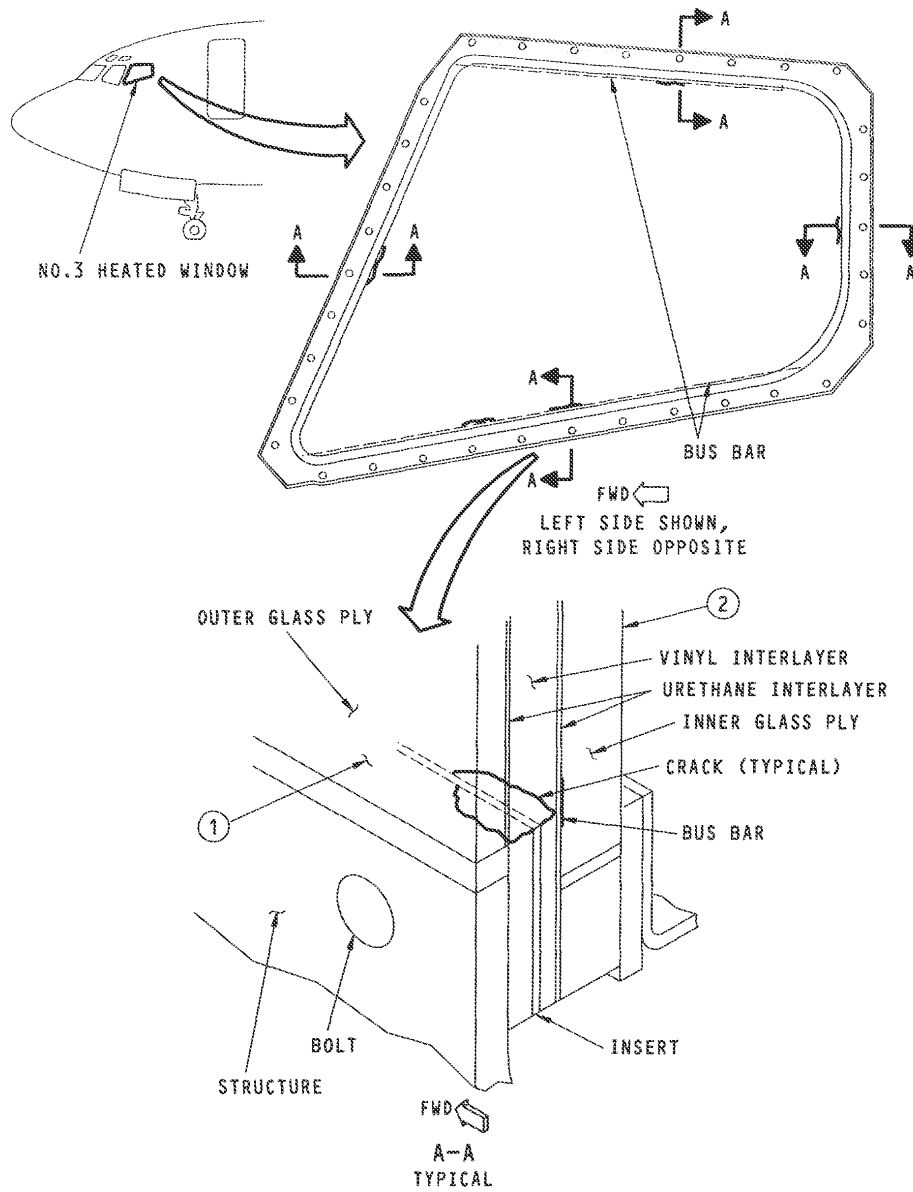
FIGURE 2

2. Perform close visual Inspection of both (LH & RH) Number 3 window for vinyl interlayer cracking in accordance with figure 1. Vinyl cracks may form along the inner edge of the window insert & extend inboard through the vinyl interlayer.

In case of window replacement : Refer to Section 3 – Accomplishment Instructions of SB 3501/ work instruction B to comply with the different pressure seal requirements depending of installed window part number.

Terminating action for this SB requirement is only when both LH & RH cabin window Nr.3 heated windows are replaced with the new heated window design PN 05-89356-41/-42.
