sabena [®] B707	Module: COCKPIT + WINDOW	A/C Reg :	Check :

DFW 56-002 rev 23/11/2007

COCKPIT – WINDOWS NR 2, 4 & 5 INITIAL INSPECTION

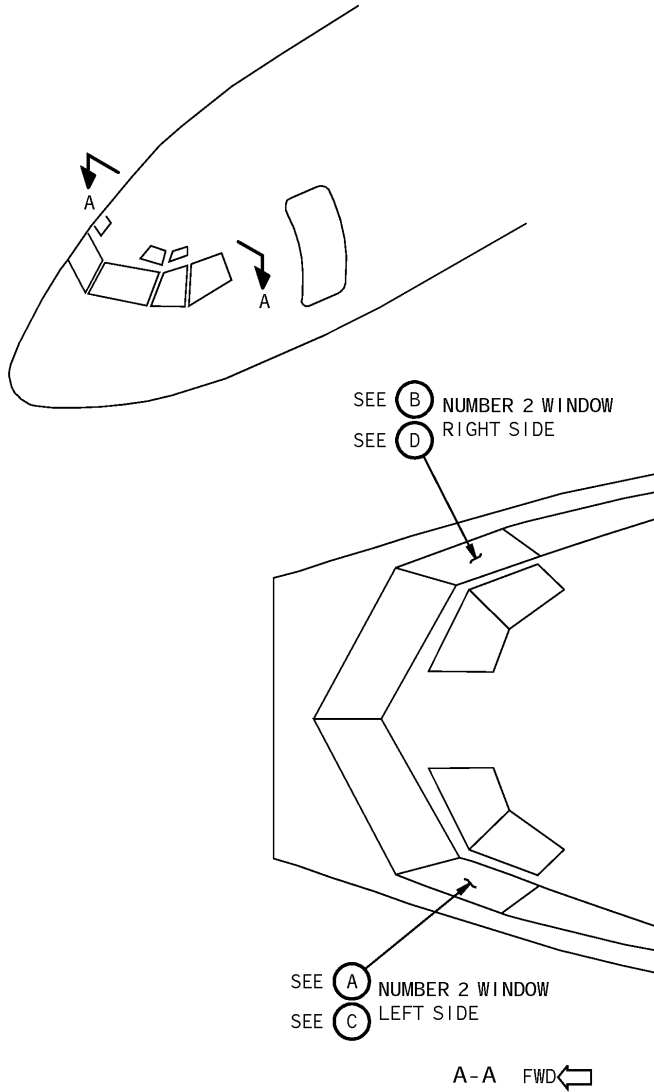
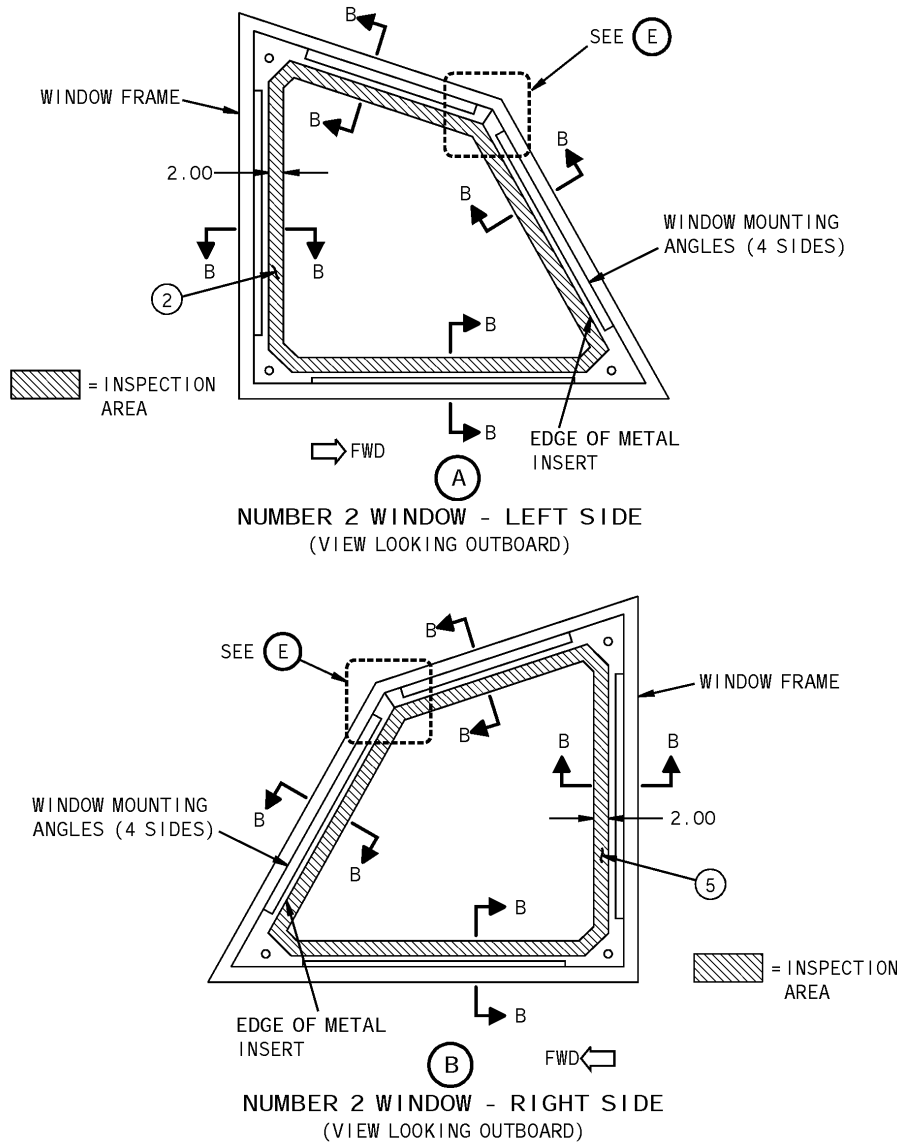
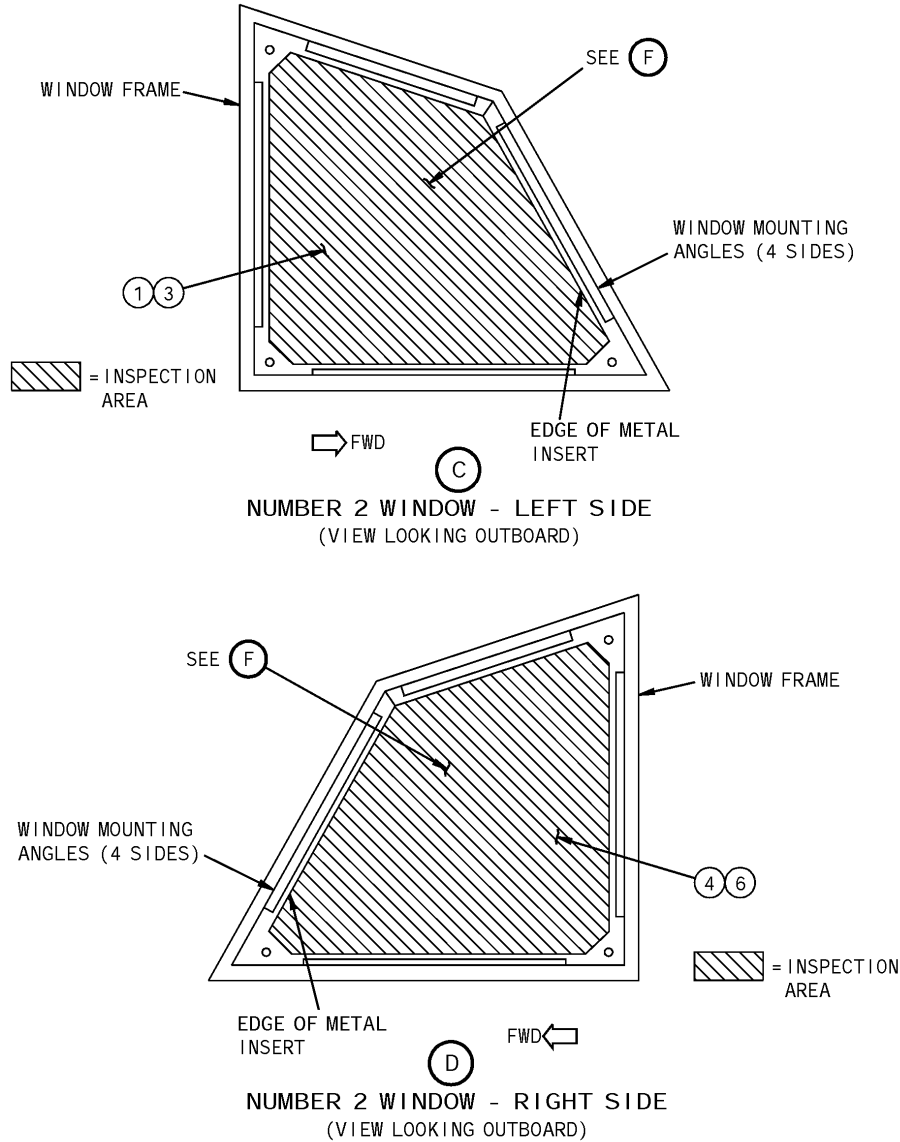
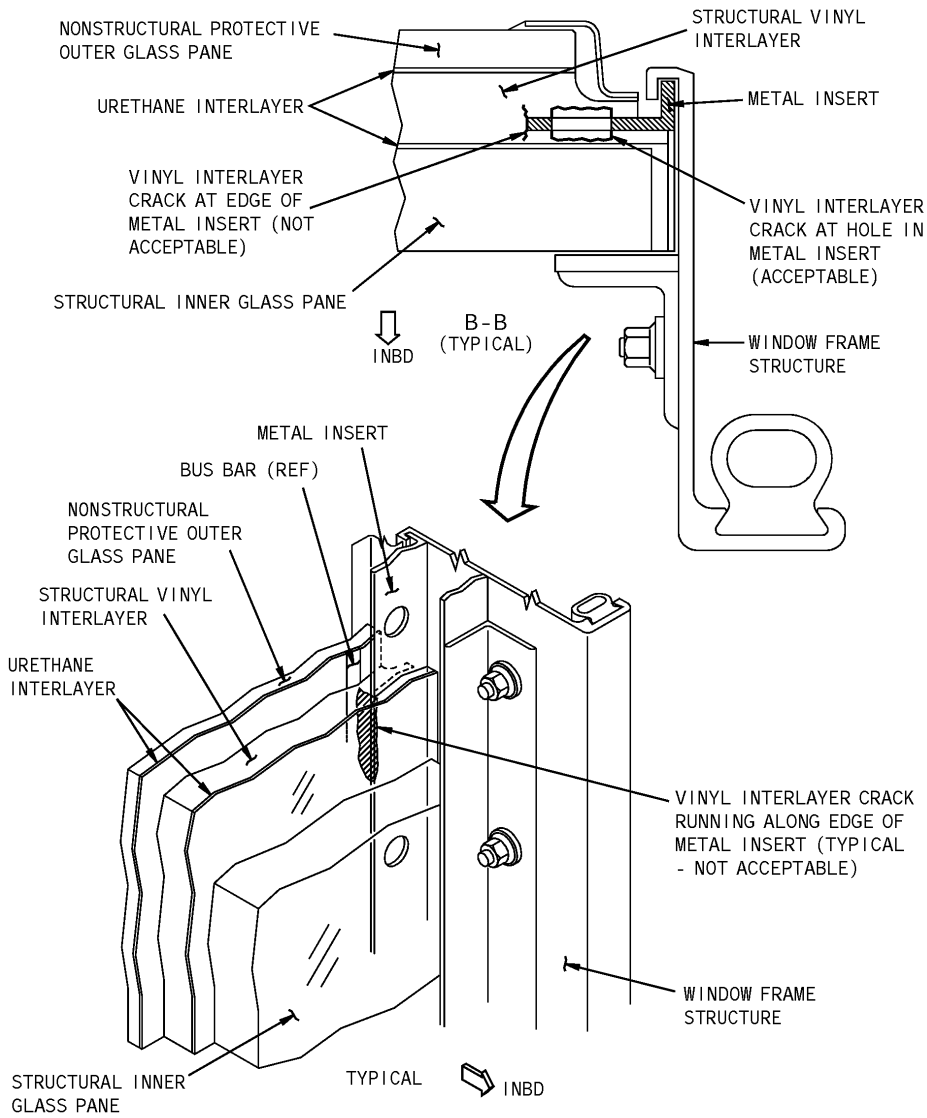
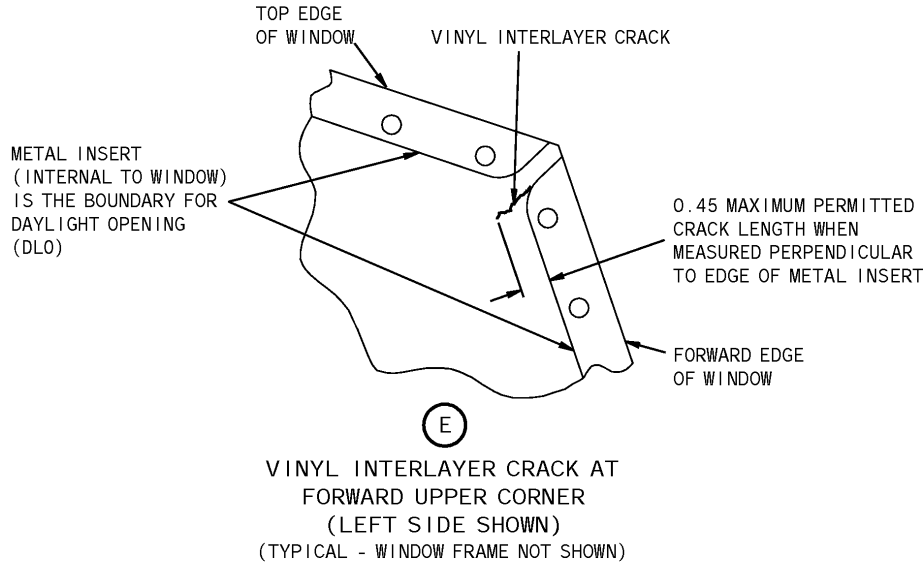
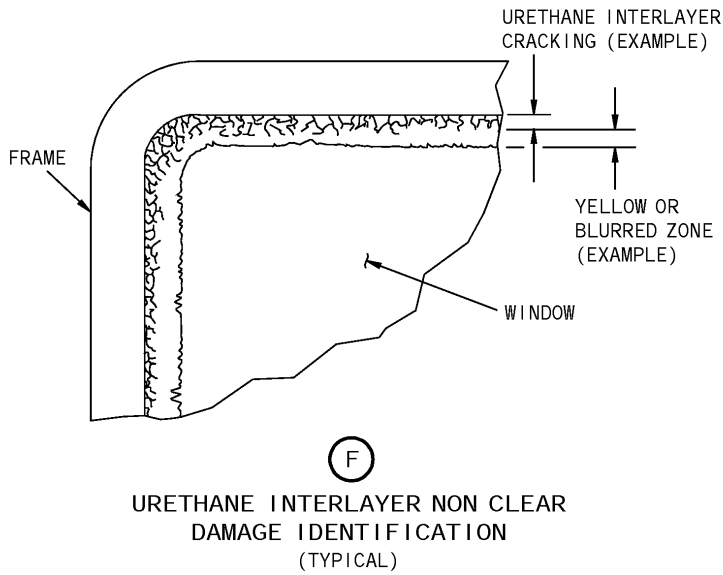
FIGURE 1: FLIGHT DECK NUMBER 2 WINDOW - INTERNAL AND EXTERNAL INSPECTION
 June 04, 2007 (SHEET 1 OF 6)

1) If any of the following conditions are found, do Alert SB 3526 Part 4 – Flight Deck Number 2 Window replacement:

- a) The window has a vinyl interlayer crack the runs along the parallel to the long edges of the metal insert.

MAINT	RII/INSP
<p>NOTE: Cylindrical cracking in vinyl interlayer at the holes in the metal insert is acceptable & not cause for window replacement (See view B-B, Fig.1).</p> <p>b) The window has a vinyl interlayer crack in the forward upper corner that exceeds the limits in Figure 1.</p> <p>c) The window has any non-clear damage which impairs inspection of the above types of damage.</p> <p>NOTE: White or yellow discoloration & cracking of the urethane interlayer is considered to be acceptable, as long as the pilot's vision is not obscured & inspection for other damage is not impaired. This should not be confused with cracking in the vinyl interlayer.</p> <p>2. PART 2 – Flight deck number 4 window inspection</p>		
<u>WINDOW NR.4 LH SIDE</u>		
<u>WINDOW NR.4 RH SIDE</u>		
<p>WARNING: REMOVE POWER FROM THE WINDOW HEAT SYSTEM BEFORE INSPECTING THE WINDOW. IF WINDOW POWER IS ON, AN ELECTRICAL SHOCK CAN OCCUR WHEN THE WINDOW IS TOUCHED. AN ELECTRICAL SHOCK CAN CAUSE INJURIES TO PERSONNEL.</p> <p>a. Make sure that power is OFF to the window heating system.</p> <p>b. Do an Internal & External Detailed Inspection of LH side & RH side flight deck number 4 window for cracking & damage as given in Figure 2.</p> <p>NOTE: Color photographs of typical flight deck number 4 window damage can be found in Fleet Team Digest Article 707-FTD-56-05001. This article can be accessed through the MyBoeingFleet web-site, or you may obtain copies from your local Boeing Field Service office.</p> <p>1) If any of the following conditions are found, do Alert SB 3526 Part 5 – Flight Deck Number 4 Window replacement:</p> <p>a) The window has a crack in any structural vinyl interlayer.</p> <p>b) The window has vinyl separation.</p> <p>c) The window has a crack in the structural inner glass pane.</p> <p>NOTE: White or yellow discoloration & cracking in this layer of the urethane interlayer is considered to be acceptable, as long as the pilot's vision is not obscured & should not be confused with cracking in the vinyl interlayer.</p> <p>d) The window has a peel type chip in the structural inner glass pane.</p> <p>e) The window shows evidence of electrical arcing.</p> <p>f) The window has any non-clear damage which impairs inspection of the above types of damage.</p> <p>NOTE: White or yellow discoloration & cracking of the urethane interlayer is considered to be acceptable, as long as the pilot's vision is not obscured & inspection for other damage is not impaired. This should not be confused with cracking in the vinyl interlayer.</p>

STEP	TASK	NAME	QTY	MORE DATA
1	Inspect	Non-Structural Protective Outer Glass Pane - Left Side	1	(a)
		Urethane Interlayer - Left Side	2	(a) (b)
2	Inspect	Structural Vinyl Interlayer - Left Side	1	(b) (c)
3	Inspect	Structural Vinyl Interlayer - Left Side	1	(b)
4	Inspect	Non-Structural Protective Outer Glass Pane - Right Side	1	(a)
		Urethane Interlayer - Right Side	2	(a) (b)
5	Inspect	Structural Vinyl Interlayer - Right Side	1	(b) (c)
6	Inspect	Structural Vinyl Interlayer - Right Side	1	(b)

(b) White or yellow discoloration and cracking of the urethane interlayer is considered to be acceptable, as long as the pilot's vision is not obscured and should not be confused with cracking in the vinyl interlayer.

(c) Do an Internal and External Detailed Inspection for cracking around the edge of the metal insert. Cracking usually appears as thick or broken lines perpendicular to the surface of the window panes. In severe cases the vinyl interlayer can appear to stretch or separate at a crack along the metal insert.

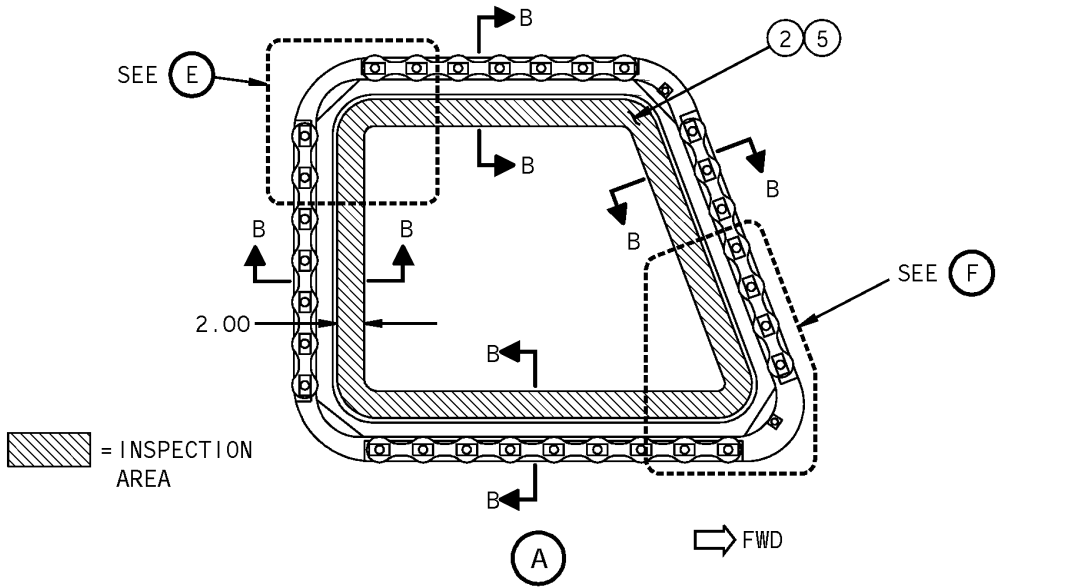
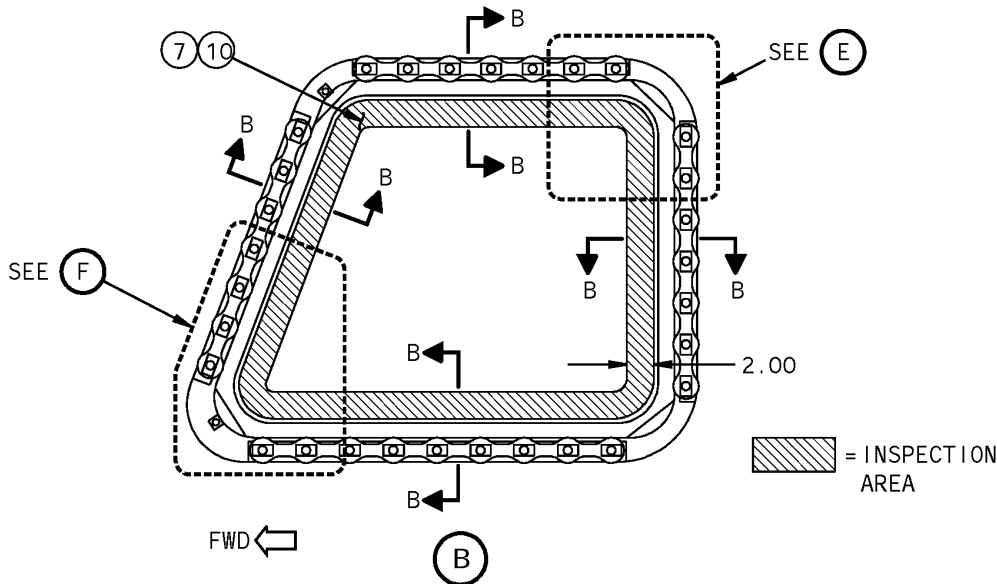
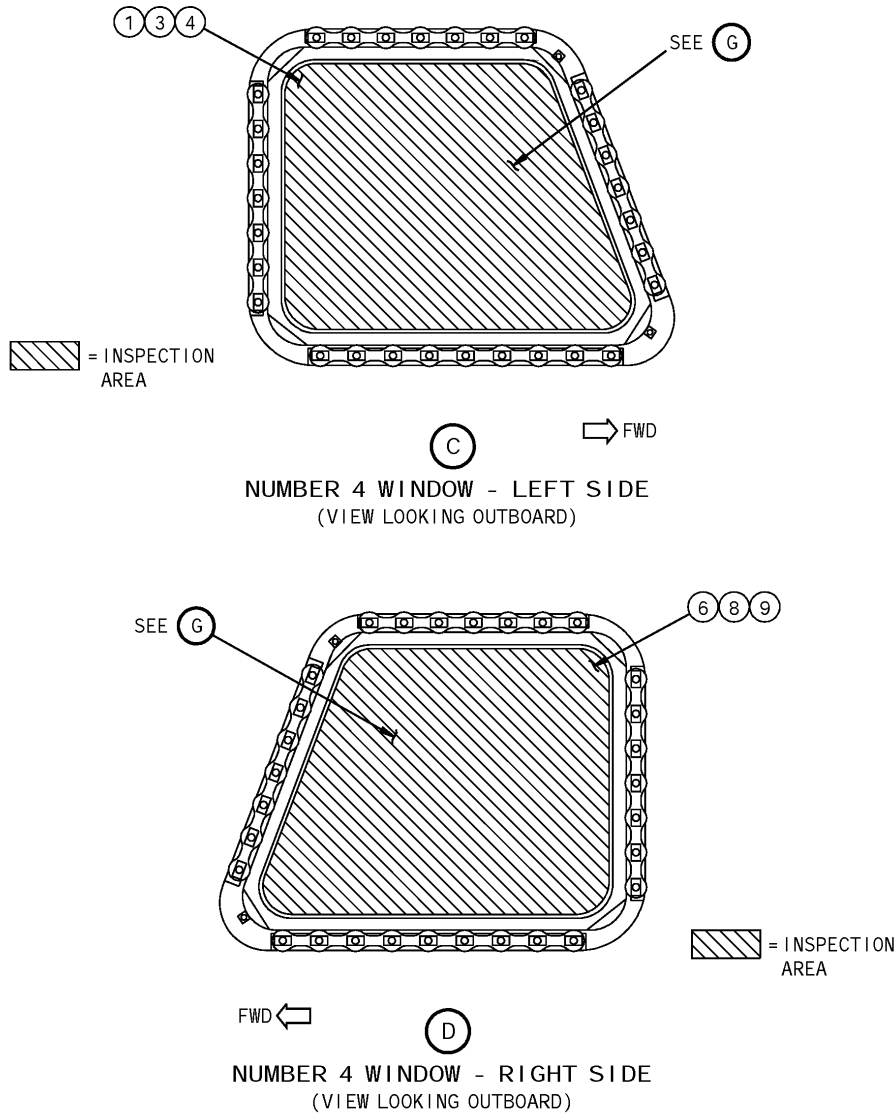
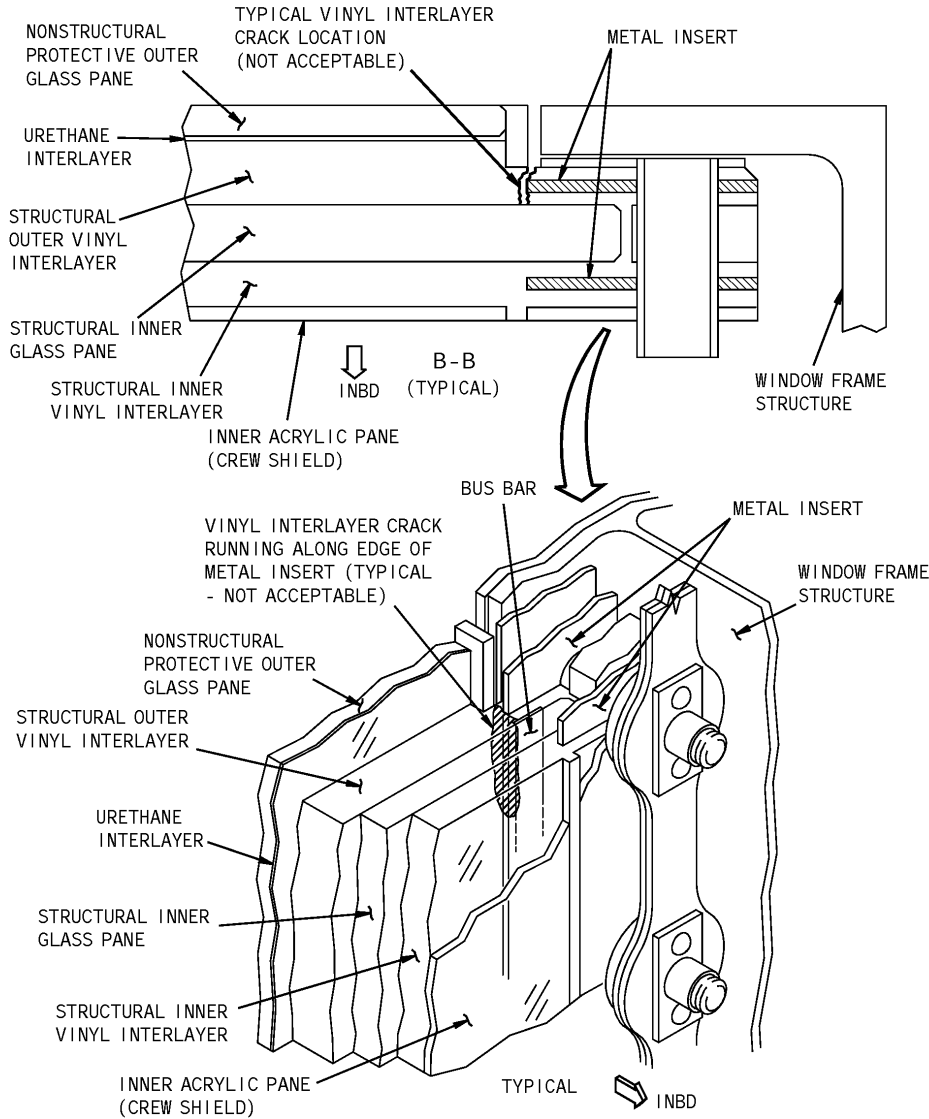
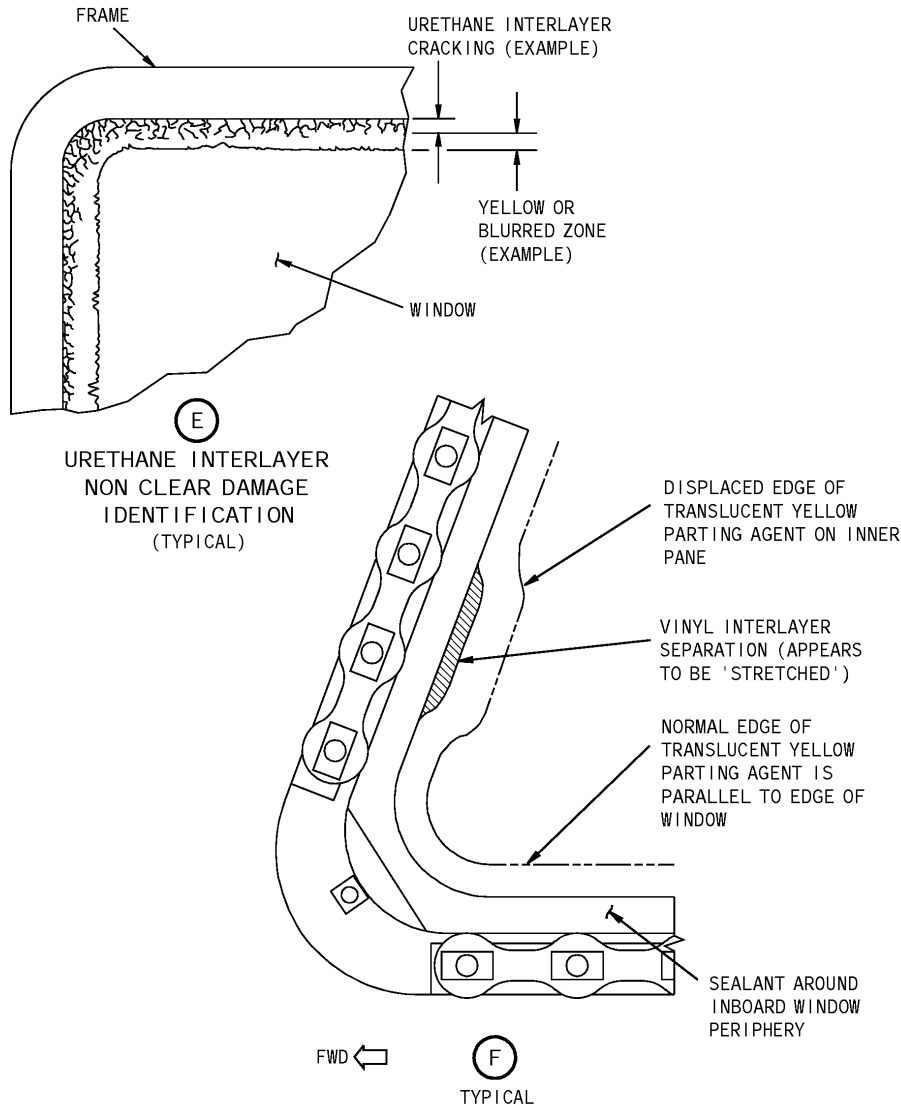
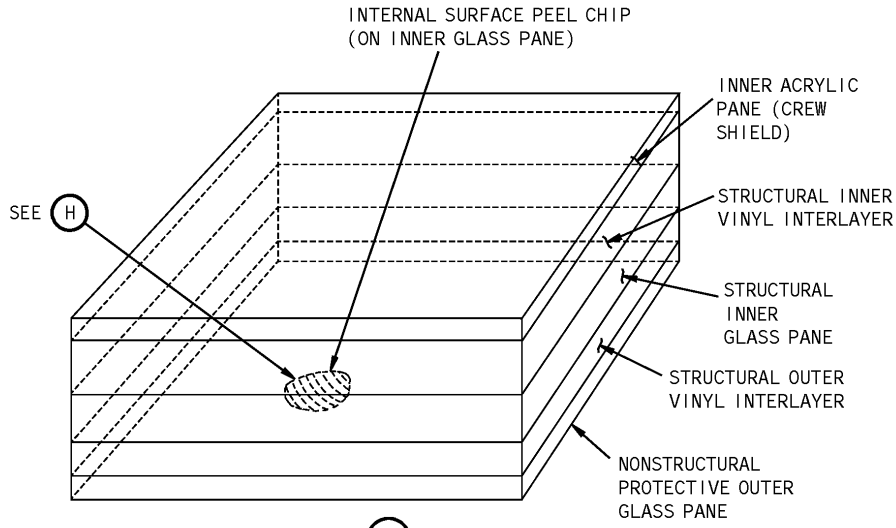
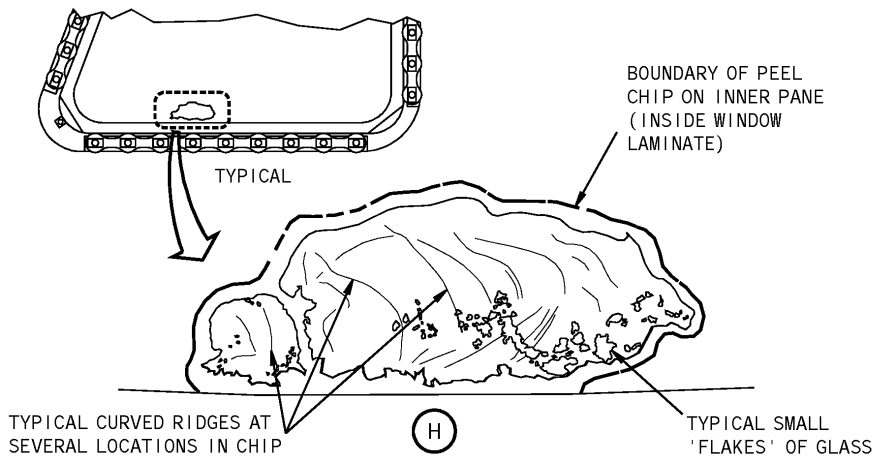
FIGURE 2: FLIGHT DECK NUMBER 4 WINDOW - INTERNAL AND EXTERNAL DETAILED INSPECTION
(SHEET 2 OF 7)

STEP	TASK	NAME	QTY	MORE DATA
1	Inspect	Non Structural Protective Outer Glass Pane - Left Side	1	(a)
		Urethane Interlayer - Left Side	2	(a) (b)
2	Inspect	Structural Vinyl Interlayer - Left Side	2	(b) (c)
3	Inspect	Structural Vinyl Interlayer - Left Side	2	(b) (d)
4	Inspect	Structural Inner Glass Pane - Left Side	1	(e)
5	Inspect	Bus Bar - Left Side	1	(f)
		Structural Vinyl Interlayer - Left Side	2	
		Non Structural Protective Outer Glass Pane - Left Side	1	
6	Inspect	Non Structural Protective Outer Glass Pane - Right Side	1	(a)
		Urethane Interlayer - Right Side	2	(a) (b)
7	Inspect	Structural Vinyl Interlayer - Right Side	2	(b) (c)
8	Inspect	Structural Vinyl Interlayer - Right Side	2	(b) (d)
9	Inspect	Structural Inner Glass Pane - Right Side	1	(e)
10	Inspect	Bus Bar - Right Side	1	(f)
		Structural Vinyl Interlayer - Right Side	2	
		Non Structural Protective Outer Glass Pane - Right Side	1

(b) White or yellow discoloration and cracking of the urethane interlayer is considered to be acceptable, as long as the pilot's vision is not obscured and inspection for other damage is not impaired. This should not be confused with cracking in the vinyl interlayer.

(c) Do an Internal and External Detailed Inspection for cracking around the edge of the metal insert. Cracking usually appears as thick or broken lines perpendicular to the window panes. In severe cases the vinyl interlayer can appear to stretch or separate at a crack along the metal insert (vinyl separation.).

(d) Do an Internal and External Detailed Inspection for cracking. Cracking usually appears as thick or broken lines perpendicular to the surface of the window panes.

(e) Do an Internal and External Detailed Inspection for cracking and chipping of the structural inner glass pane. A crack will appear as a smooth fissure perpendicular to the surface. A Peel type chip will have circular or curved periphery with many fine hairlines or ridges that follows the outline of the outer edge and degenerate toward the center or deepest point of the chip, similar to a clamshell.

(f) Do an Internal and External Detailed Inspection for evidence of arcing. Arcing usually occurs near the window bus bars and will cause dark brown or black burn marks on the bus bar and the interlayer. Small bubbles in the interlayer can be visible at the arc location.

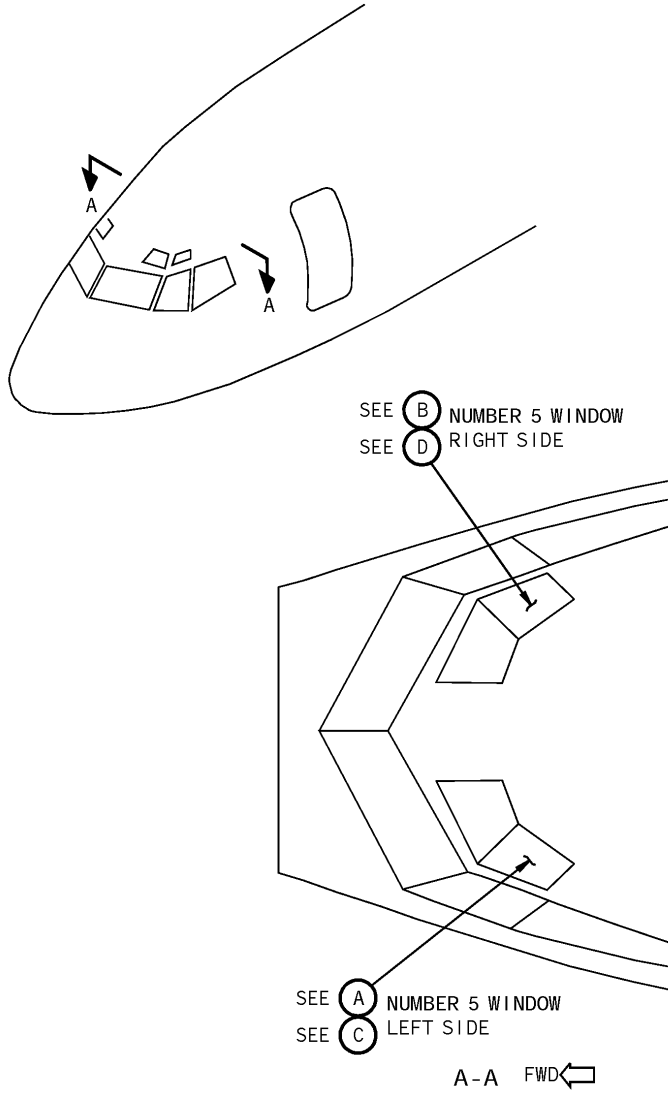
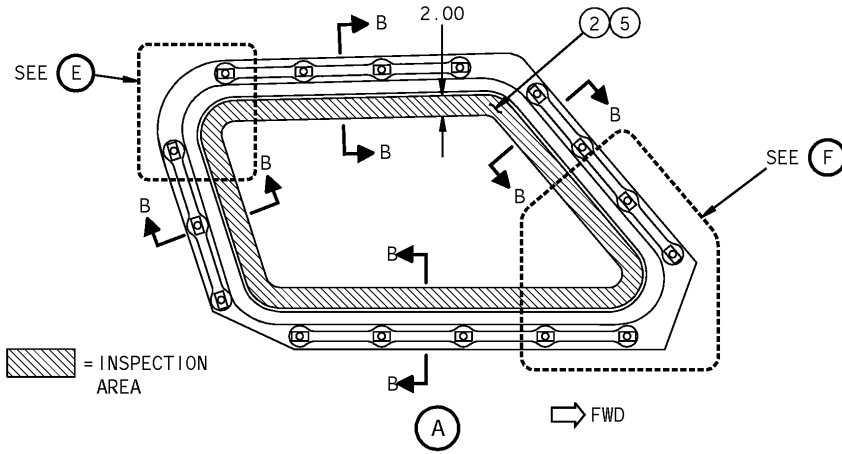
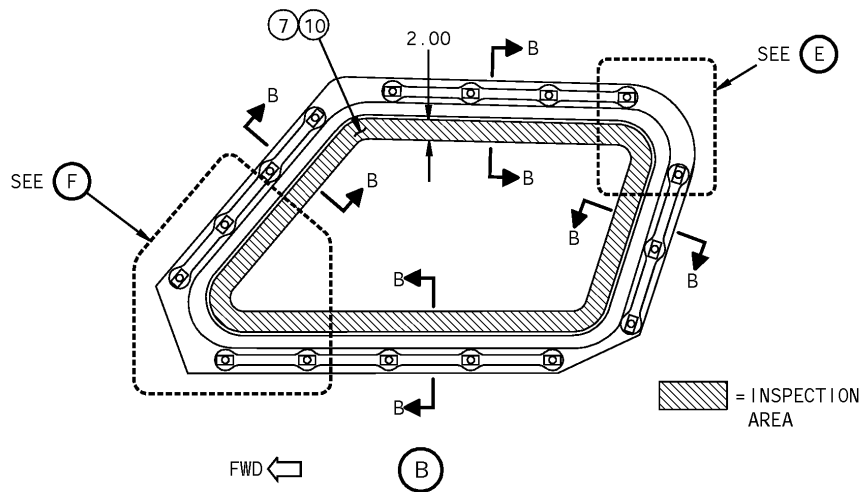
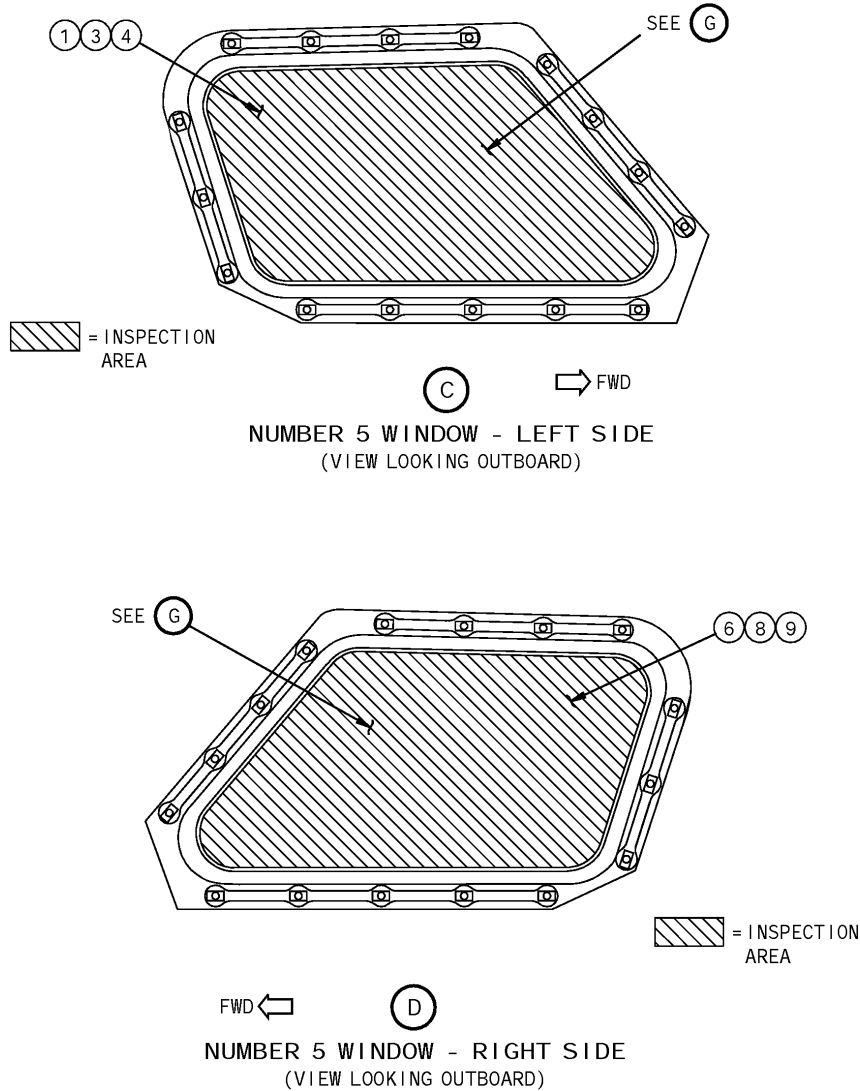
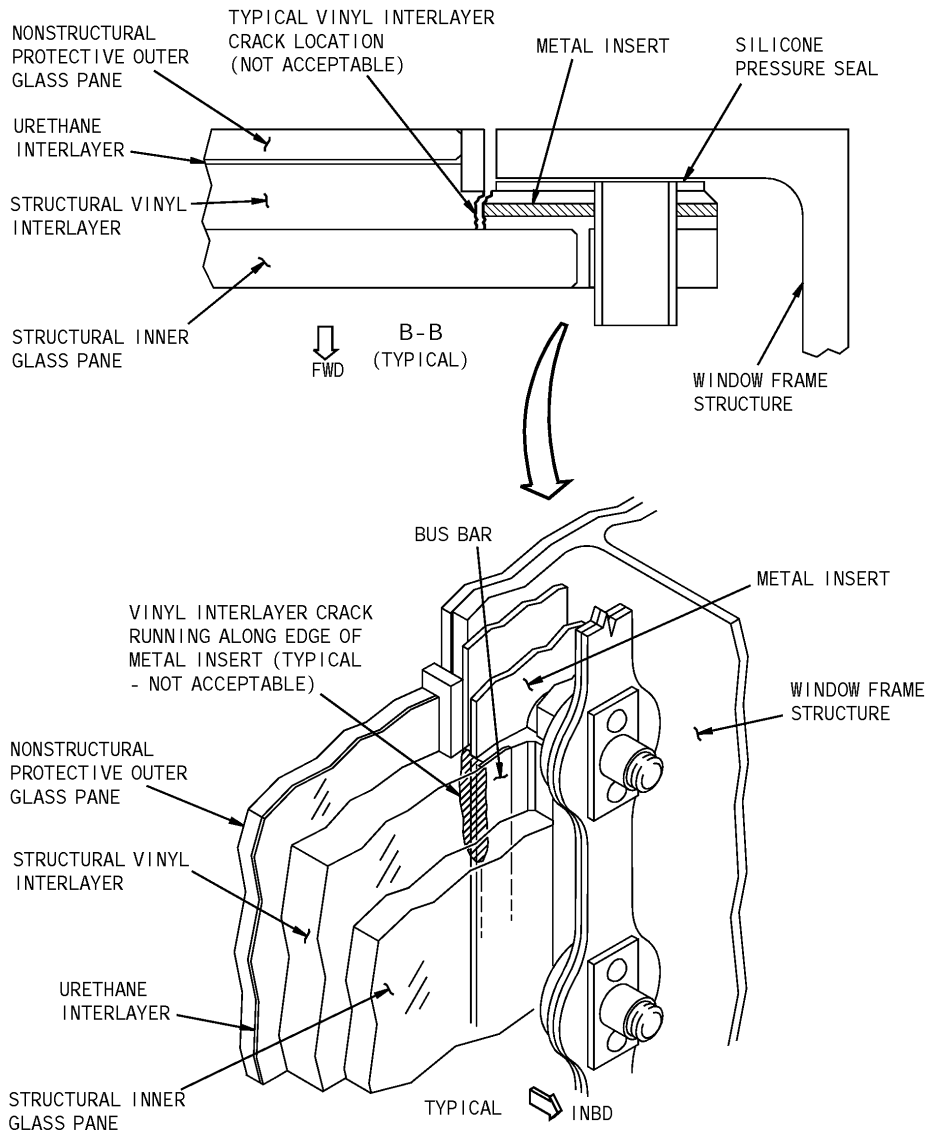
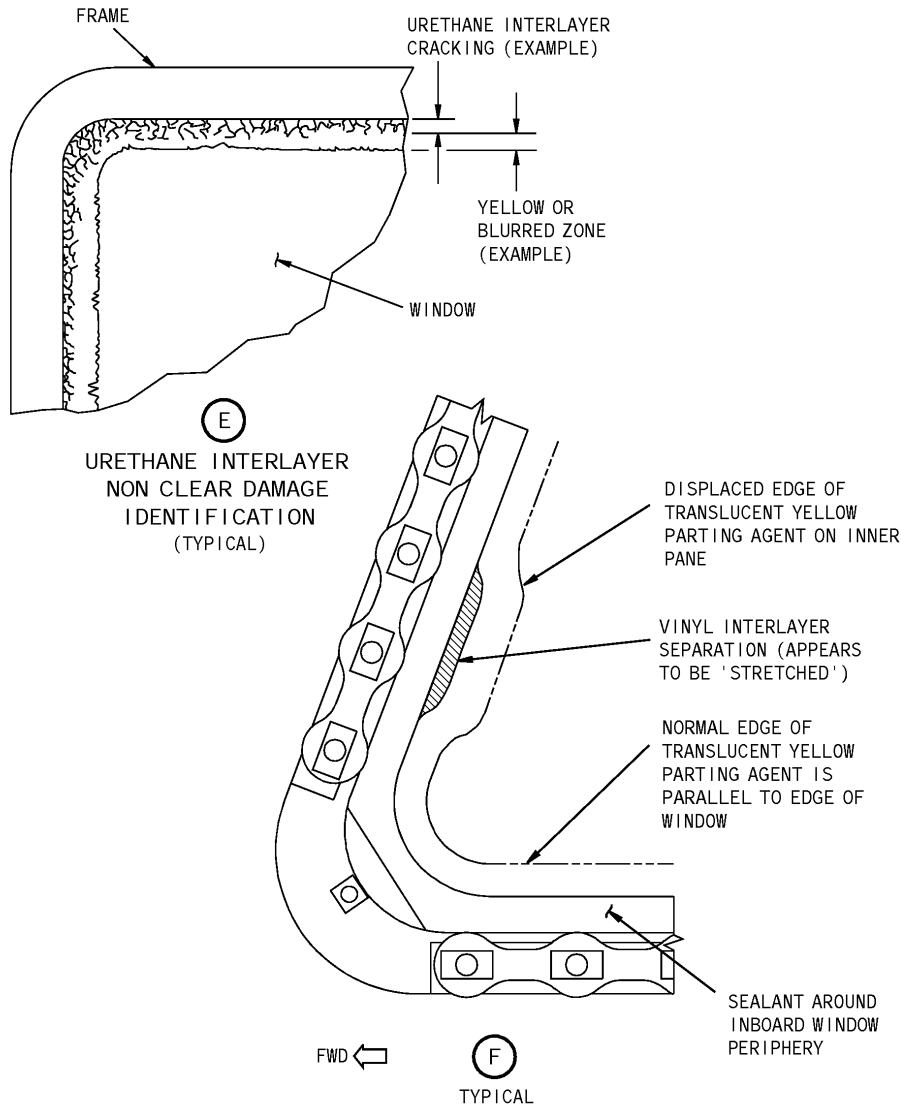
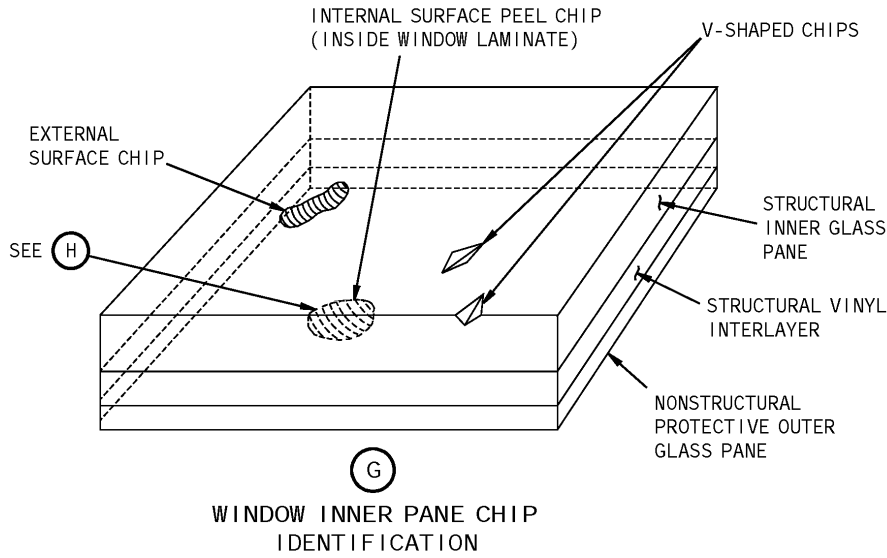
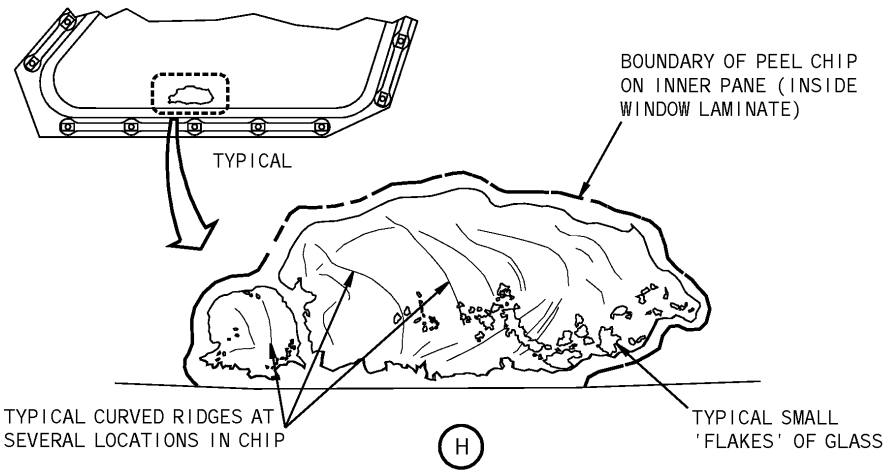
FIGURE 3: FLIGHT DECK NUMBER 5 WINDOW - INTERNAL AND EXTERNAL DETAILED INSPECTION
June 04, 2007 (SHEET 1 OF 7)

1) If any of the following conditions are found, do Alert SB 3526 Part 6 – Flight Deck Number 5 Window replacement:		
a) The window has a crack in the structural vinyl interlayer.

b) The window has vinyl separation.		
c) The window has a chip with a depth of more than 0.015 inches on the inner surface of the structural inner glass pane.

d) The window has a peel type chip in the structural inner glass pane.		
<u>NOTE:</u> A peel chip is found inside the window on the structural inner glass pane.

e) The window has a V type chip on the inner surface of the structural inner glass pane.		
f) The window shows evidence of electrical arcing.		
g) The window has any non-clear damage which impairs inspection of the above types of damage.		
<u>NOTE:</u> White or yellow discoloration & cracking of the urethane interlayer is considered to be acceptable, as long as the pilot's vision is not obscured & inspection for other damage is not impaired. This should not be confused with cracking in the vinyl interlayer.		
<u>CAUTION:</u> Obey all of the warnings & cautions given in the specified manual sections.

STEP	TASK	NAME	QTY	MORE DATA
1	Inspect	Non Structural Protective Outer Glass Pane - Left Side	1	(a)
		Urethane Interlayer - Left Side	2	(a) (b)
2	Inspect	Structural Vinyl Interlayer - Left Side	1	(b) (c)
3	Inspect	Structural Inner Glass Pane - Left Side	1	(d)
4	Inspect	Structural Inner Glass Pane - Left Side	1	(e)
5	Inspect	Bus Bar - Left Side	1	(f)
		Structural Vinyl Interlayer - Left Side	1	
		Non Structural Protective Outer Glass Pane - Left Side	1	
6	Inspect	Non Structural Protective Outer Glass Pane - Right Side	1	(a)
		Urethane Interlayer - Right Side	2	(a) (b)
7	Inspect	Structural Vinyl Interlayer - Right Side	1	(b) (c)
8	Inspect	Structural Inner Glass Pane - Right Side	1	(d)
9	Inspect	Structural Inner Glass Pane - Right Side	1	(e)
10	Inspect	Bus Bar - Right Side	1	(f)
		Structural Vinyl Interlayer - Right Side	1	
		Non Structural Protective Outer Glass Pane - Right Side	1

- (b) White or yellow discoloration and cracking of the urethane interlayer is considered to be acceptable, as long as the pilot's vision is not obscured and inspection for other damage is not impaired. This should not be confused with cracking in the vinyl interlayer.

- (c) Do an Internal and External Detailed Inspection for cracking around the edge of the metal insert. Cracking usually appears as thick or broken lines perpendicular to the window panes. In severe cases the vinyl interlayer can appear to stretch or separate at a crack along the metal insert (vinyl separation).

- (d) Do an Internal and External Detailed Inspection for peel chips on the internal surface of the structural inner glass pane (inside the window laminate). A Peel type chip will have circular or curved periphery with many fine hairlines or ridges that follows the outline of the outer edge and degenerate toward the center or deepest point of the chip, similar to a clamshell (inside the window laminate).

- (e) Do an Internal and External Detailed Inspection for cracking and chipping on the inner surface of the structural inner glass pane. A crack will appear as a smooth fissure perpendicular to the surface. A Spall or Shell type chip will have circular or curved periphery with many fine hairlines or ridges that follows the outline of the outer edge and degenerate toward the center or deepest point of the chip, similar to a clamshell.

- (f) Do an Internal and External Detailed Inspection for evidence of arcing. Arcing usually occurs near the window bus bars and will cause dark brown or black burn marks on the bus bar and the interlayer. Small bubbles in the interlayer can be visible at the arc location.

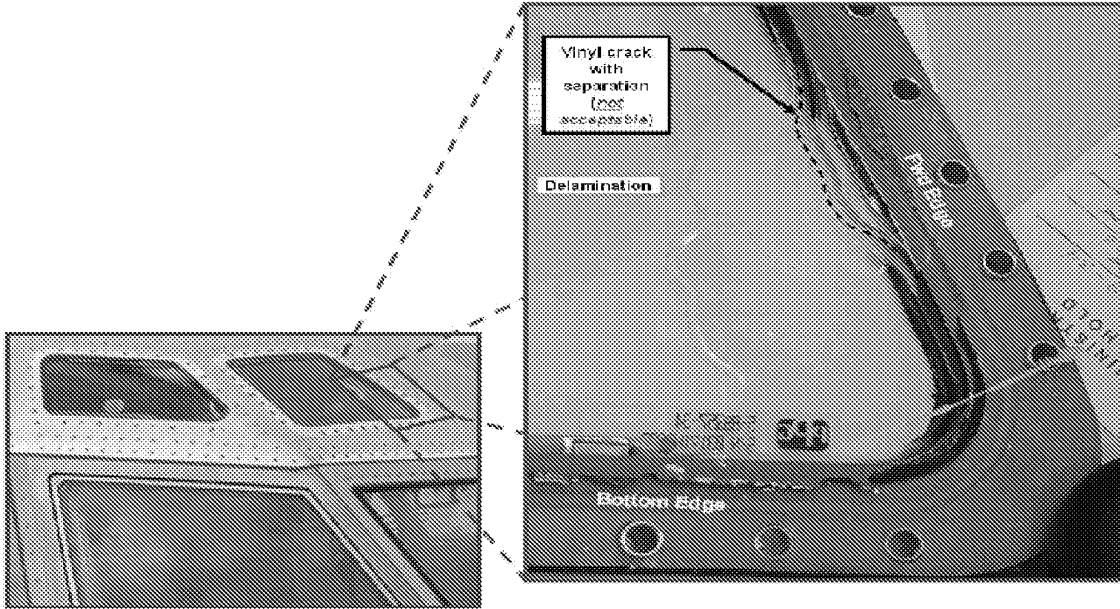
Picture 1 : Window Nr. 4 – Crack with separation

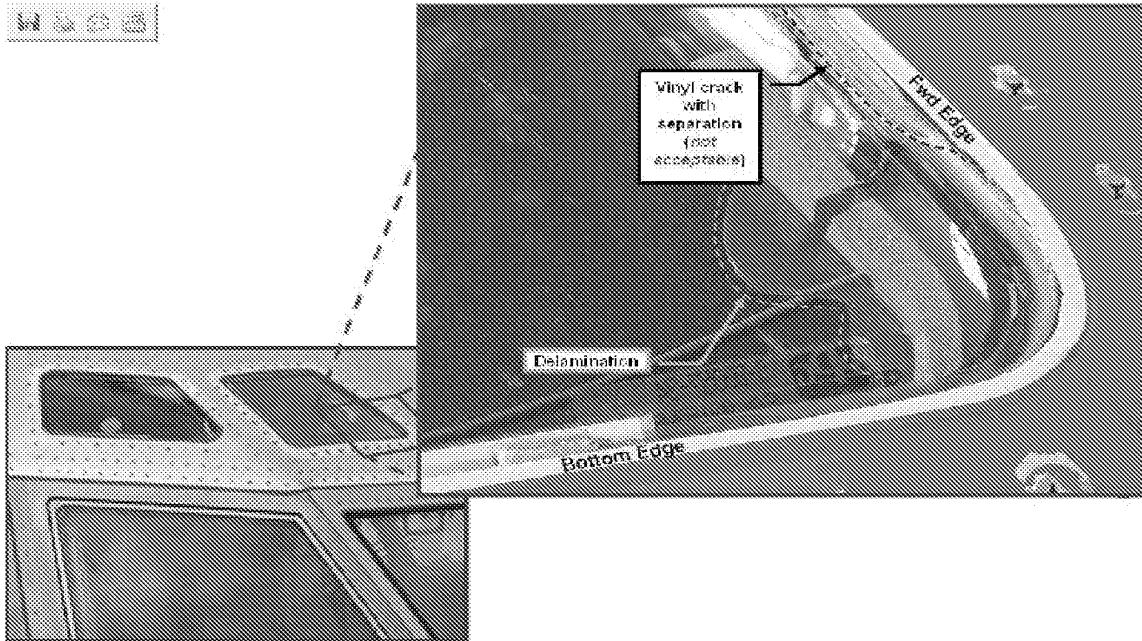
Picture 2: Window Nr. 4 – Crack with separation

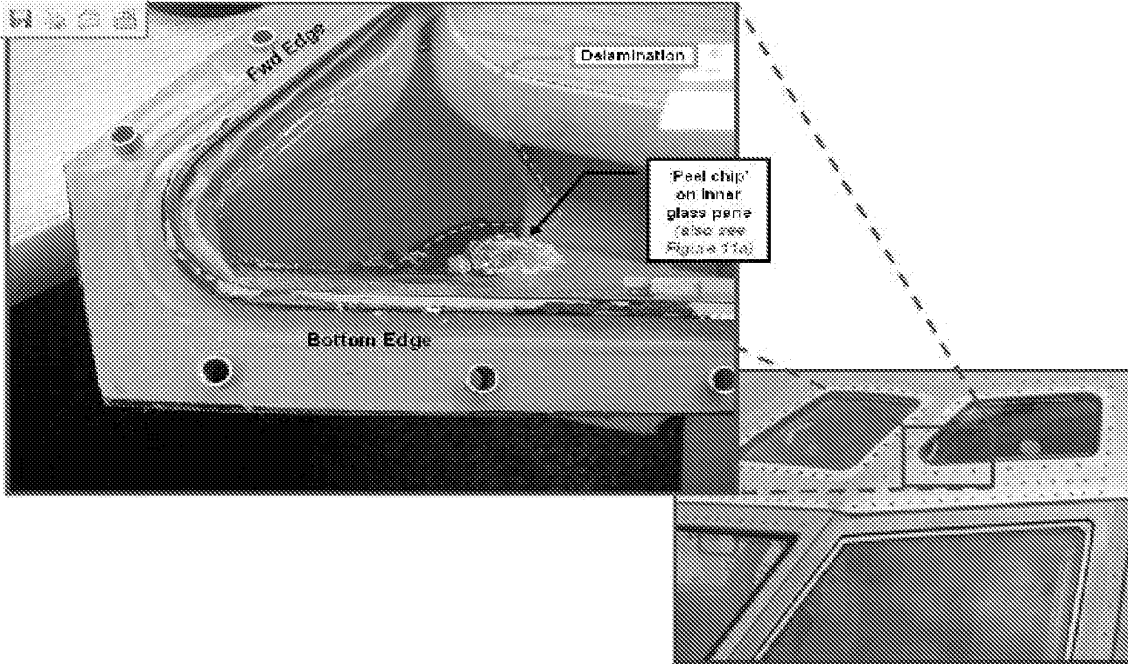
Picture 3 : Window Nr. 5 – Peel chip

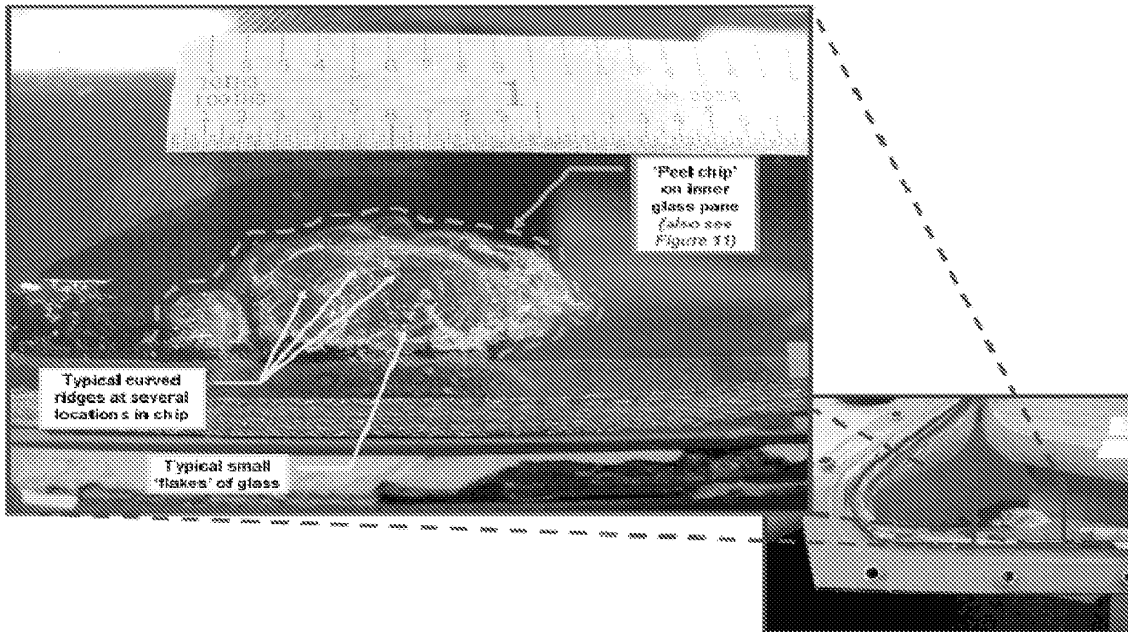
Picture 4: Window Nr. 5 – Peel chip on inner glass pane
