H4G2000001 Page 2 of 5
	Oper. : NRT	Issuer : A59513	Cert.St.: 45379	
	Type : MODIF	Release Date: 05.12.2007		
Spec. : SHEET METAL

DFW B707-53-509 MLG W.W. BS 960 FAIRING ACCESS PANEL MODIFICATION

ENGINEERING INSTRUCTION	Ref.: DWF B707-53-509 Revision: ATA chap.: 53 Date: 15 Jan.2007 Page: 13 of 14
--	--------------------------------	--

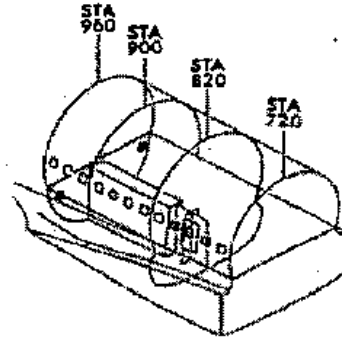
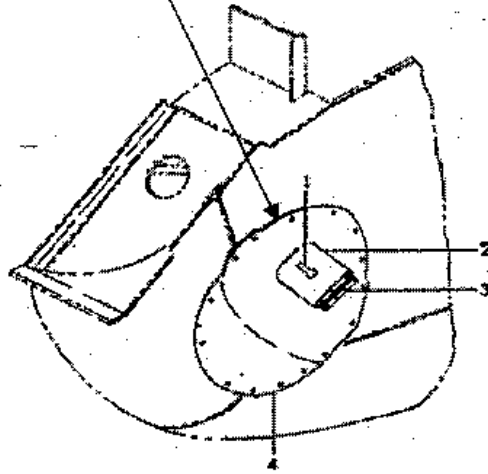
**Fig.1
BS 960 Fairing Access Door Instl.**

**Cover Assy to be replaced
by a Blank Panel per Step 2
or
Reworked per Step 3.**

- Remove existing LH side Round Cover Assy's shown in Fig.1 (Ref. IPB 53-07-7 item 8).
Note : *location of the Screws and retain them for reinstallation. Visually inspect nutplates installed along the cutout for general conditions and replace as required per SRM 51 -2-2.*

- Manufacture 2ea. Fairing Covers out of a sheet from 2024T3 AlClad 0.040 in.thk. per SAE AMS QQ-A-2506.
Shape new Fairing Covers as the removed ones except for the latch door cutout that need not be performed. See Fig.1 item 4.
Follow BAC5300 requirements when shaping and forming aluminum sheet. Anodize Fairing Covers per MIL-A-8625 and apply 2ea. coats of MIL-PRF- 23377 epoxy primer per MM 51-90-00.
Identify Covers as PIN DWF-B707-53-509-1 for the LH side.

- As an option to the repair per step 2 above, the fairing assy can be reworked by removing and scrapping the latch door and the internal cutout doubler (see Fig.1 items 2 and 3) and a new internal doubler can be manufactured and installed according to SRM 51 -1 4-2 Fig. 1 requirements.

- Install the 2ea. new or reworked Fairing Cover panels on the lower LH BS 960 W/W Fairings using screws retained in step 1. Coat screws thread and shank with Mastinox or CORBAN-27L before reinstalling them in order to prevent corrosion and sizing.

MAINT	RII/INSP
<u>RH MLG W/W/ BS 960 FAIRING ACCESS PANEL MODIFICATION</u>		
<u>Modification instructions</u>		
1. Remove existing RH side Round Cover Assy's shown in Fig.1 (Ref. IPB 53-07-7 item 8).		
<u>Note :</u> <i>location of the Screws and retain them for reinstallation.</i> <i>Visually inspect nutplates installed along the cutout for general conditions and replace as required per SRM 51 -2-2.</i>

2. Manufacture 2ea. Fairing Covers out of a sheet from 2024T3 AlClad 0.040 in.thk. per SAE AMS QQ-A-2506. Shape new Fairing Covers as the removed ones except for the latch door cutout that need not be performed. See Fig.1 item 4. Follow BAC5300 requirements when shaping and forming aluminum sheet. Anodize Fairing Covers per MIL-A-8625 and apply 2ea. coats of MIL-PRF- 23377 epoxy primer per MM 51-90-00. Identify Covers as PIN DWF-B707-53-509-2 for the RH side.

3. As an option to the repair per step 2 above, the fairing assy can be reworked by removing and scrapping the latch door and the internal cutout doubler (see Fig.1 items 2 and 3) and a new internal doubler can be manufactured and installed according to SRM 51 -1 4-2 Fig. 1 requirements.

4. Install the 2ea. new or reworked Fairing Cover panels on the lower LHIRH BS 960 W/W Fairings using screws retained in step 1. Coat screws thread and shank with Mastinox or CORBAN-27L before reinstalling them in order to prevent corrosion and sizing.
