sabena [®] B707	Module: MLG WW + DOORS	A/C Reg :	Check :

AD 63-11-01 rev 568

RH MLG TRUCK BEAM INSP

RH MLG TRUCK BEAM AND TRUCK BEAM PROTECTION SHIELD INSPECTION.

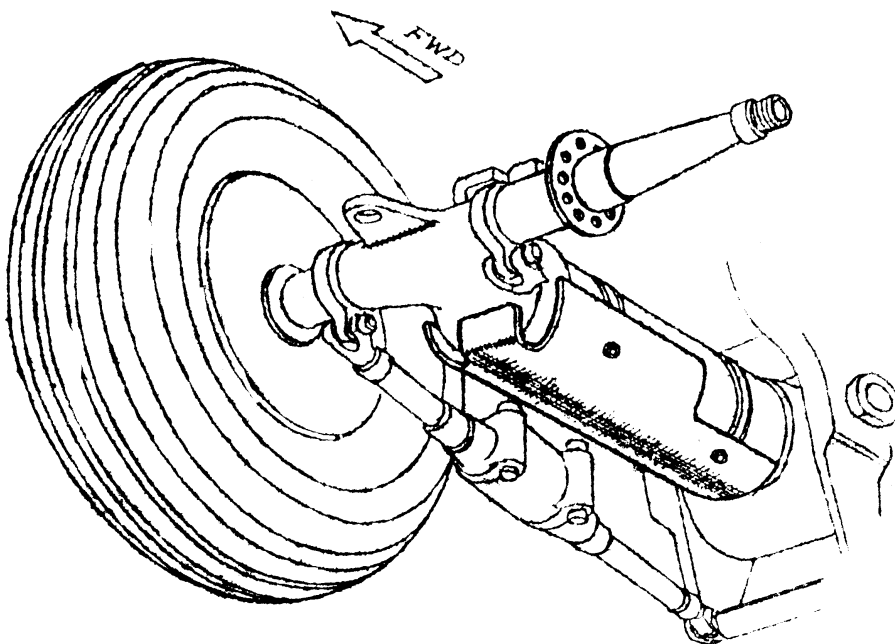
1. Clean all visible parts on MLG truck beam:
2. Close visual inspection of truck beam using mirror as necessary and a strong light to detect any evidence of jack marks, scratcheds gouges, corrosion or impact dents. Remove any straps around the beam which show evidence of damage.

Particular attention shall be given to:

- The lower section of the beam for evidence of jack marks caused by jack slippage or improperly placed jack.
- The FWD area of the beam where contact is possible with the torsion link pivot pin retaining bolt.
- To the AFT area of the beam where contact is possible with the shock strut inner cylinder upon snubber failure.
