<b>sabena</b> <sup>®</sup> <b>B707</b>	Module: PYLON 1	A/C Reg :	Check :

**SB A3502      NACELLE STRUT OVERWING SUPPORT FITTINGS INSP**

**LH & RH wings, Inboard & outboard nacelle strut overwing support fitting bolts inspection.**

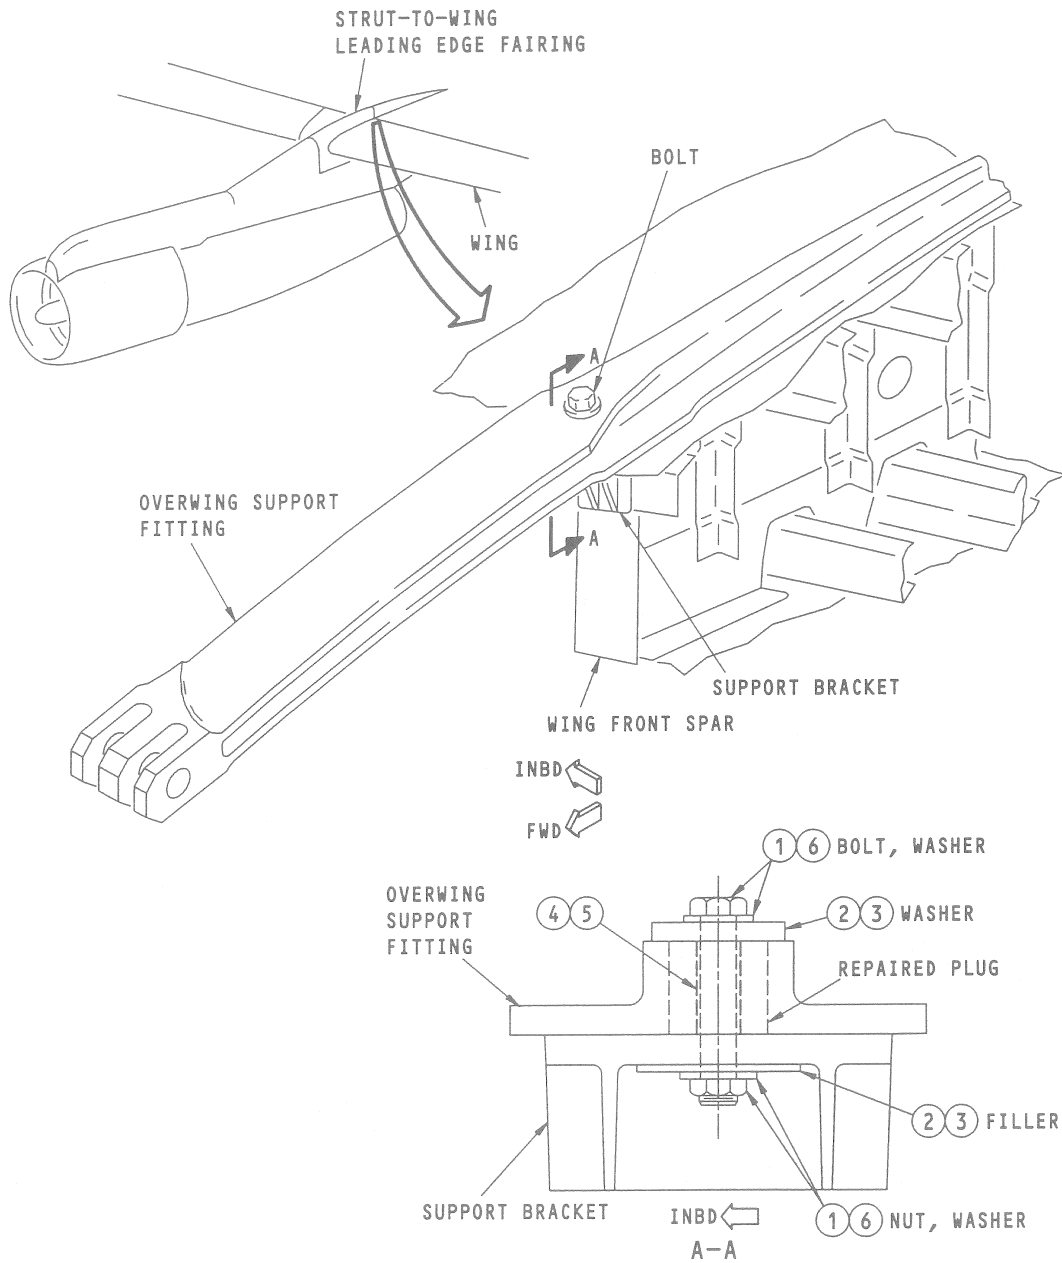
FIGURE 2 OVERWING SUPPORT FITTING BOLT REPLACEMENT

b. Determine if the bolts FWD of the wing front spar on nacelle strut overwing support fitting are BACB30US. (bacb30us8 for out side & bacb30us7 for inb side). If the bolts are BACB30US, no further action. If the bolts are not BACB30US, replace the bolts I.A.W. SB3502 Fig 2 instructions.

STEP	TASK	NAME	PART NUMBER and SPECIFICATION	QTY	NOTES and REFERENCES
1	Remove and discard	Bolt		1	(f)
		washer		2	
		Nut		1	
2	Remove and keep	Washer	1/8 inch thick steel	(e)	(g)
		Filler	8-8112-3093 (outboard only)	1	
3	Install kept	Washer	1/8 inch thick steel	(e)	(g)
		Filler	8-8112-3093 (outboard only)	1	
4	Examine	Hole Bore	High-Frequency Eddy Current	1	(i), 707 NDT Manual Part 6 Subject 51-00-00, Figure 11
5	Measure	Hole Diameter	0.500 - 0.504 inch (outboard)	1	(h), (j)

0.5620 - 0.5630 inch (outboard)	1	(j) for 09441 only
			0.438 - 0.442 inch (inboard)	1	(h), (j)
			0.7495 - 0.7505 inch (inboard)	1	(j) for 09441 only
6	Install	Bolt	BACB30US8K32 (outboard)	1	(a), (h)
			or BACB30US8K34 (outboard)	1	(a), (h)
			BACB30US8K41 (outboard)	1	(a) for 09441 only
			or BACB30US8K43 (outboard)	1	(a) for 09441 only
		Washer	BACB30US7K30 (inboard)	1	(a), (h)
			or BACD30US7K32 (inboard)	1	(a), (h)
			BACB30US12K41 (inboard)	1	(a) for 09441 only
			or BACB30US12K43 (inboard)	1	(a) for 09441 only
			BACW10BP8CD (outboard)	1	under bolt (h)
		BACW10BP7CD (inboard) *	1	under bolt (h)	
		BACW10BP12CD (inboard)	1	under bolt for 09441 only	
		Washer	BACW10BP8DP (outboard)	1	under nut
			BACW10BP12DP (inboard)	1	under nut for 09441 only
Nut	BACN10HR8CD (outboard)	1	(a), (b)		
	BACN10HR7CD (inboard)	1	(a), (c), (h)		
	BACN10HR12CD (inboard)	1	(a), (d), for 09441 only

- (a) Apply BMS 5-95 sealant to fasteners then capseal fastener after apply torque to fasteners.
- (b) Torque nut with 630 to 950 Inch-Pounds.
- (c) Torque nut with 370 to 610 Inch-Pounds.
- (d) Torque nut with 2400 to 3100 Inch-Pounds.
- (e) Quantity may be zero or one.
- (f) Quantity may be one in some locations and up to two in other locations.
- (g) For installation with a 1/8 inch thick steel washer located over a repaired support fitting plug only (repaired work done by service bulletin 707-3365).
- (h) For all airplanes except for airplane with variable number 09441.
- (i) If corrosion is found, contact Boeing for corrective action. If cracks are found, contact Boeing for corrective action.
- (j) If hole diameter is not as indicated, contact Boeing for corrective action.
