<b>sabena</b> <sup>®</sup> <b>B707</b>	Module: HOR STAB + FL CT	A/C Reg :	Check :

<b>61F2000501</b>
	Oper. : RT-MP LC	Issuer : A43710	Cert.St.: 24828	
	Type : MEC-INSP	Release Date: 11.10.2001		Page 1 of 3
Spec. : MECHANIC

AD 91-07-07 rev 6493

**STAB CENTER SECT INSP**

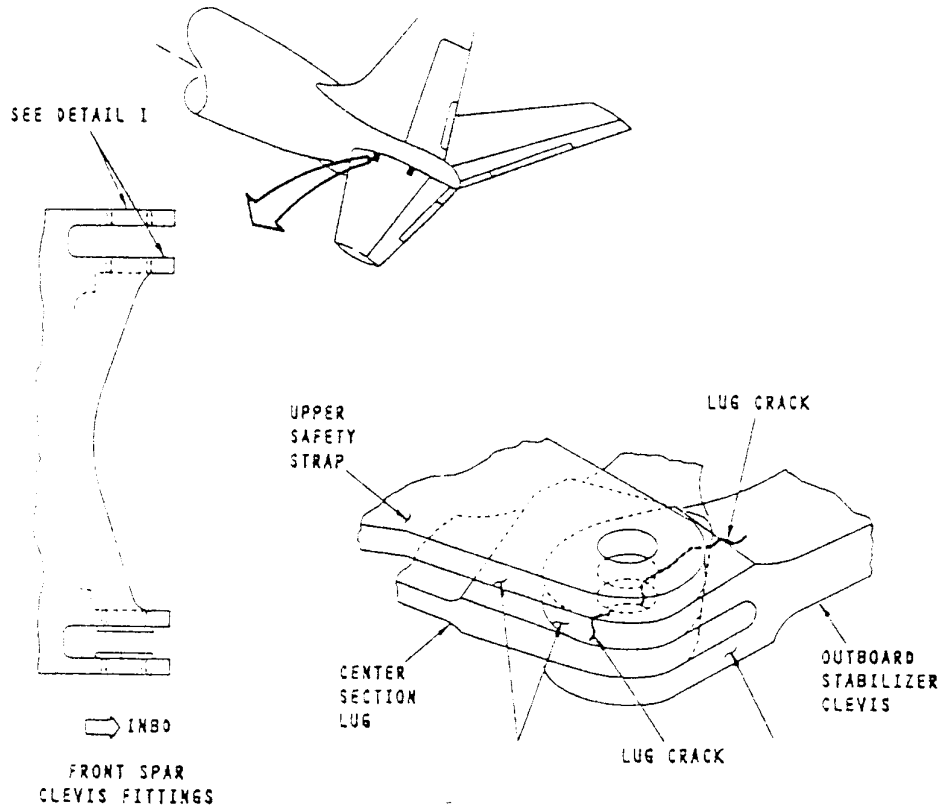
FIGURE 3. UPPER CLEVIS UPPER LUG INSPECTION

**OUTBOARD SECTION FRONT SPAR UPPER CLEVIS UPPER LUG OF STABILIZER CENTER SECTION INSPECTION.**

1. Close visual inspection of the safety strap and clevis lugs for cracks, special attention should be given to the FWD inboard and AFT outboard areas of the lugs.
2. If no cracks are found: Ultrasonic inspection (DOC. D6-48023 p4, subj 55-10-07 fig 1 & 2) of the lugs.
3. After inspection apply BMS 3-23.
