sabena [®] B707	Module: NLG / TAIL LDG	A/C Reg :	Check :

DFW B707-32-0001

NOSE GEAR WHEEL SNUBBER BRAKE CRACK AT CLAMP SECTION INSP

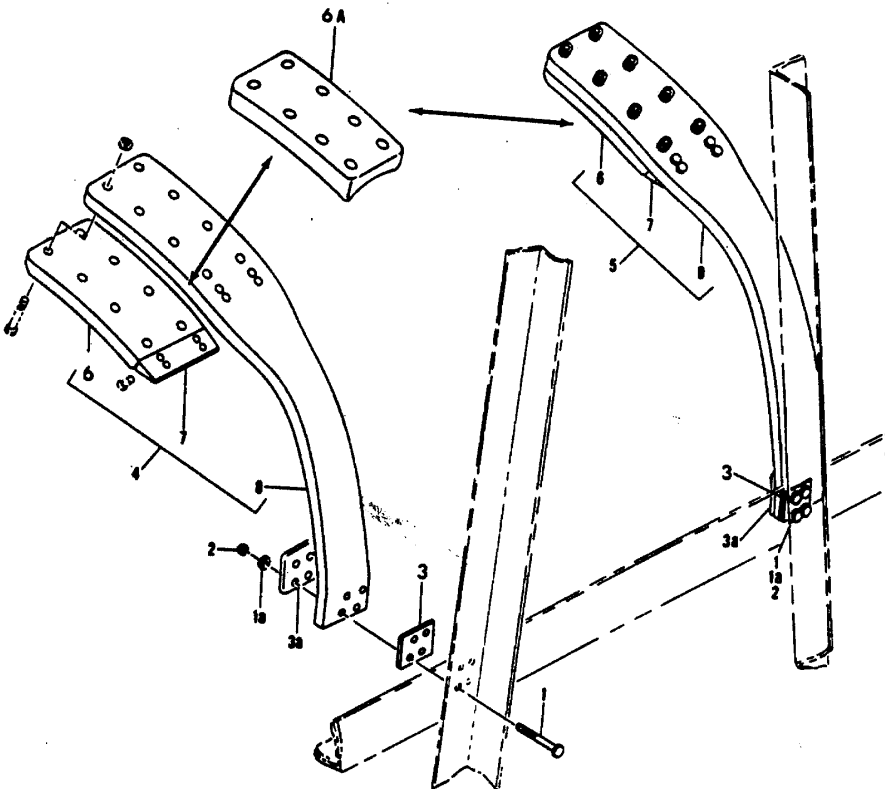
SEE NOTE ON PARTS LIST PAGES
 FIGURE 19. BRAKE INSTL, NOSE GEAR WHEEL SNUBBER

NOSE GEAR WHEEL SNUBBER BRAKE CRACKS

1. Gain access to the nose landing gear wheel snubber brake assemblies.
2. Remove the nose gear wheel snubber filler, 66-13388-2.
3. Perform a high frequency eddy current inspection of the bores and surface around the four (4) attaching fastener holes i.a.w. Chapter 51-06-00 of D6-48023 "Non Destructive Test Manual".

Cracked nose gear wheel snubber brake bands should be immediately repaired, replaced, or removed from the airplane. Operation of the airplane without the nose gear wheel snubber assembly installed is allowed, but the flight crew may hear additional noise coming from the nose wheel well as the nose gear wheels gradually spin down.

If findings are found => Repair per DFW-B707-32-0001.

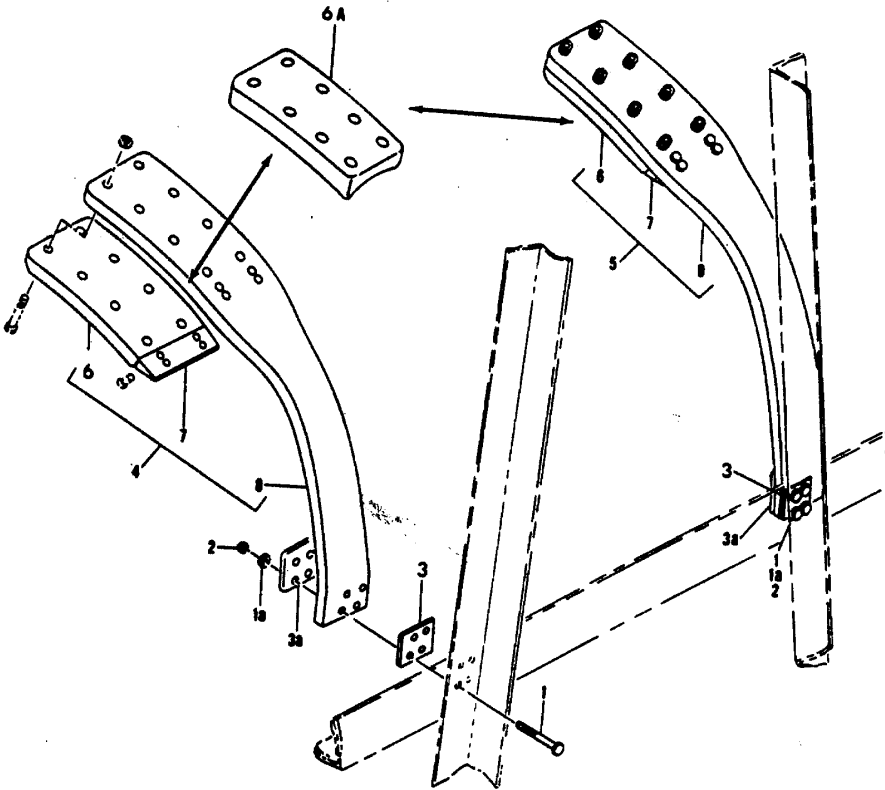
SEE NOTE ON PARTS LIST PAGES
 FIGURE 19. BRAKE INSTL, NOSE GEAR WHEEL SNUBBER

NOSE GEAR WHEEL SNUBBER BRAKE CRACKS

1. Gain access to the nose landing gear wheel snubber brake assemblies.
2. Remove the nose gear wheel snubber filler, 66-13388-2.
3. Perform a close visual inspection of the four (4) attaching fasteners & the area around the fasteners for corrosion or cracks.
If findings are found => Repair per DFW-B707-32-0001.
4. Install the nose gear wheel snubber filler, 66-13388-2.
