<b>sabena</b> <sup>®</sup> <b>B707</b>	Module: PYLON 3	A/C Reg :	Check :

**NACELLE 3 FRONT SPAR FITTING INSP**

**CLOSE VISUAL INSPECTION NACELLE 3 FRONT SPAR FITTING**

**BOEING SERVICE BULLETIN A3514**

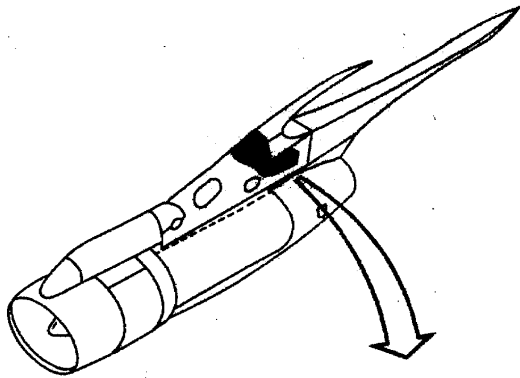
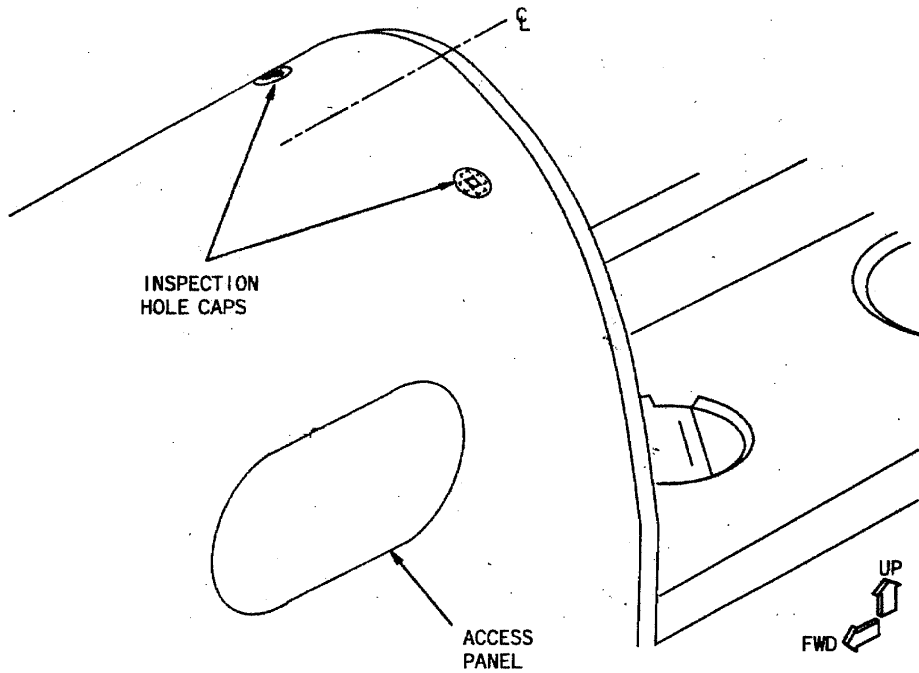
**FIGURE 1: NACELLE ACCESS - FRONT SPAR FITTING - ALL NACELLES (SHEET 1 OF 1)**

3. Remove access 1742/1708 LH &RH Nacelle #3 door on LH side of the strut nearest to the front spar fitting. Or, if the airplane was manufactured with removable inspection hole caps, see fig 1, remove the inspection hole caps on both side of the strut.

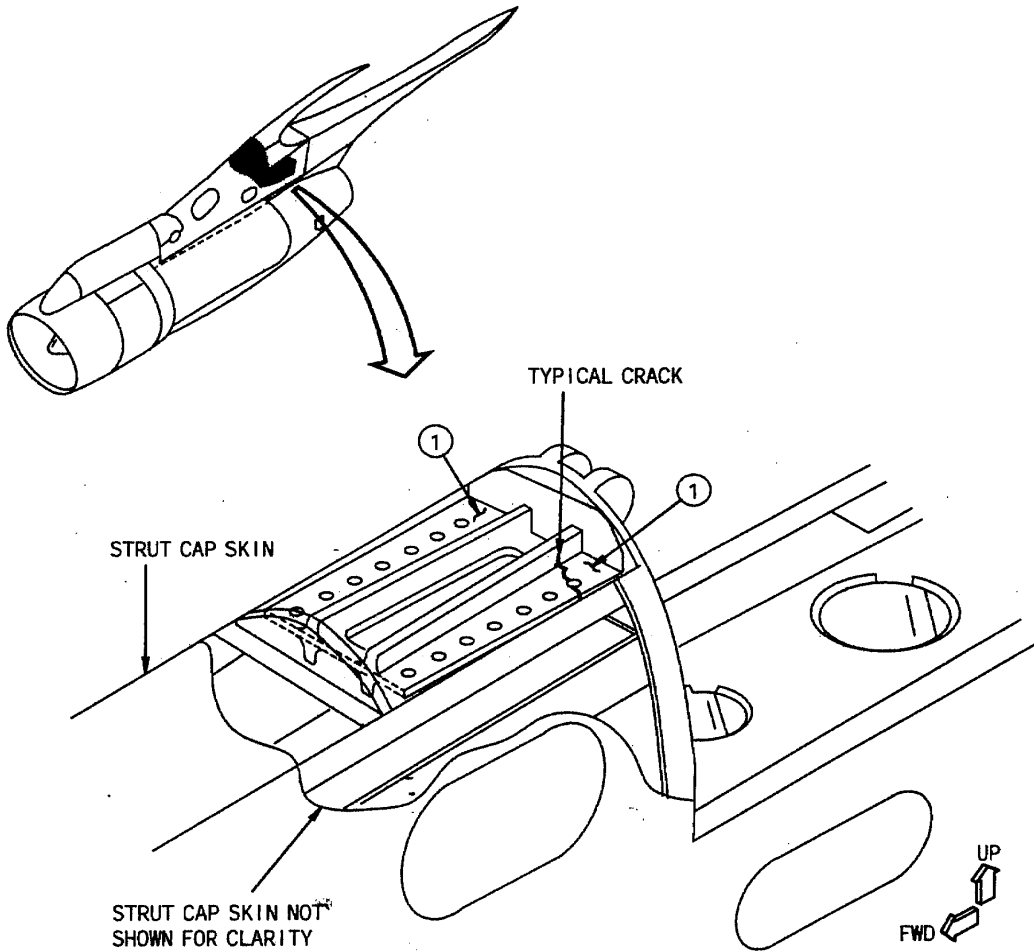
**FIGURE 2: NACELLE NUMBER 1 - FRONT SPAR FITTING - INSPECTION**

4. Do a CLOSE VISUAL INSPECTION of upper surface of front spar fitting for cracks, damage failure or irregularity as shown in fig 2.
5. Install access 1742/1708 LH&RH Nacelle #3 door on left side of the strut nearest to the front spar fitting. Or, if the airplane was manufactured with removable inspection hole caps, see fig 1, install the inspection hole caps on both side of the strut.

The step numbers shown below agree with the numbers shown in the circle symbols in the figure.

STEP	TASK	NAME	PROCEDURE	REFERENCES	MORE DATA
1	Inspect	Front Spar Fitting	Detailed Inspection	-	(a)
(a) Do a detailed inspection of the upper surface of the front spar fitting. Pay particular attention to the front spar fitting surface around the fasteners.
