sabena [®] B707	Module: COCKPIT + WINDOW	A/C Reg :	Check :

DFW 56-002 rev 23/11/2007

COCKPIT – WINDOWS NR 2, 4 & 5 INITIAL INSPECTION

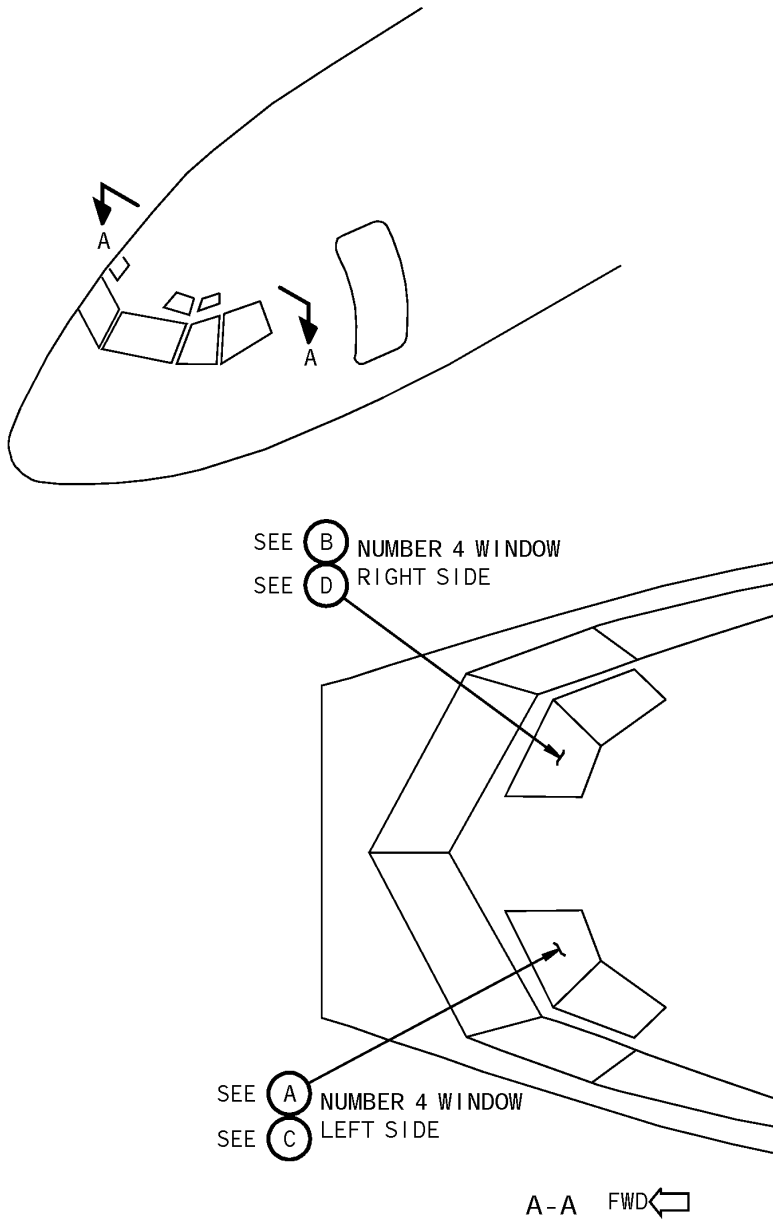
FIGURE 2: FLIGHT DECK NUMBER 4 WINDOW - INTERNAL AND EXTERNAL DETAILED INSPECTION
 June 04, 2007 (SHEET 1 OF 7)

(c) Do an Internal and External Detailed Inspection for cracking around the edge of the metal insert. Cracking usually appears as thick or broken lines perpendicular to the surface of the window panes. In severe cases the vinyl interlayer can appear to stretch or separate at a crack along the metal insert.
