STRUCTURAL REPAIR

CHAPTER 53

FUSELAGE

BOEING
707

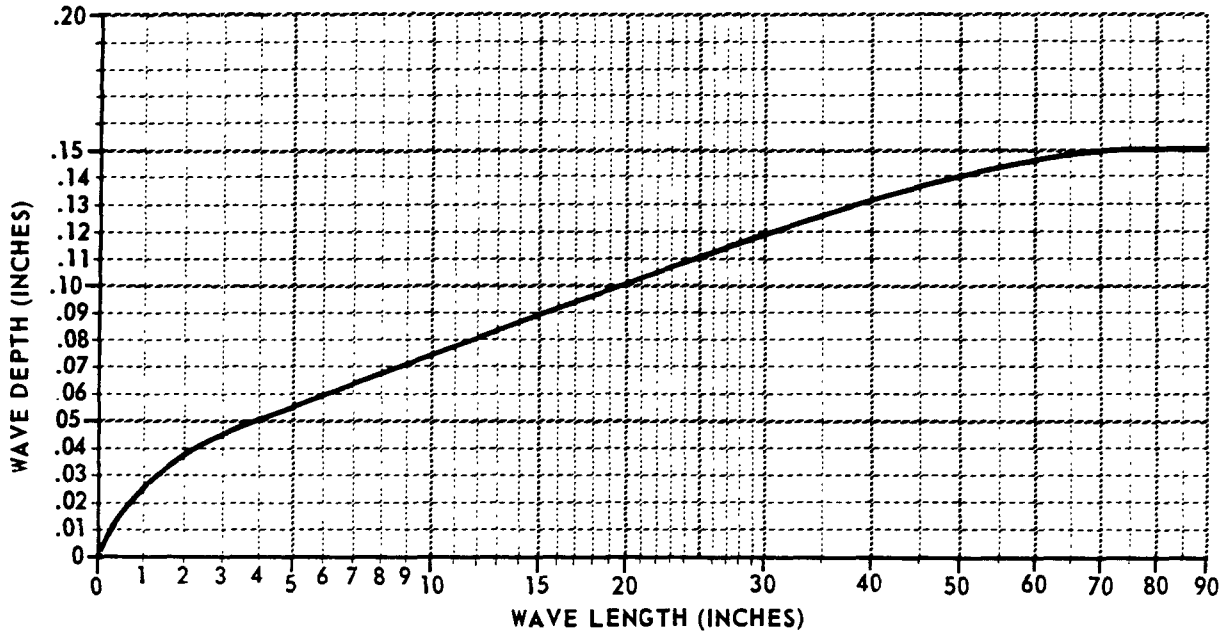
DENT LIMITATIONS FOR FUSELAGE AND DOOR SKIN
STA 178-1440

2. IF DENTS EXCEED THE LIMITS OF THE CURVE AND THERE IS NO EVIDENCE OF SHEARED OR LOOSE FASTENERS OR ELONGATED HOLES AT FASTENERS IN THE DENT AREA AND IT IS NOT POSSIBLE TO MAKE AN IMMEDIATE REPAIR, THEN PERIODICALLY EXAMINE THE DENT FOR POSSIBLE DEVELOPMENT OF CORROSION AND FATIGUE CRACKS.

3. IF FATIGUE CRACKS DEVELOP IN THE DENT AREA EVALUATE THE DAMAGE AND REPAIR AS OUTLINED IN FIGURE 2.

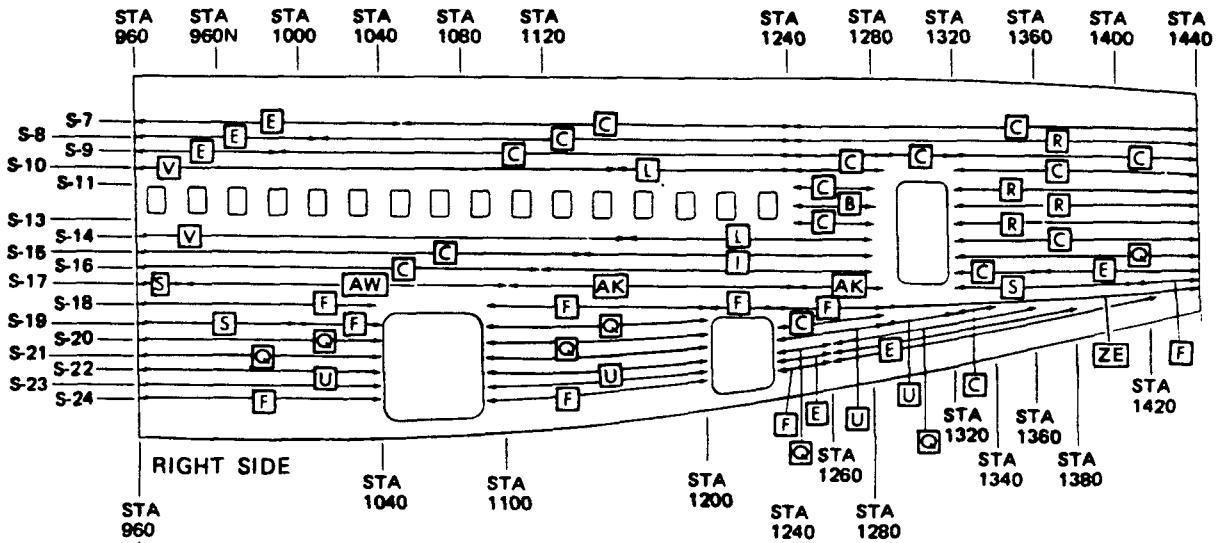
Fuselage Stringer Identification
Figure 8 (Sheet 12)

PLAN VIEW OF TOP

PLAN VIEW OF BOTTOM

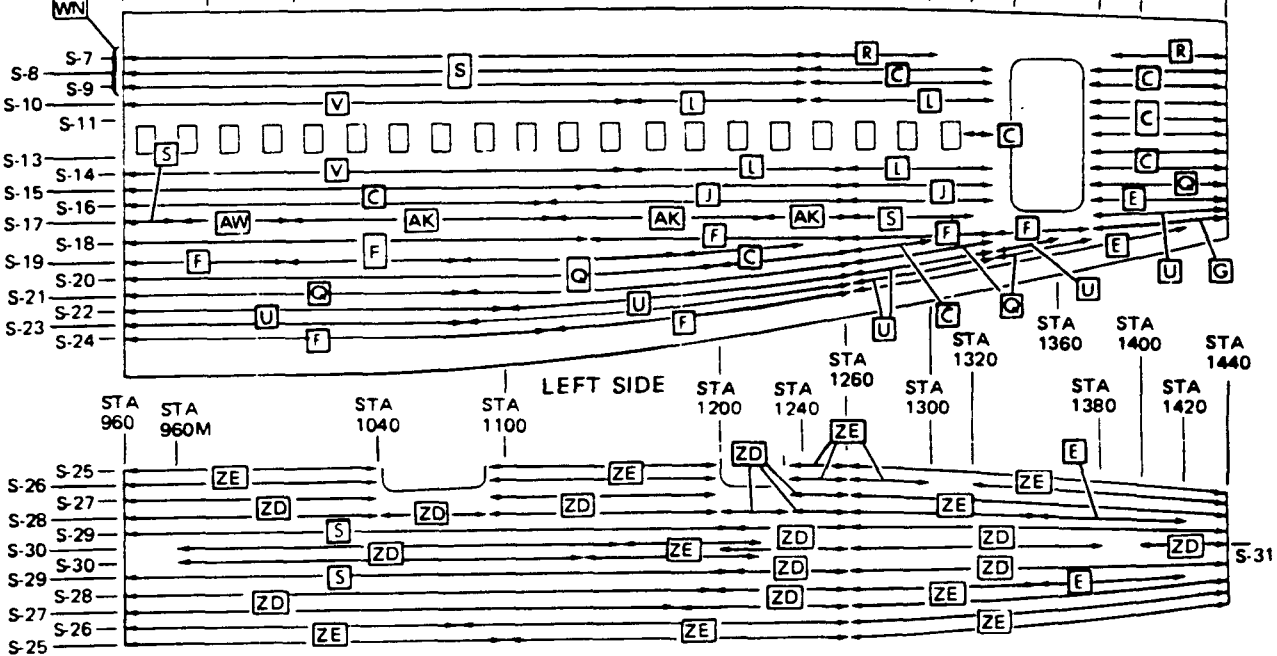
PLAN VIEW OF BOTTOM
Fuselage Stringer Identification
Figure 8 (Sheet 29)

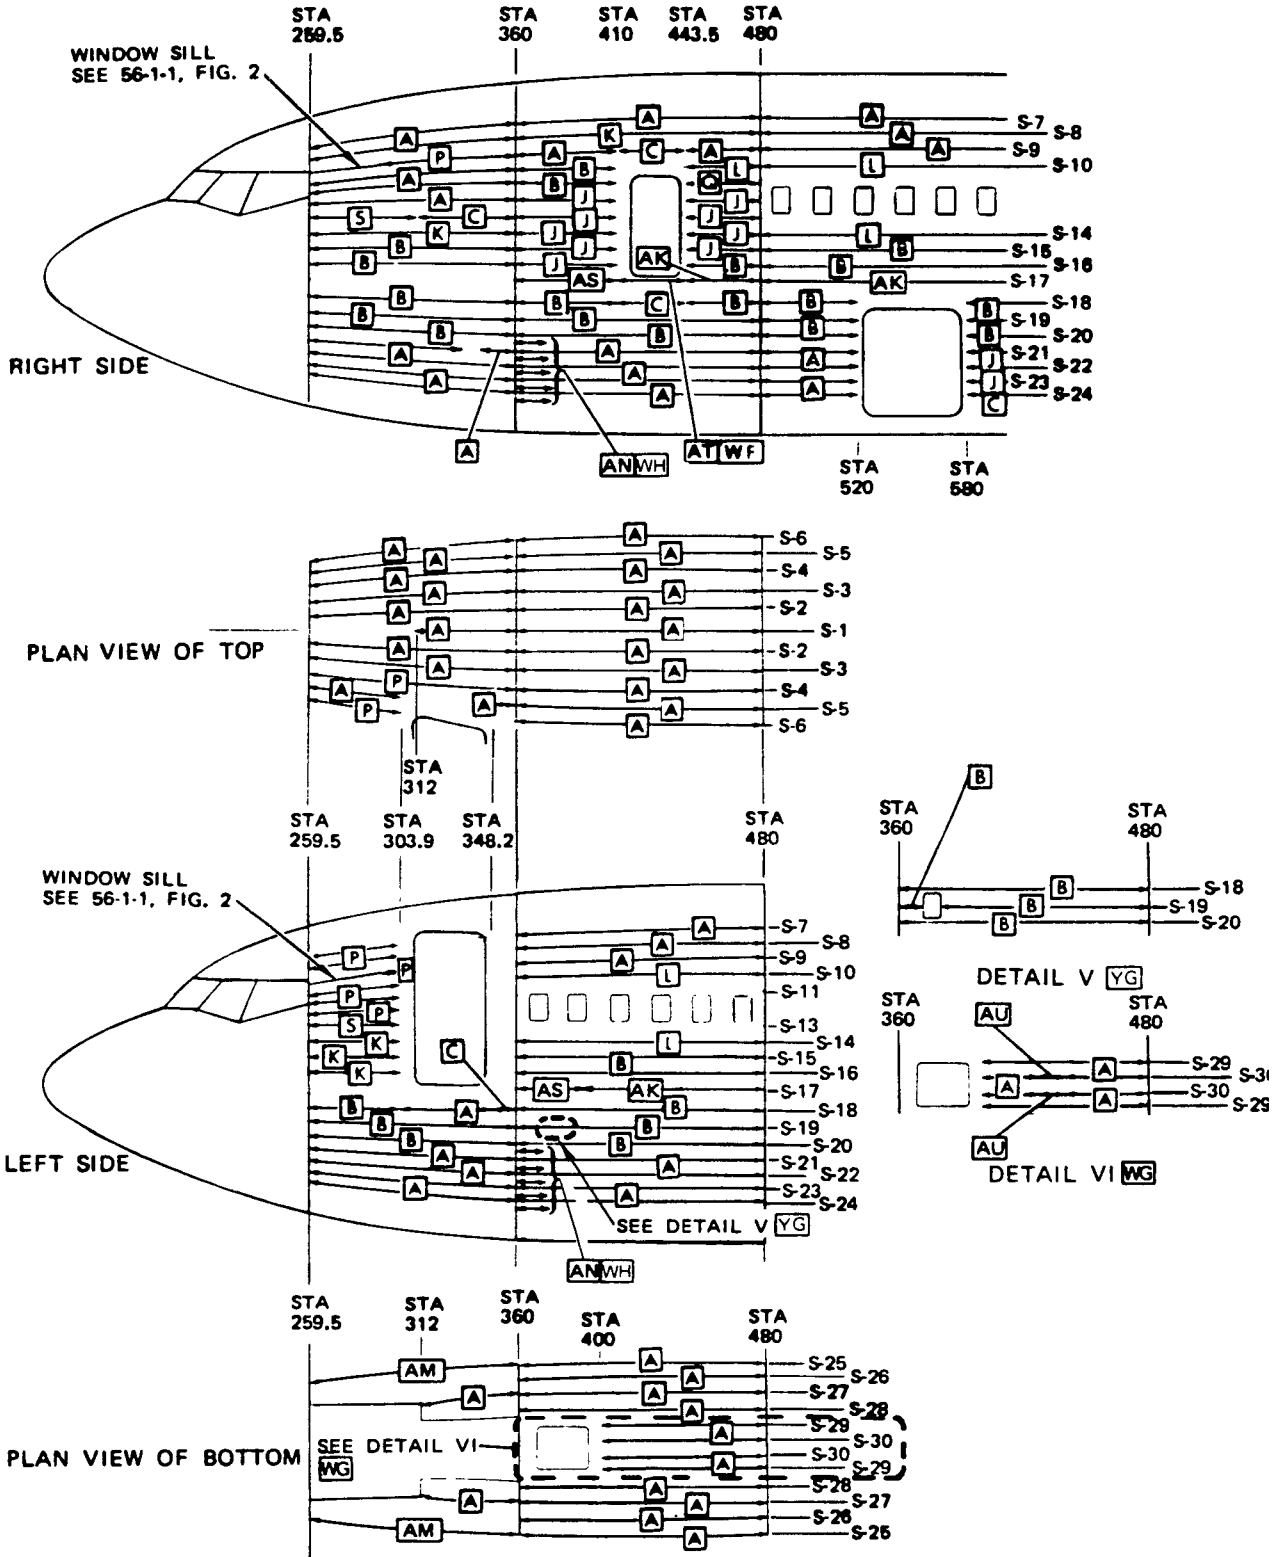
Fuselage Stringer Identification
Figure 8 (Sheet 31)

EFFECTIVITY	
W2	XA
NON-CARGO

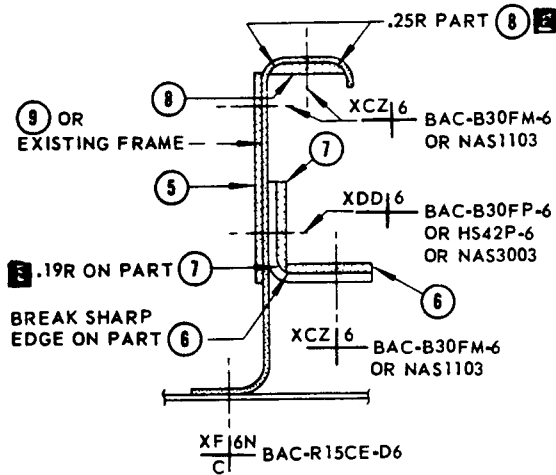
Fuselage Lower Frame Repair at Stringer
Figure 3 (Sheet 2 of 2)

REPAIR MATERIAL			
PART	QTY.	MATERIAL	
5	PLATE	2	CLAD 7075-T6 A
6	STRAP	2	7075-T6 F
7	STRAP	2	7075-T6 F
8	STRAP	2	7075-T6 F
9	Z FRAME	1	D

SECTION THROUGH REPAIR AT SPLICE

- D** MAKE FROM PRODUCTION SPARE PART FRAME.
- E** OPTIONAL: CHAMFER TO SUIT RADIUS OF ORIGINAL STRUCTURAL PART.
- F** TWICE THE GAGE OF AN ORIGINAL FRAME.

OPTIONAL REPAIR METHOD
(SPLICE AT ONE END OF REPAIR SHOWN - OPPOSITE END TYPICAL)

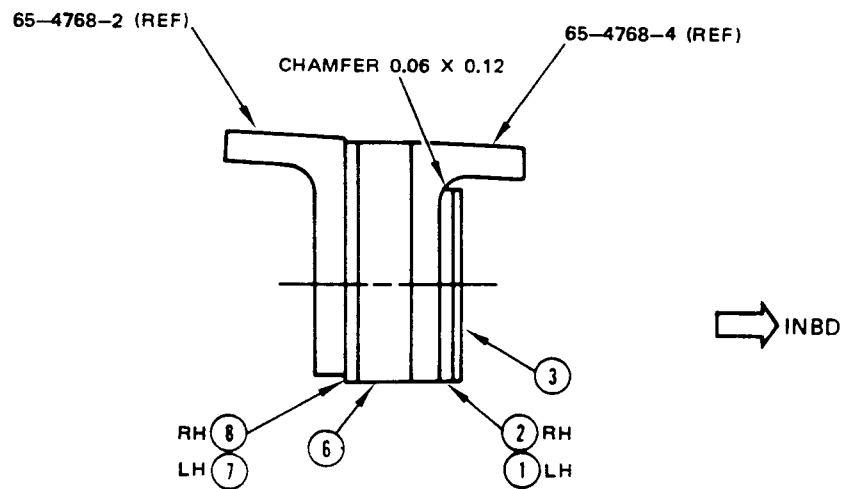
Keel Beam Splice Angle Repair
Figure 4 (Sheet 5)

SECTION A-A

SECTION B-B
