sabena [®] B707	Module: MAIN CARGO CMPT	A/C Reg :	Check :

AD 85-12-01 MAIN CARGO DOOR CAM SPT FTG HFEC INSP

MAIN CARGO DOOR CAM SUPPORT FITTING INSP.

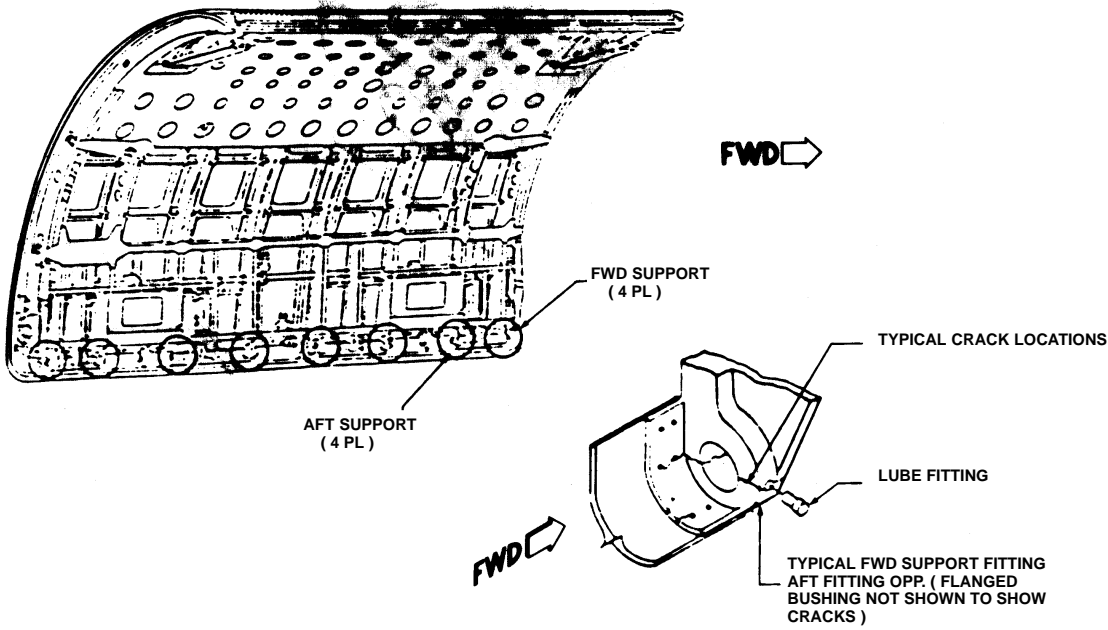
**UPPER DECK MAIN CARGO DOOR
CAM SUPPORT FITTING INSPECTION**

Clean the inspection area.
 Inspect cam support fitting assies (8 places) for cracks in area around fitting flanged bushing & in fitting lower curved flange by using a HIGH FREQUENCY EDDY CURRENT inspection per D6-48023 p6, SUB 51-00-00 FIG. 4. Pay particular attention to area of lube fitting.

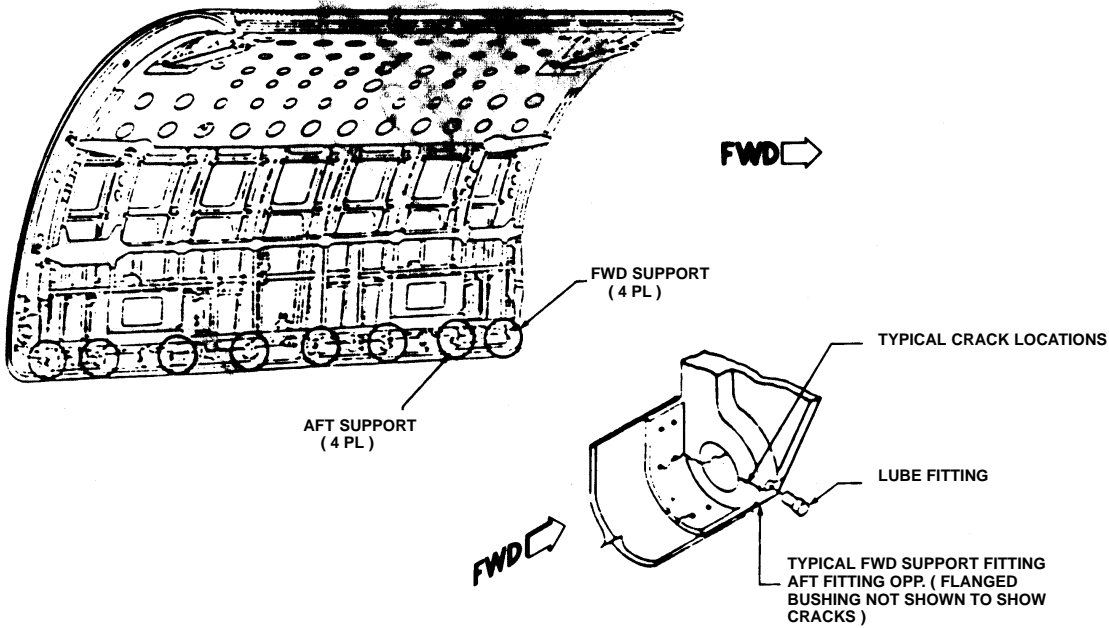
**UPPER DECK MAIN CARGO DOOR
CAM SUPPORT FITTING INSPECTION**

Inspect cam support fitting assies (8 places) for cracks in area around fitting flanged bushing & in fitting lower curved flange by using a HIGH FREQUENCY EDDY CURRENT inspection per D6-48023 p6, SUB 51-00-00 FIG. 4. Pay particular attention to area of lube fitting.

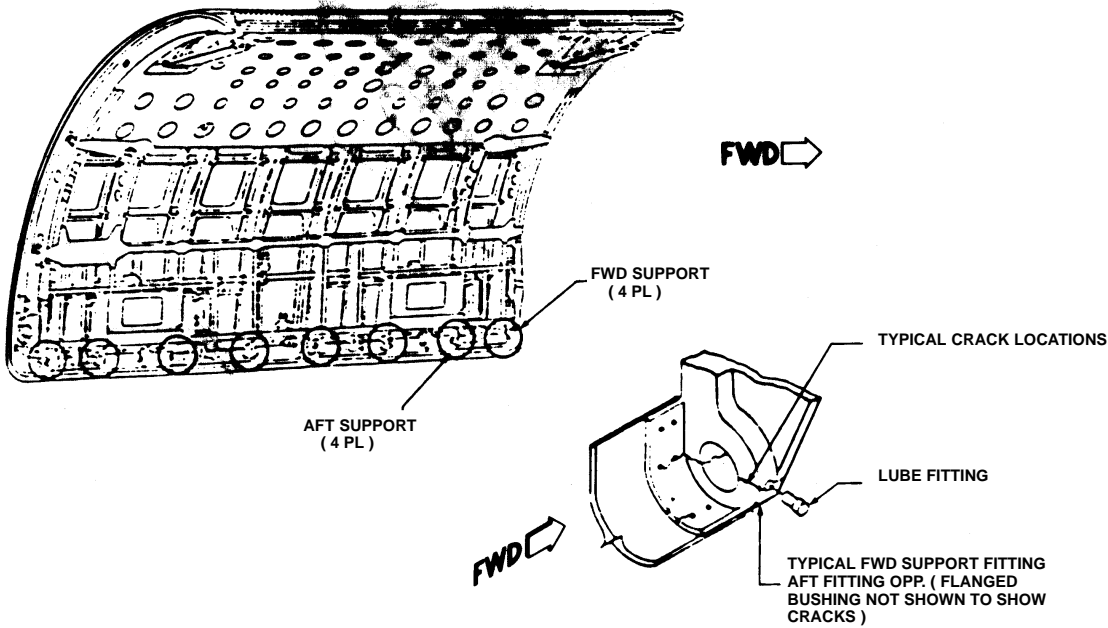
**UPPER DECK MAIN CARGO DOOR
CAM SUPPORT FITTING INSPECTION**

Inspect cam support fitting assies (8 places) for cracks in area around fitting flanged bushing & in fitting lower curved flange by using a HIGH FREQUENCY EDDY CURRENT inspection per D6-48023 p6, SUB 51-00-00 FIG. 4. Pay particular attention to area of lube fitting.
