<b>sabena</b> <sup>®</sup> <b>B707</b>	Module: MLG WW + DOORS	A/C Reg :	Check :

AD 63-11-01 rev 568                      LH MLG TRUCK BEAM INSP

**LH MLG TRUCK BEAM AND TRUCK BEAM PROTECTION SHIELD INSPECTION.**

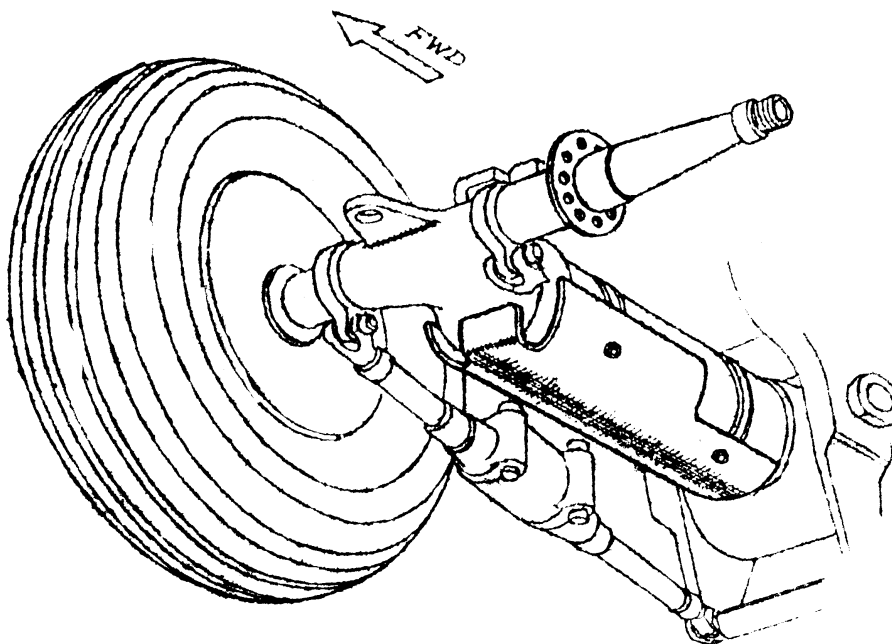
1. Clean all visible parts on MLG truck beam:
2. Close visual inspection of truck beam using mirror as necessary and a strong light to detect any evidence of jack marks, scratches gouges, corrosion or impact dents. Remove any straps around the beam which show evidence of damage.

Particular attention shall be given to:

- The lower section of the beam for evidence of jack marks caused by jack slippage or improperly placed jack.
- The FWD area of the beam where contact is possible with the torsion link pivot pin retaining bolt.
- To the AFT area of the beam where contact is possible with the shock strut inner cylinder upon snubber failure.
