sabena B707	Module: ENGINE 2	A/C Reg :	Check :

ENG #2 SENSING LOOP WIRING LWR LOOP CONN INSP

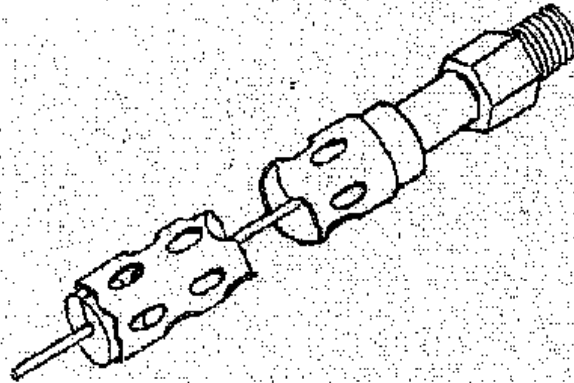
FIGURE 1 : Shrouded element section (typical)

Fig. 1 to Fig. 3 are for reference only

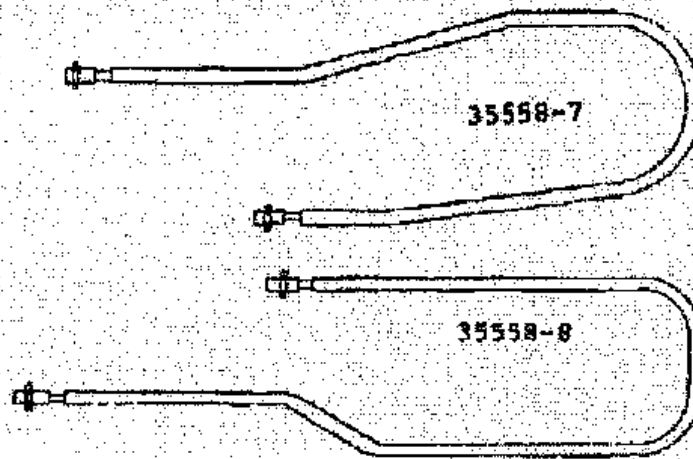
FIGURE 2: Shrouded lower und upper fire sensing elements

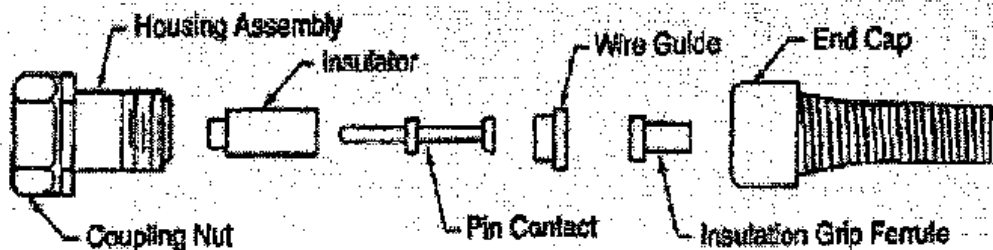
Figure 3: Fenwal PN: 35303-12 Connector

<p>Step 2. Perform a detailed visual inspection of Engine Fire Loop electrical connector for:</p> <ul style="list-style-type: none"> a) any signs of damaged sealing b) proper safety lock wire installation c) any signs of looseness of connector <p>NOTE: If no discrepancies are found iaw step 2 requirements the connector need <u>NOT</u> to be disconnected for further inspection.</p> <ul style="list-style-type: none"> d) In case of any damaged sealing, improper installation such as looseness the connector of the sensing element has to be disconnected and inspected. Perform the following: <ul style="list-style-type: none"> 1) Cleaning of connector 2) Inspection of connector for contamination and/or corrosion 3) Inspection of connector parts for any obvious damage <p style="text-align: center;">LOWER ENGINE FIRE LOOP</p>
