<b>sabena</b> <b>B707</b>	Module: ENGINE 3	A/C Reg :	Check :

<b>P1F1000504</b>
	Oper. : RT-MP LC			
	Type : REI-INSP	Issuer : A59513	Cert.St.: 45379	<b>Page 1 of 7</b>
Spec. : REI INSP	Release Date: 11.09.2008

**ENG #3 SENSING LOOP WIRING UP LOOP CONN**

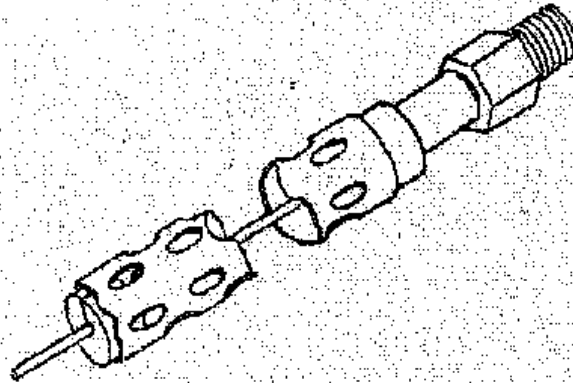
**FIGURE 2: Shrouded lower und upper fire sensing elements**
