SECTION 18

STRUCTURAL REPAIR

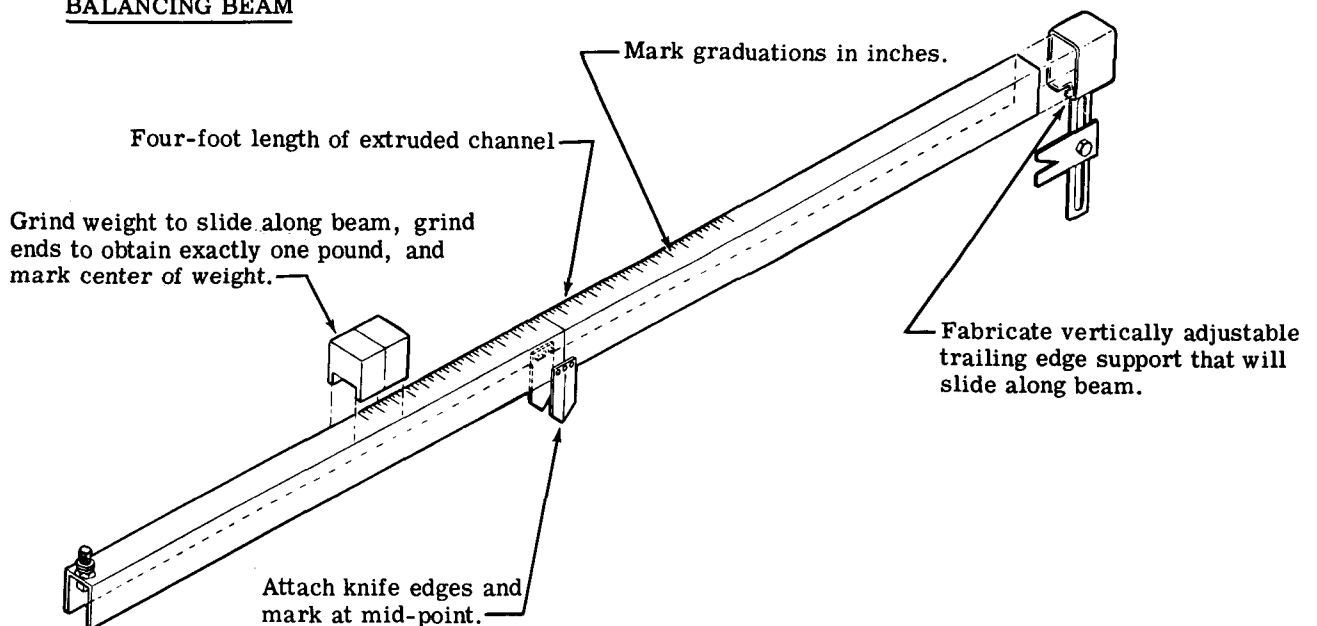
Figure 18-3. Control Surface Balancing (Sheet 2 of 5)

- g. If modification of the rudder/elevator balance weight is necessary to correct an out-of-balance condition, the balance weight can be lightened by drilling out part of the weight. The weight can be increased by fusing bar stock solder to the weight after removal from rudder/elevator.

BALANCING BEAM

Detail A

18-36. **AILERON BALANCING.** Following repair, replacement or painting, the aileron must be balanced. Complete instructions for fabricating balancing fixtures and mandrels and their use are given in figure 18-3.

18-49. ELEVATOR AND RUDDER BALANCING. Following repair, replacement or painting, the elevators and rudder must be balanced. Complete instructions for fabricating balancing fixtures and mandrels and their use are given in figure 18-3.

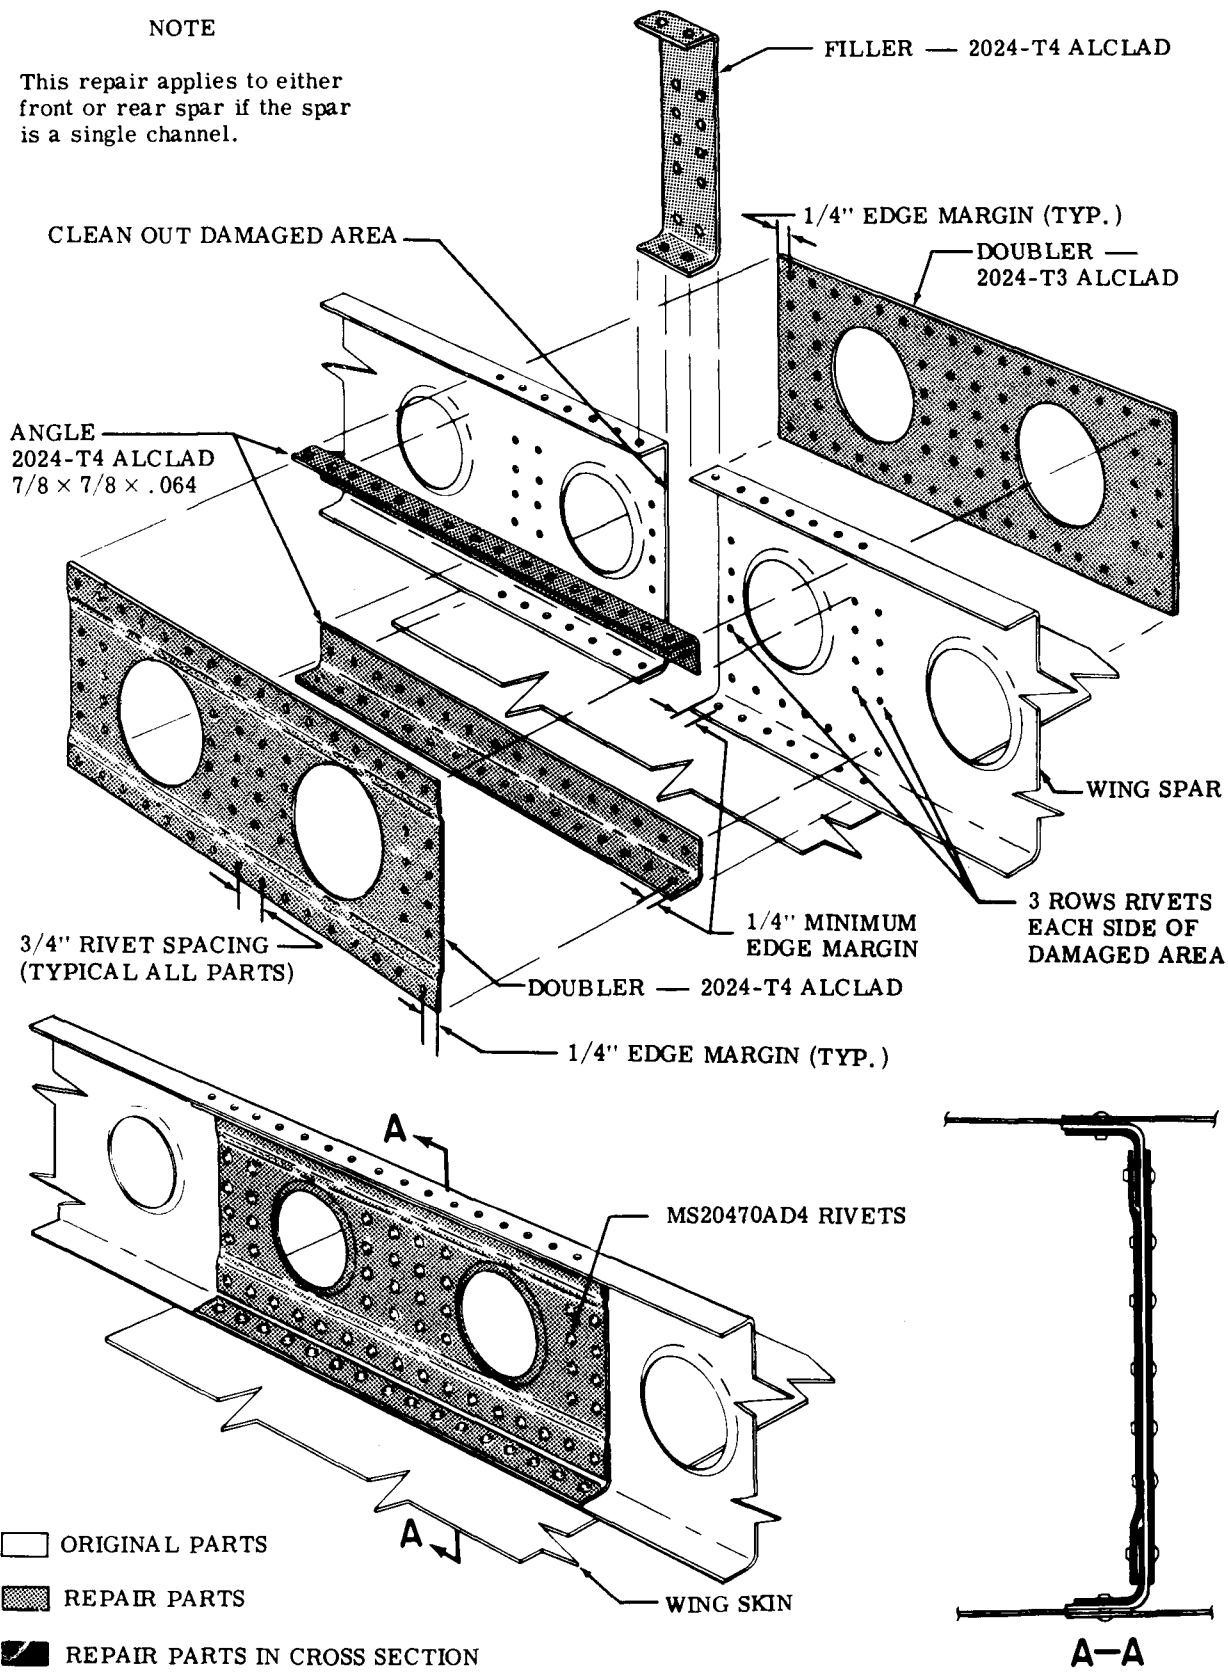
Figure 18-7. Wing Spar Repair (Sheet 2 of 3)

This repair applies to either front or rear spar if the spar is a single channel.

18-30. **REPAIRABLE DAMAGE.** Figure 18-7 illustrates typical spar repairs. It is often practical to cut repair pieces from service parts listed in the Parts Catalog. Service Kits are available for certain types of spar repairs.

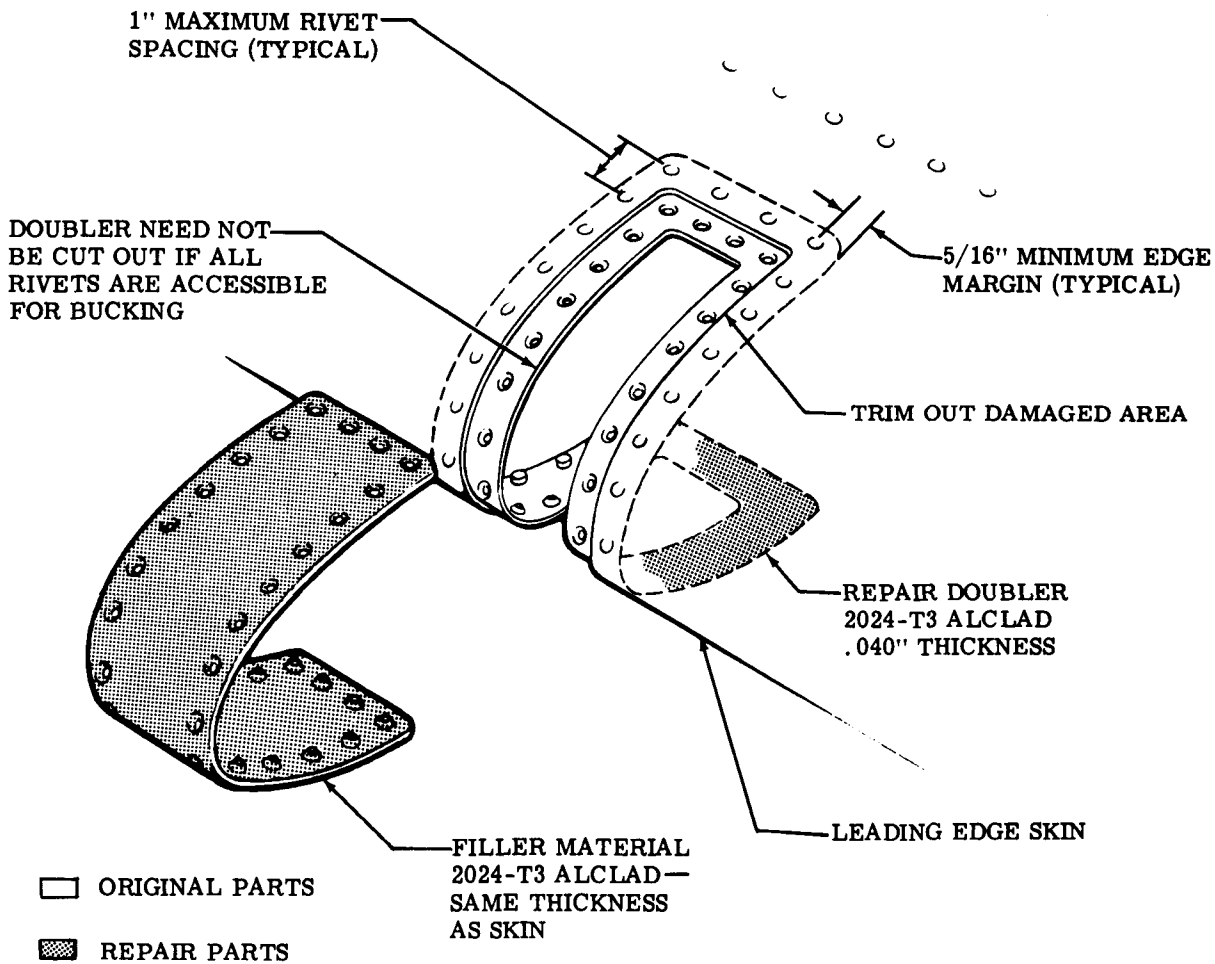
Figure 18-9. Leading Edge Repair

1. Dimple leading edge skin and filler material; countersink the doubler.
2. Use MS20426AD4 rivets to install doubler.
3. Use MS20426AD4 rivets to install filler, except where bucking is impossible. Use CR162-4 Cherry (blind) rivets where regular rivets cannot be bucked.
4. Contour must be maintained; after repair has been completed, use epoxy filler as necessary and sand smooth before painting.
5. Vertical size is limited by ability to install doubler clear of front spar.
6. Lateral size is limited to seven inches across trimmed out area.
7. Number of repairs is limited to one in each bay.

18-34. **REPAIRABLE DAMAGE.** The repair shown in figure 18-9 may be used to repair damage to aileron leading edge skins. Figure 18-4 may be used to repair damage to flat surfaces between corrugations, when damage area includes corrugations refer to figure 18-3A. It is recommended that material used for repair be cut from spare parts of the same gauge and corrugation spacing. Following repair the aileron must be balanced. Refer to paragraph 18-36 and figure 18-3 for balancing the aileron. If damage would require a repair which could not be made between adjacent ribs, see the following paragraph.

18-43. REPAIRABLE DAMAGE. A typical leading edge skin repair is shown in figure 18-9. An epoxy-type filler may be used to fill gaps at butt-joints. To facilitate repair, extra access holes may be installed in the locations noted in figure 18-11. If the damage would require a repair which could not be made between adjacent ribs, refer to the following paragraph.
