<b>sabena</b> <sup>®</sup> <b>B707</b>	Module: GENERAL	A/C Reg :	Check :

<b>01F100002</b>
	Oper. : RT-MP LC			
	Type : REI-INSP	Issuer : A59513	Cert.St.: 45379	<b>Page 1 of 2</b>
Spec. : REI INSP	Release Date: 11.09.2008

**RH RVSM CRITICAL AREA MARKERS INSPECTION**

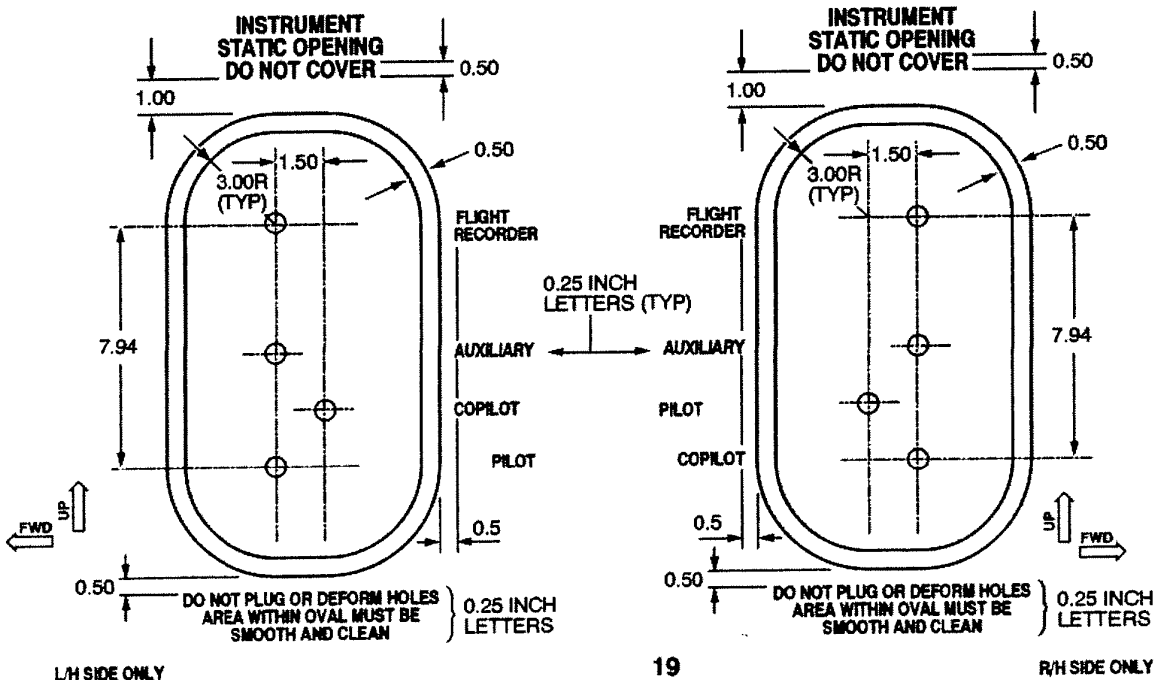
Fig. 3 Markings FWD Body Section (Sheet 7 of 10)

CHECK FOR MARKERS ON THE EDGES OF THE RH RVSM CRITICAL AREA MUST BE VISIBLE & IN GOOD CONDITION.

**19**  
LOCATION: STA 514 ABOVE AND BELOW  
WL 155, L/H AND R/H  
COLOR: LETTERING BLACK NO. 17038  
BAND RED NO. 11136  
PER FED-STD-595
