sabena [®] B707	Module: UPPR FUS /RADOME	A/C Reg :	Check :

AFT ENTRY DOOR CUTOUT NDT INSP

AFT ENTRY DOOR CUTOUT NDT INSPECTION.

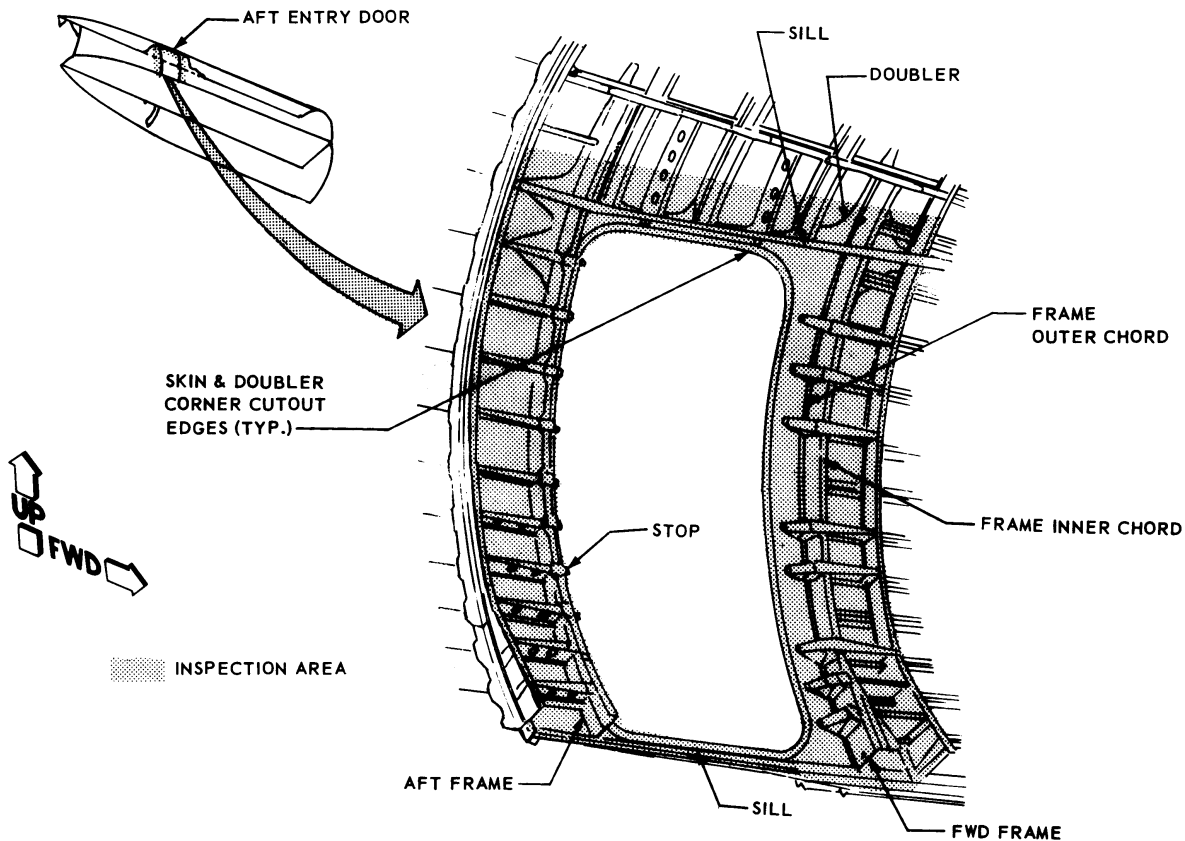
X-RAY external inspection of doubler sandwiched between fuselage skin and inner skin doubler. Skin lap areas. Frame, sill outer chord intersections. Fuselage skin beneath external steel stap. Skin and skin doubler around edge of door corners. Refer. DOC D6-48023 PART 2, 53-10-07 FIG 15.

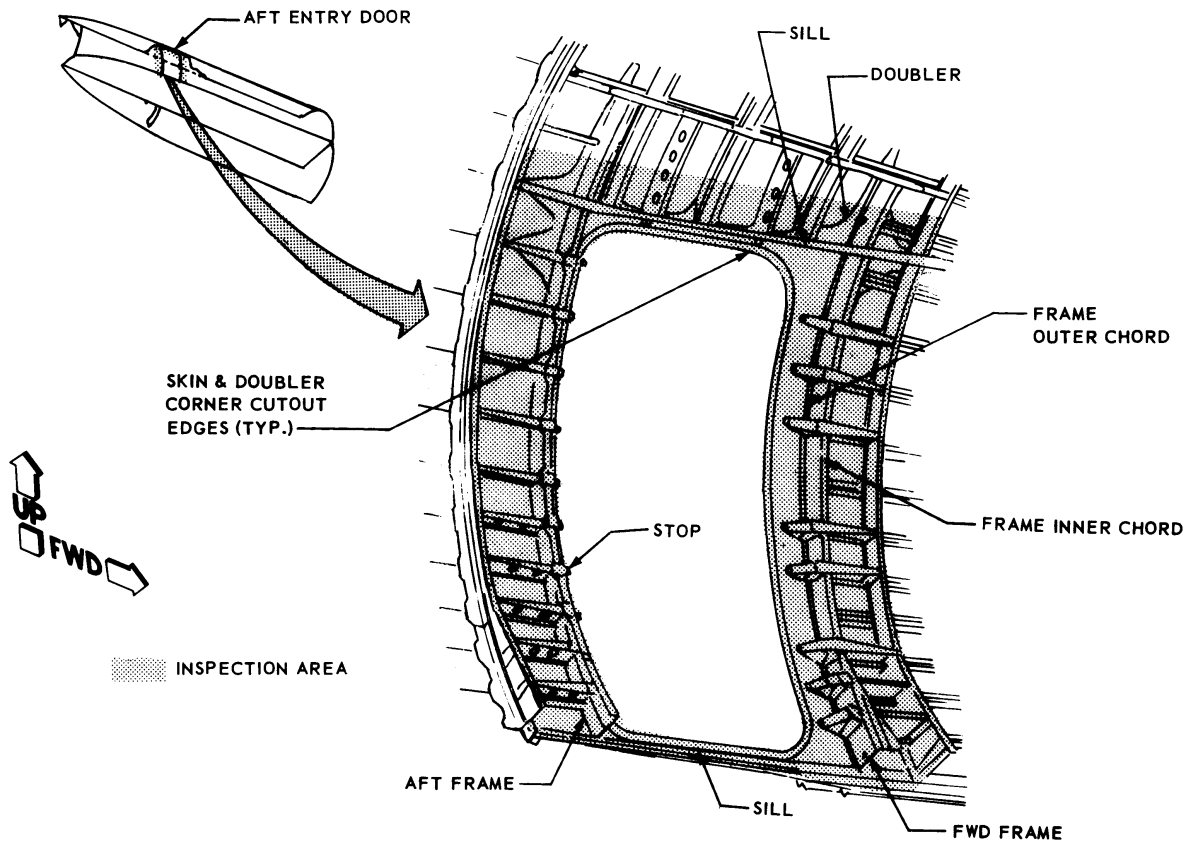
X-RAY external inspection of doubler sandwiched between fuselage skin and inner skin doubler. Skin lap areas. Frame, sill outer chord intersections. Fuselage skin beneath external steel stap. Skin and skin doubler around edge of door corners. Refer. DOC D6-48023 PART 2, 53-10-07 FIG 15.

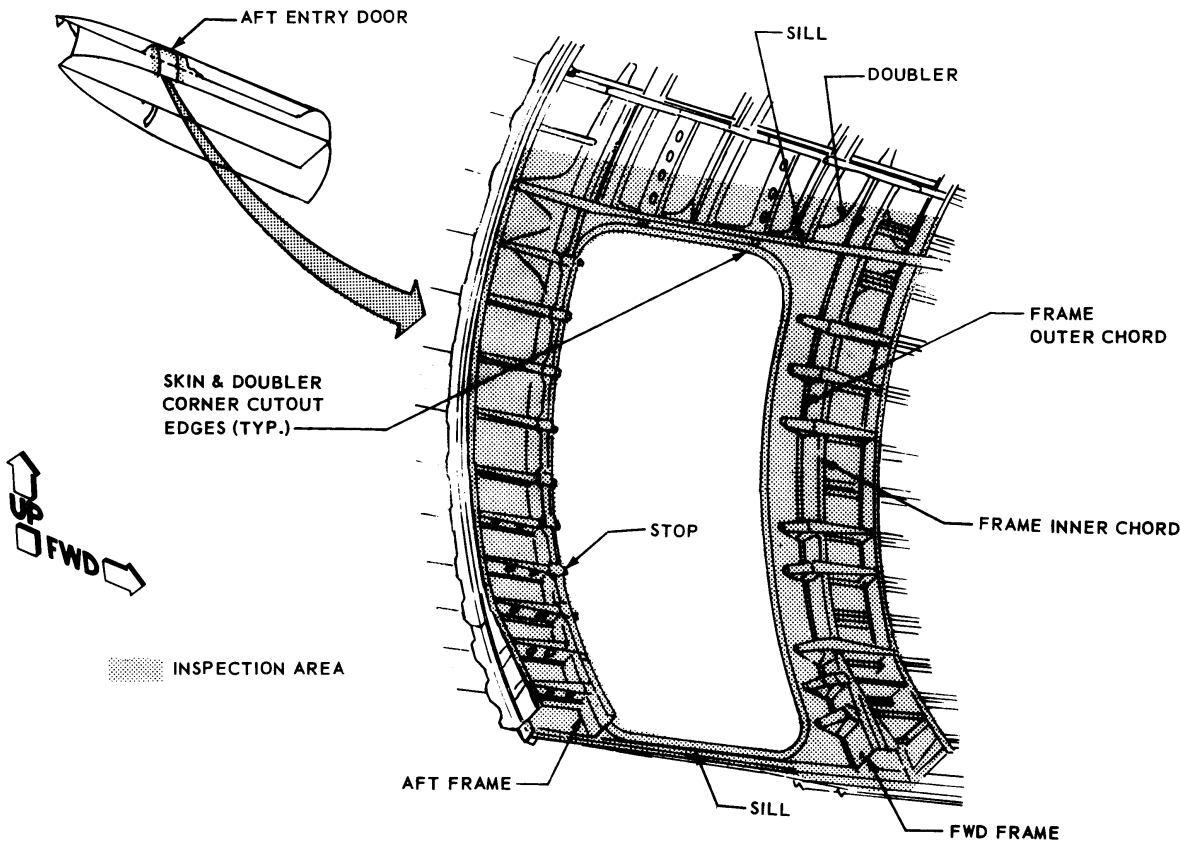
X-RAY external inspection of doubler sandwiched between fuselage skin and inner skin doubler. Skin lap areas. Frame, sill outer chord intersections. Fuselage skin beneath external steel stap. Skin and skin doubler around edge of door corners. Refer. DOC D6-48023 PART 2, 53-10-07 FIG 15.
