<b>sabena</b> <sup>®</sup> <b>B707</b>	Module: LWR FUS / EMPENA	A/C Reg :	Check :

AD 85-12-01 rev . FWD LWR CARGO DOOR CUTOUT INSP

**FUSELAGE FWD LOWER CARGO COMPARTMENT DOOR CUTOUT INSPECTION.**

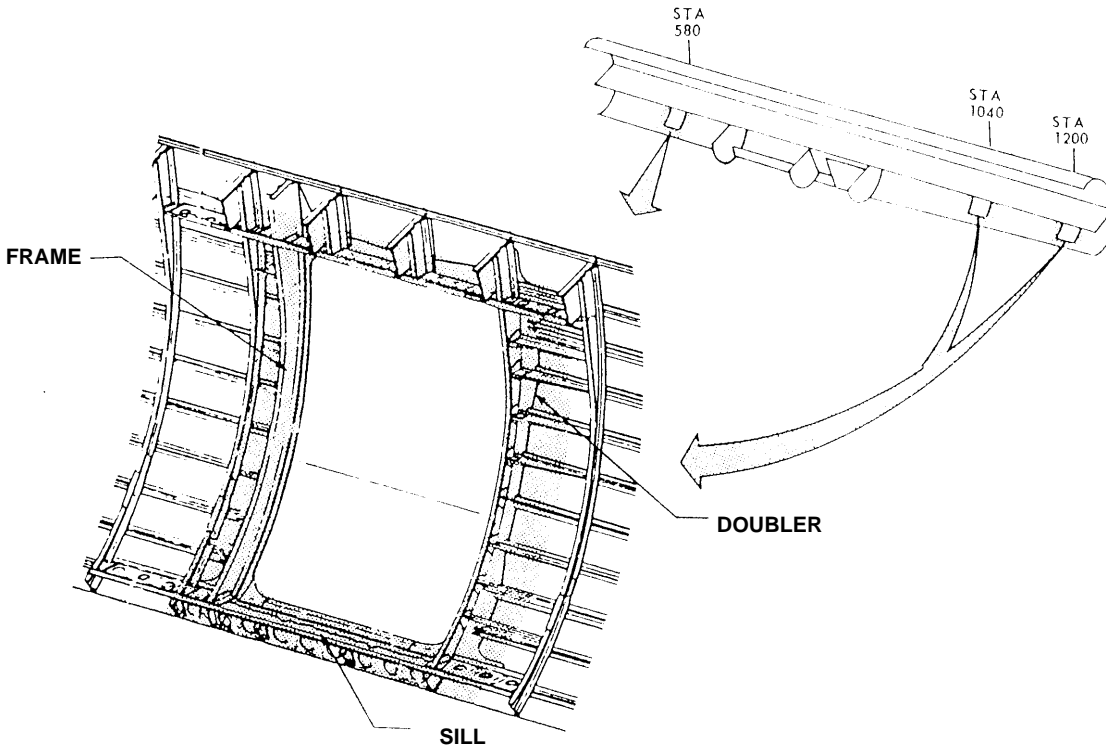
Inspect close visual, external for cracks in fuselage framing, skin, sill, door stop support fittings and doubler around door cutout. Pay particular attention to the cutouts exposed edge and doubler attach fastener areas surrounding the cutout on the FWD LOWER CARGO DOOR CUTOUT.

FUSELAGE LOWER CARGO COMPARTMENT CUTOUT INSPECTION.

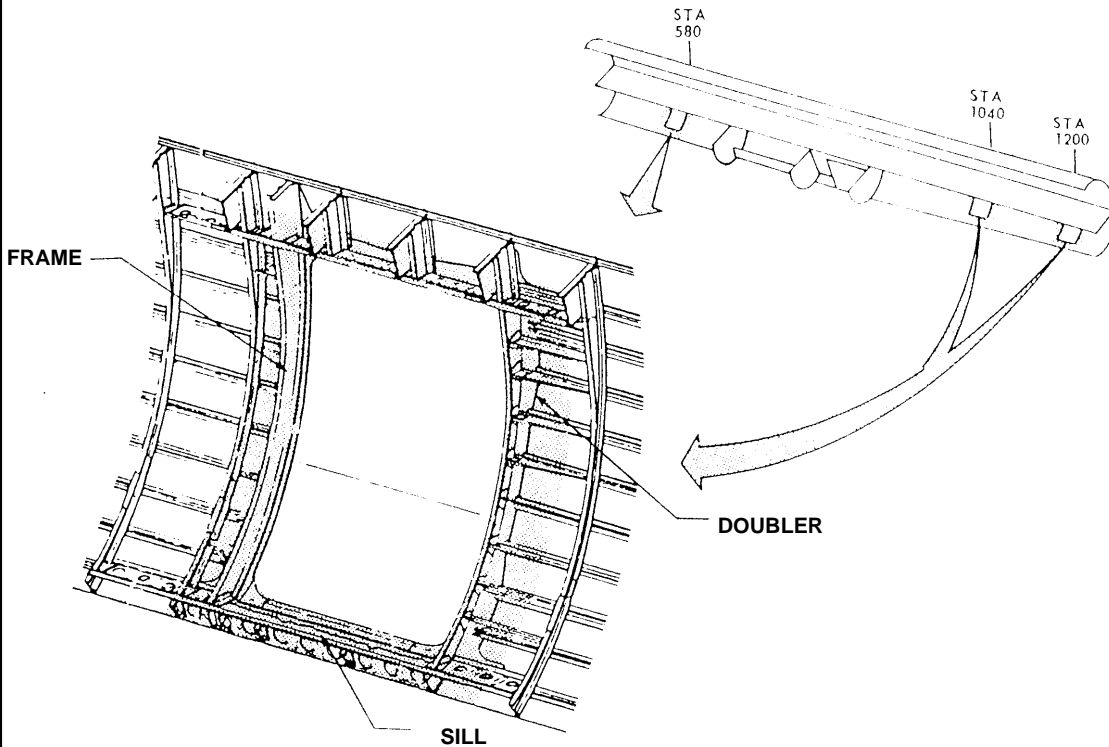
Inspect close visual, external for cracks in fuselage framing, skin, sill, door stop support fittings and doubler around door cutout. Pay particular attention to the cutouts exposed edge and doubler attach fastener areas surrounding the cutout on the FWD LOWER CARGO DOOR CUTOUT.

FUSELAGE LOWER CARGO COMPARTMENT CUTOUT INSPECTION.

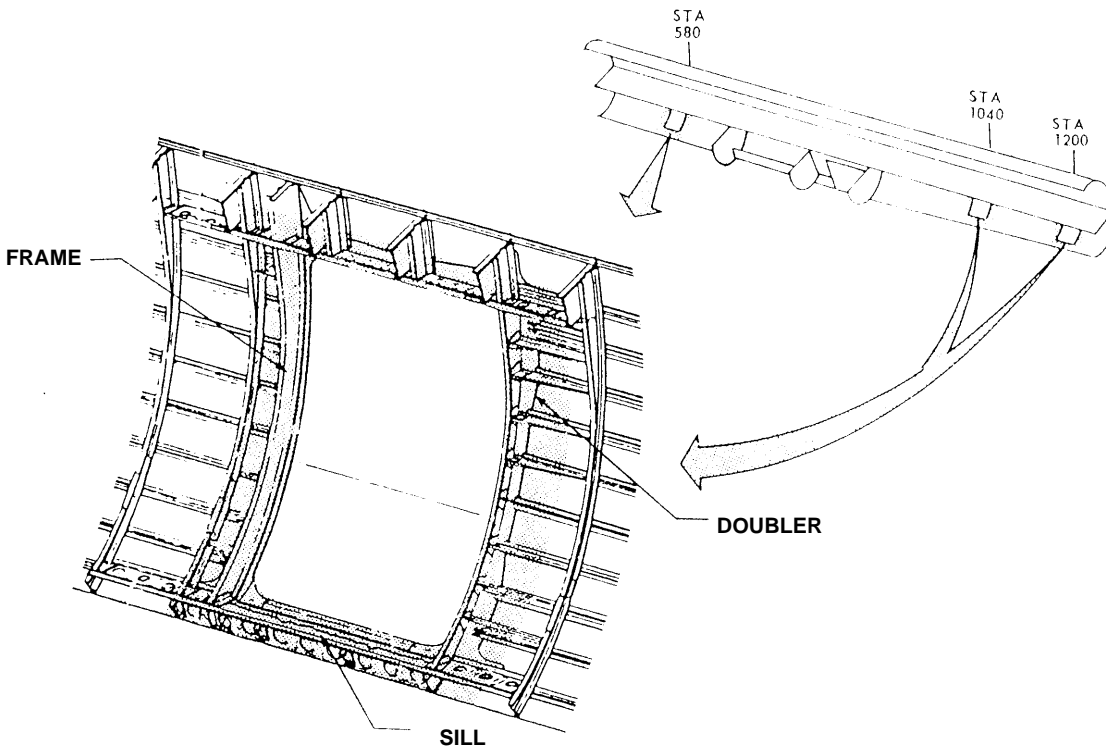
Inspect close visual, external for cracks in fuselage framing, skin, sill, door stop support fittings and doubler around door cutout. Pay particular attention to the cutouts exposed edge and doubler attach fastener areas surrounding the cutout on the FWD LOWER CARGO DOOR CUTOUT.

FUSELAGE LOWER CARGO COMPARTMENT CUTOUT INSPECTION.
