AD 85-12-01 rev . AFT LWR CARGO DOOR CUTOUT INSP

MAINT	RII/INSP
Nr.	Hardtime	Task	Spec.	Related Documents		
1.	21884 CYC	E3	INS	AD 85-12-01 R1 rev 5439 MMS-328 530180 02020 rev 15.07.05 SSID 53-A45-08/A rev .		
Check: C1						
Zones: 113						
Access:						
NRC YES <input type="radio"/> NO <input type="radio"/>		IF YES, NUMBER(S):

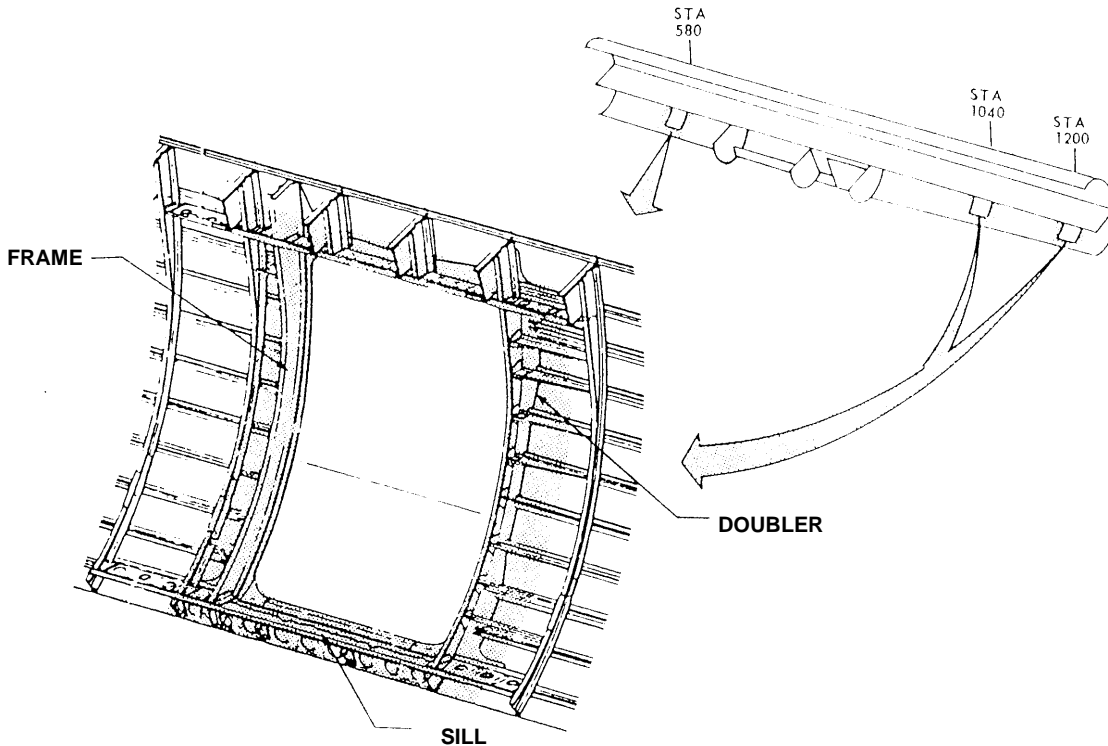
FUSELAGE LOWER CARGO COMPARTMENT CUTOUT INSPECTION.

FUSELAGE FWD LOWER CARGO COMPARTMENT DOOR CUTOUT INSPECTION.

Inspect close visual, external for cracks in fuselage framing, skin, sill, door stop support fittings and doubler around door cutout. Pay particular attention to the cutouts exposed edge and doubler attach fastener areas surrounding the cutout on the FWD LOWER CARGO DOOR CUTOUT.

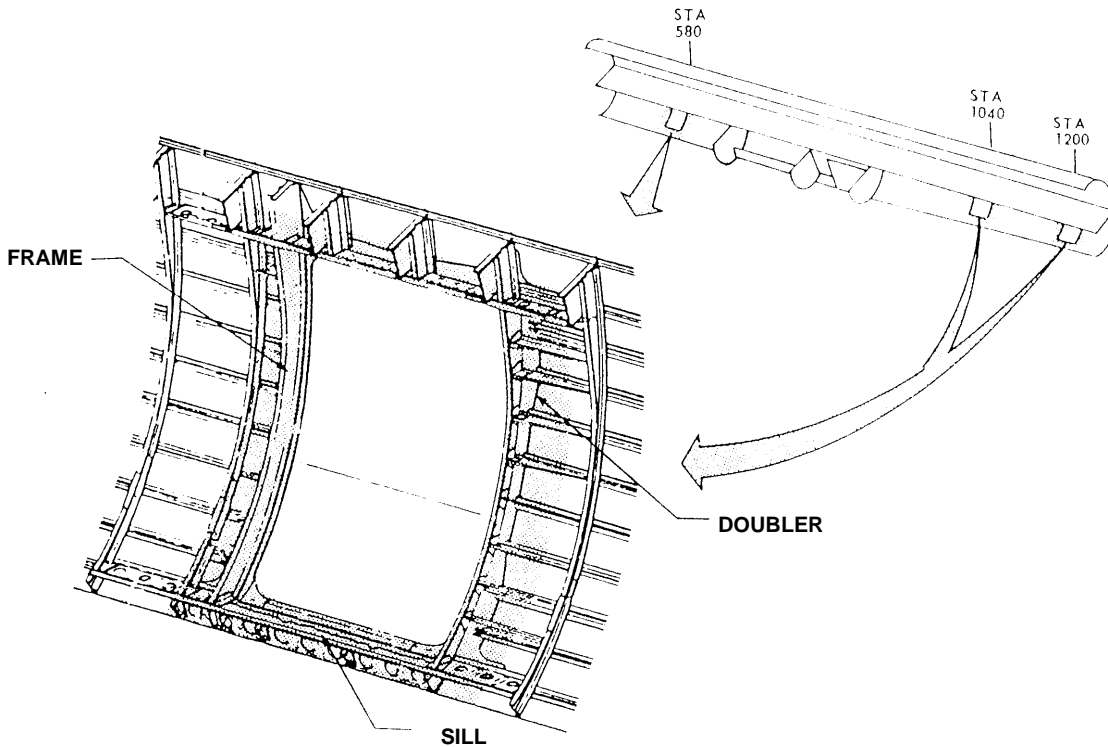
FUSELAGE LOWER CARGO COMPARTMENT CUTOUT INSPECTION.

FUSELAGE AFT LOWER CARGO COMPARTMENT DOOR CUTOUT INSPECTION.

Inspect close visual, external for cracks in fuselage framing, skin, sill, door stop support fittings and doubler around door cutout. Pay particular attention to the cutouts exposed edge and doubler attach fastener areas surrounding the cutout on the AFT LOWER CARGO DOOR CUTOUT.
