41F4000515
	Oper. : RT-MP LC			
	Type : NDT INSP	Issuer : A59513	Cert.St.: 46928	Page 1 of 7
Spec. : NDT INSP	Release Date: 22.11.2006

RH WING REAR SPAR LOWER CHORD NDI INSPECTION

MAINT	RII/INSP
Nr.	Hardtime	Task	Spec.	Related Documents		
1.	22083 CYC	E4	NDT	AD 85-12-01 R1 rev 5439 MMS-328 572080 02002 rev 15.07.05 SSID 57-A45-05/C1 rev P		
Check: C1						
Zones: 136, 673, 685						
Access: 1324R						
NRC YES <input type="radio"/> NO <input type="radio"/>		IF YES, NUMBER(S):

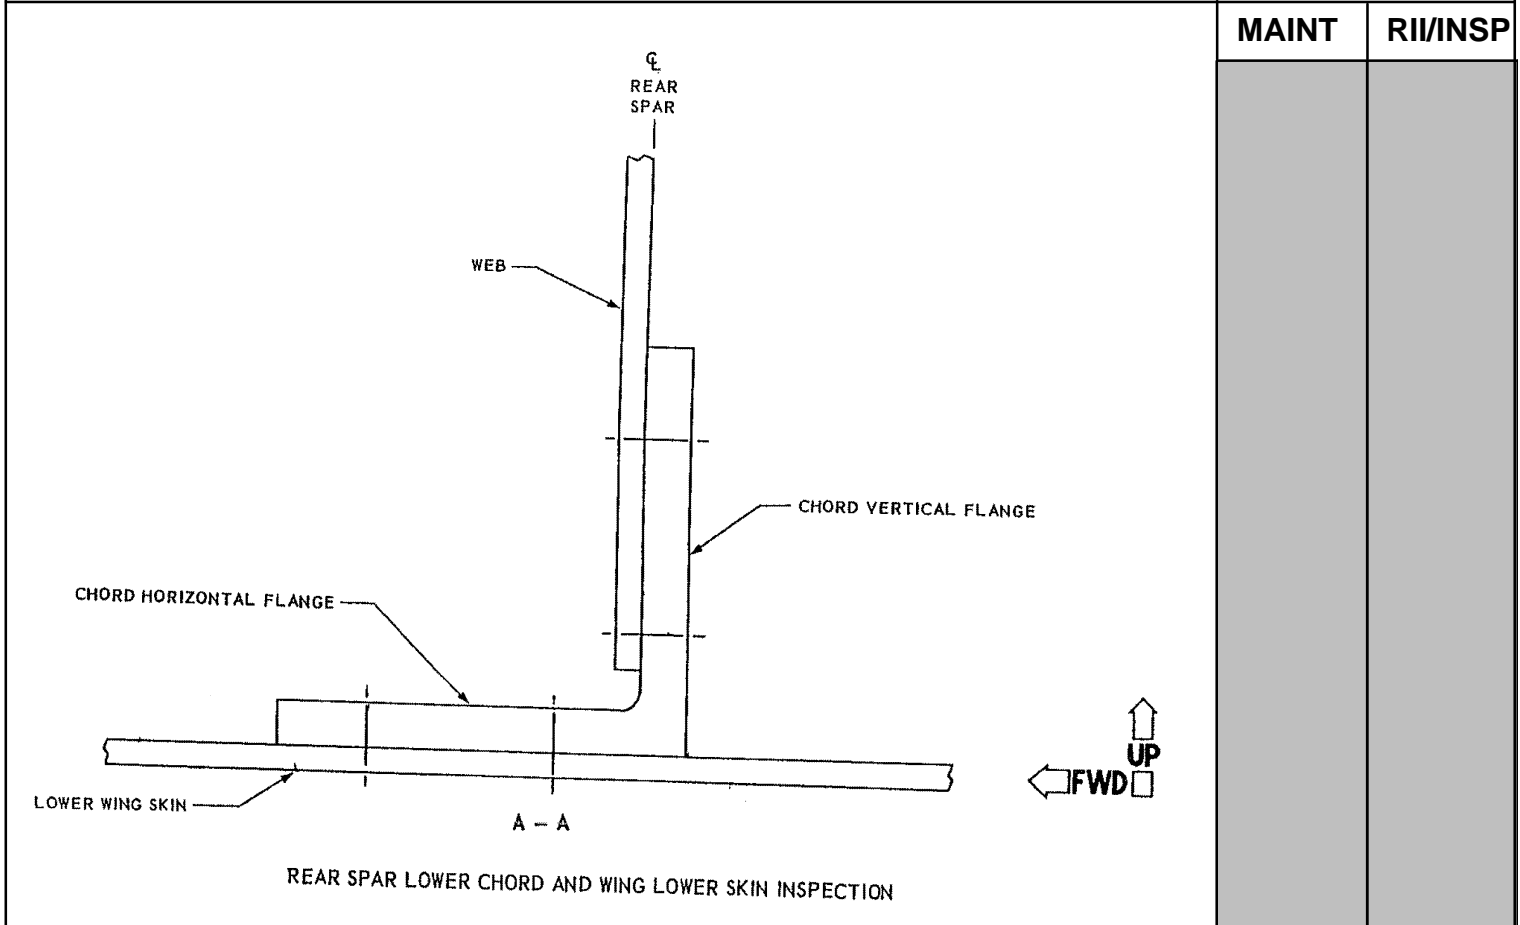
RH WING REAR SPAR LOWER CHORD, WEB TERMINAL FITTING / SPAR CHORD & WING LOWER SKIN BBL 70.50 TO WBL 59.24.

Do an X-RAY internal inspection of rear spar chord horizontal flange at all fastener locations.
Refer. DOC D6-48023, Part 2, 57-10-07, Fig 21.

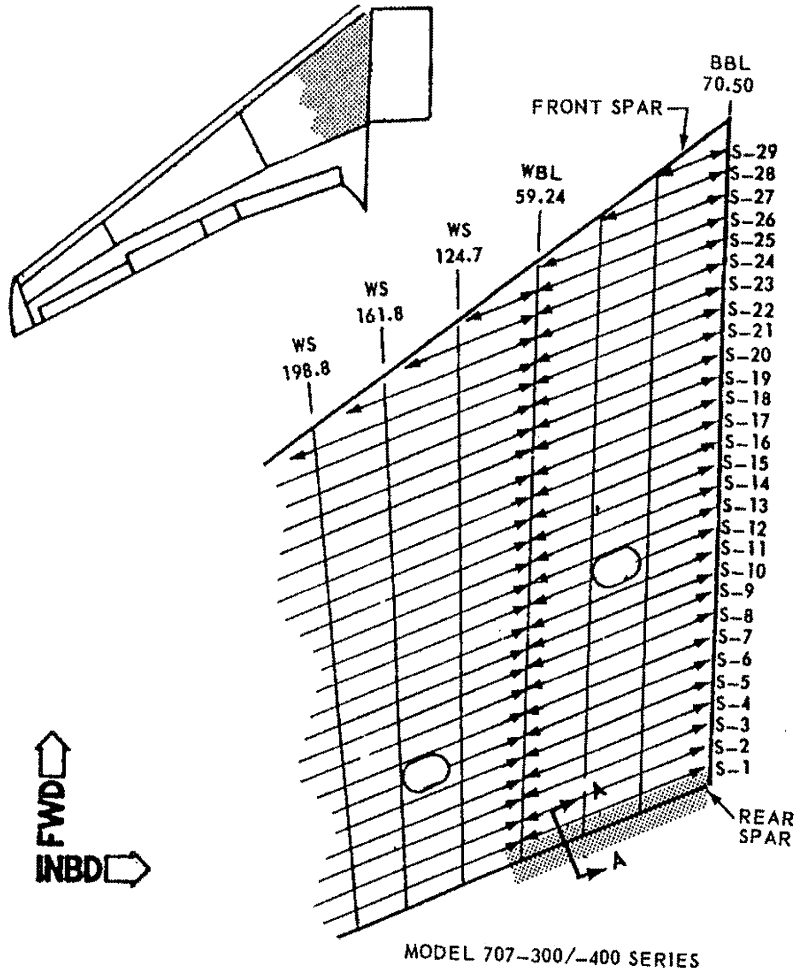
REAR SPAR LOWER CHORD AND WING LOWER SKIN INSPECTION
BBL 70.50 THRU WBL 129.62/59.24

INSPECTION AREA
