<b>sabena</b> <b>B707</b>	Module: RH WING + FL CTR	A/C Reg :	Check :

<b>41F4000516</b>
	Oper. : RT-MP LC			
	Type : NDT INSP	Issuer : A59513	Cert.St.: 46928	<b>Page 1 of 7</b>
Spec. : NDT INSP	Release Date: 22.11.2006

**RH WING REAR SPAR LOWER CHORD NDI INSPECTION**

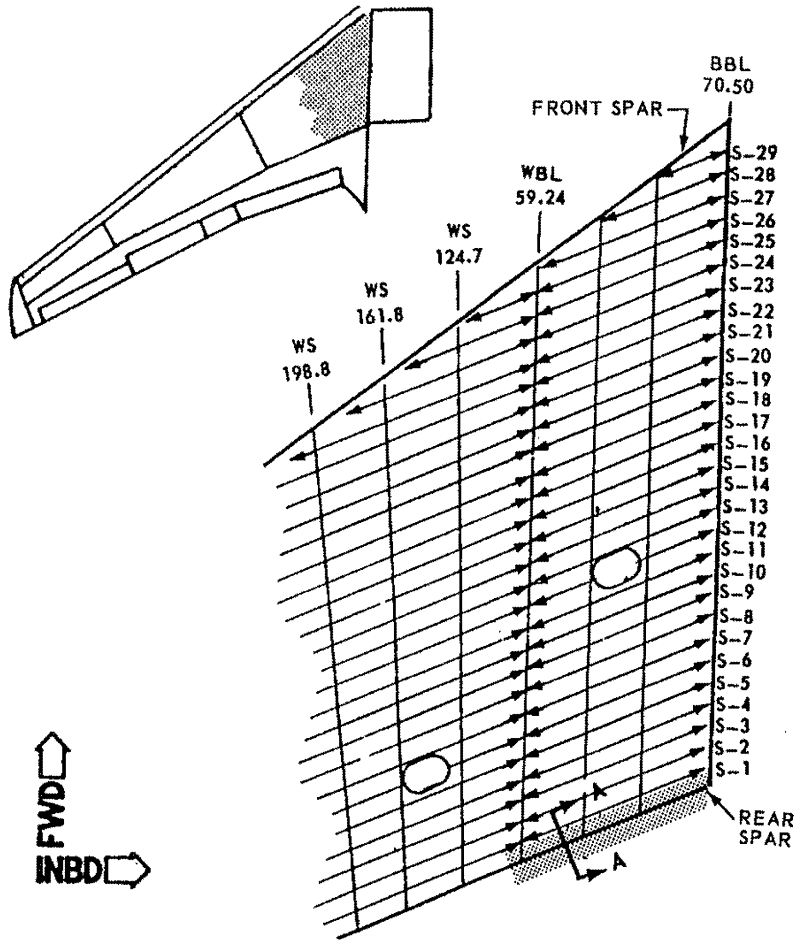
Do an H.F.E.C. internal inspection of wing lower skin, chord splice & all areas where presence of secondary structure impaired external inspection.  
Refer. DOC D6-48023, Part 6, 57-10-07, Fig 53

REAR SPAR LOWER CHORD AND WING LOWER SKIN INSPECTION  
BBL 70.50 THRU WBL 129.62/59.24

INSPECTION AREA

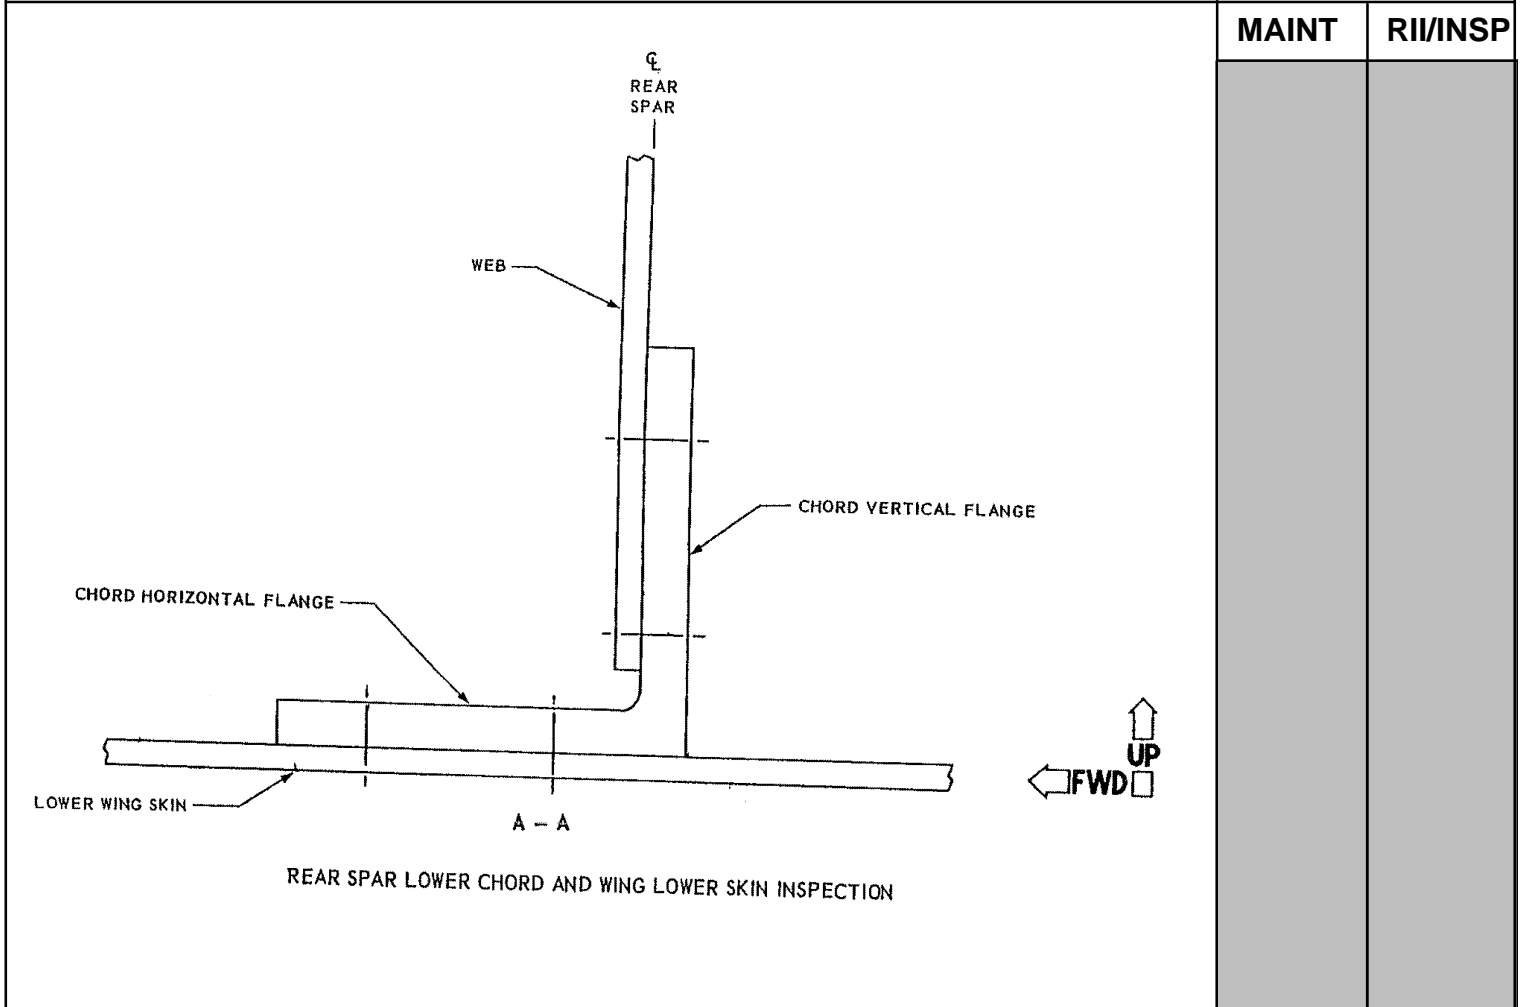
**RH WING REAR SPAR LOWER CHORD, WEB TERMINAL FITTING / SPAR CHORD & WING LOWER SKIN BBL 70.50 TO WBL 59.24.**

Do an H.F.E.C. internal inspection of wing lower skin, chord splice & all areas where presence of secondary structure impaired external inspection.

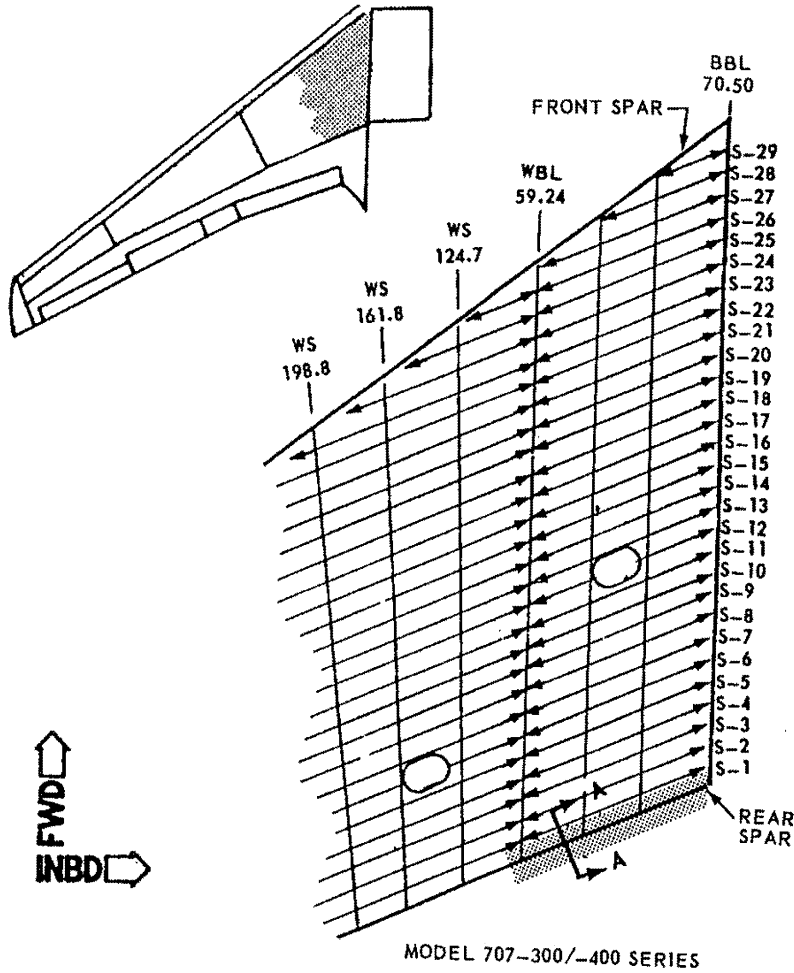
REAR SPAR LOWER CHORD AND WING LOWER SKIN INSPECTION  
 BBL 70.50 THRU WBL 129.62/59.24

INSPECTION AREA

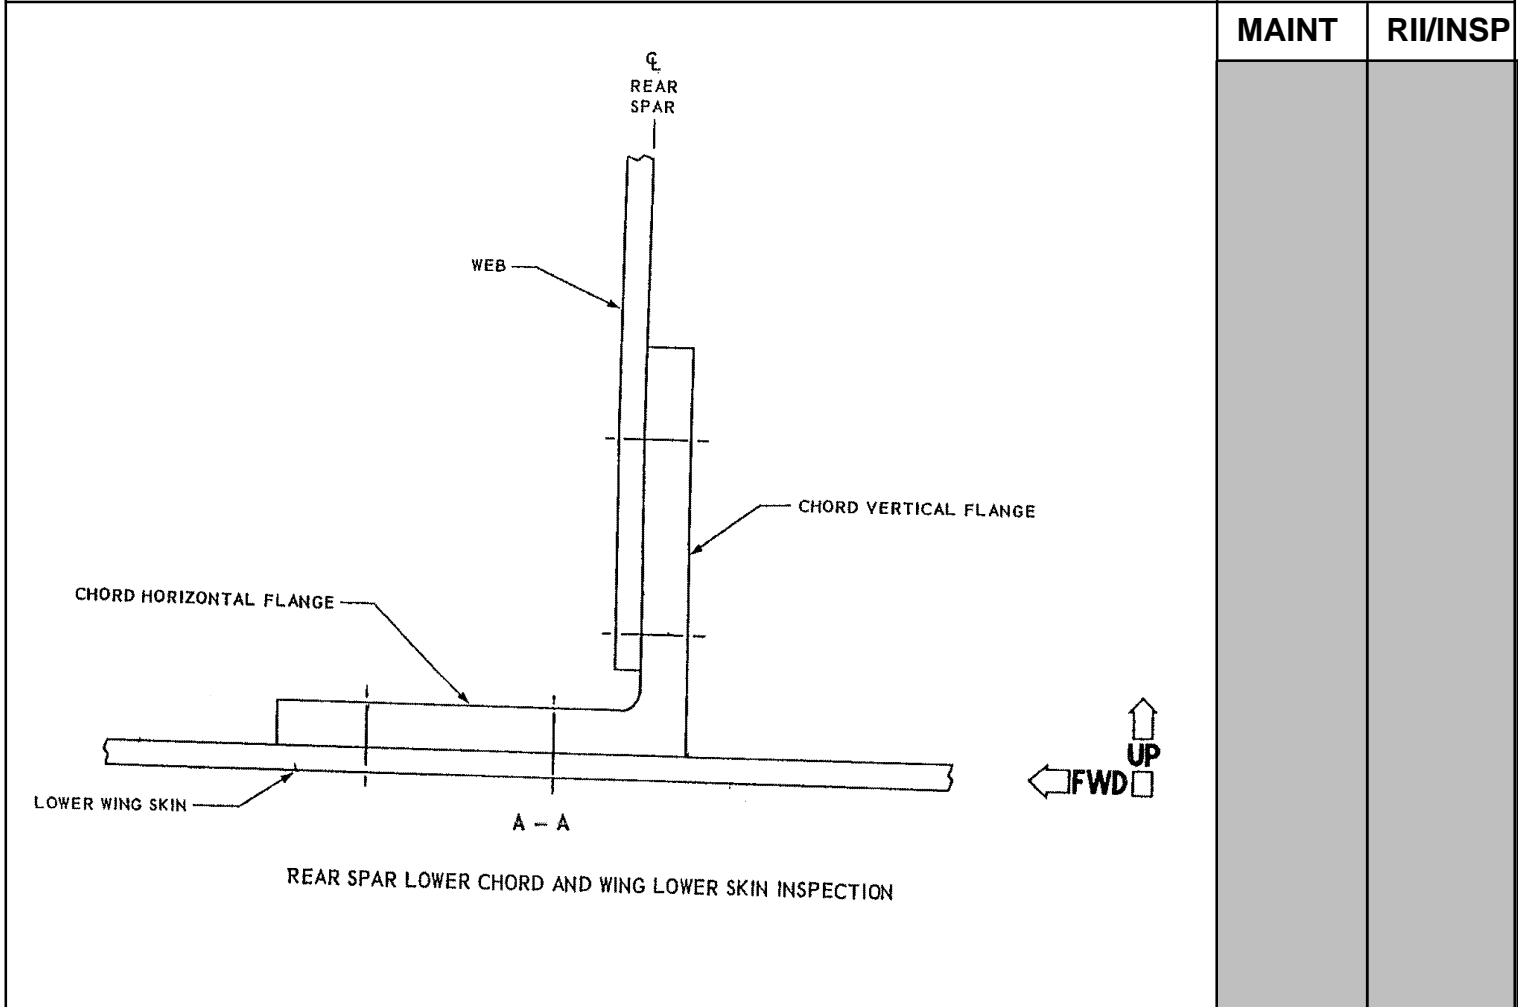
**RH WING REAR SPAR LOWER CHORD, WEB TERMINAL FITTING / SPAR CHORD & WING LOWER SKIN BBL 70.50 TO WBL 59.24.**

Do an H.F.E.C. internal inspection of wing lower skin, chord splice & all areas where presence of secondary structure impaired external inspection.

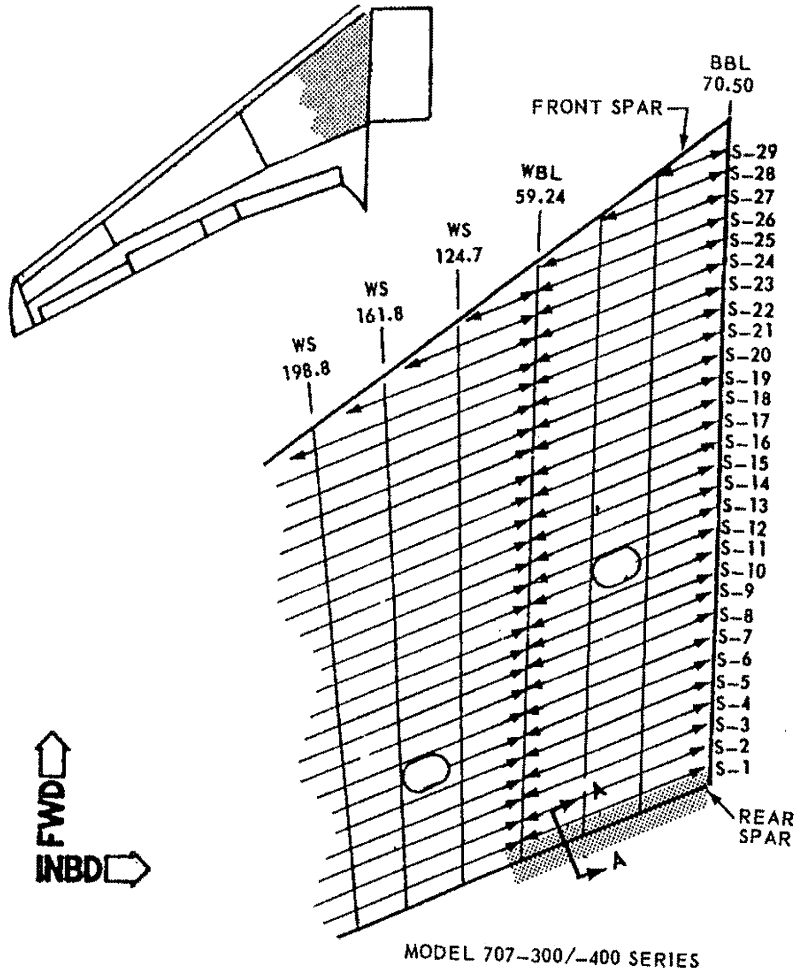
MODEL 707-300/-400 SERIES  
REAR SPAR LOWER CHORD AND WING LOWER SKIN INSPECTION  
BBL 70.50 THRU WBL 129.62/59.24

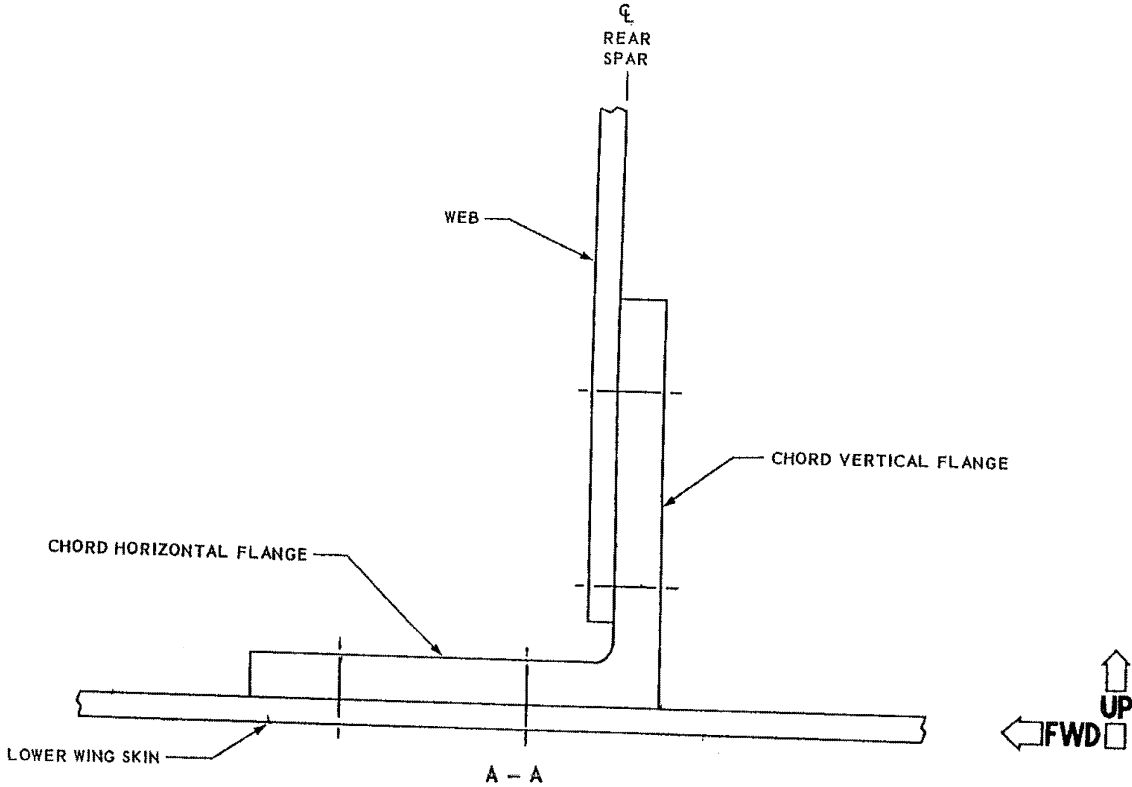
REAR SPAR LOWER CHORD AND WING LOWER SKIN INSPECTION
