HOR STAB CENTER SEC HINGE HOUS & DIAG BRACES NDT INSP

HORIZONTAL STABILIZER CENTER SECTION HINGE HOUSING & DIAGONAL BRACES NDT INSPECTION.

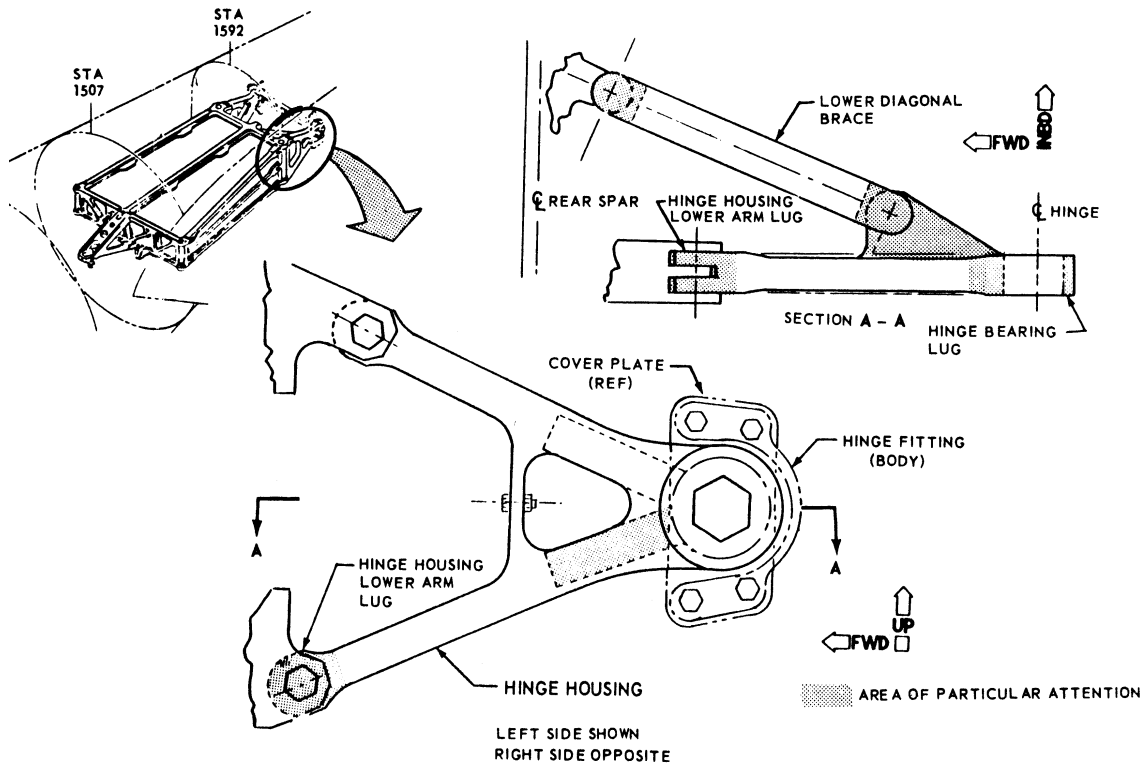
Close visual HIGH FREQUENCY EDDY CURRENT internal inspection of all accessible areas of the hinge housing & diagonal braces for cracks. Particular attention should be given to hinge housing lower arm lugs, lower diagonal brace lugs & aft end of hinge housing from the lugs for the diagonal braces to the hinge bearing lug/cover plate.
Refer DOC D6-48023 part 6, 55-10-07, fig 5.
