AD 85-12-01 BULK CARGO DOOR CUTOUT INSP

BULK CARGO DOOR CUTOUT INSPECTION.

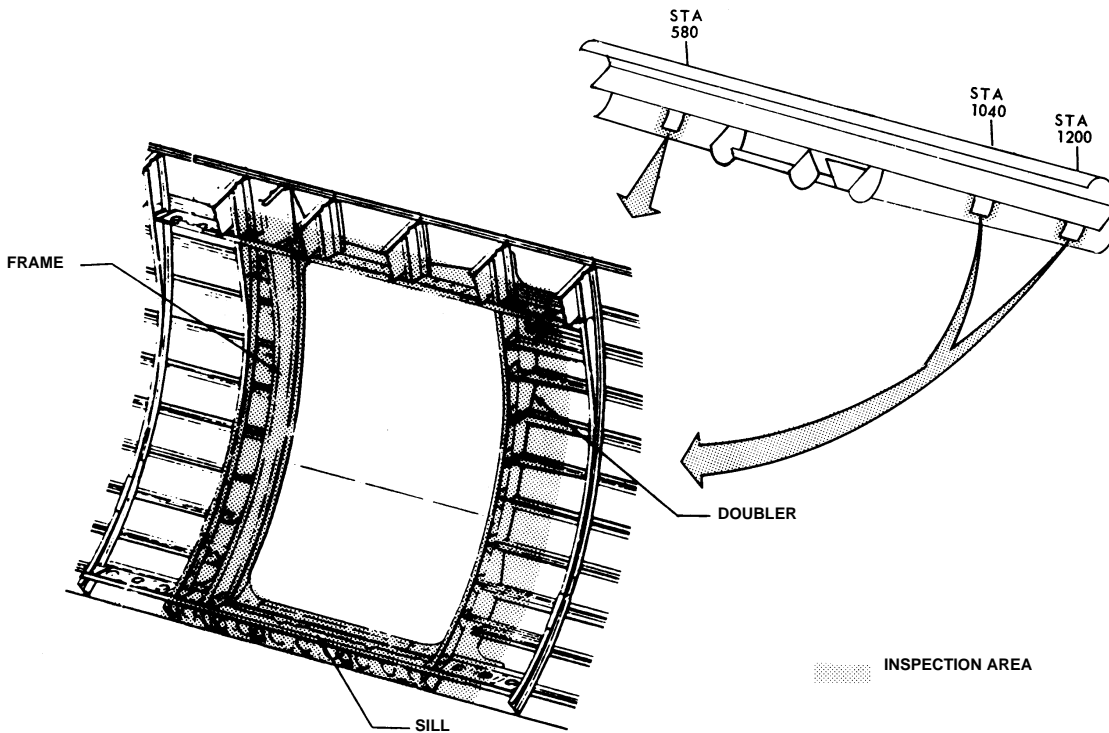
Close visual external inspection of the fwd frame for cracks in fuselage framing, skin, sill, door stop support fittings and doubler around door cutout. Pay particular attention to the cutouts exposed edge and doubler attach fastener areas surrounding the cutout.

FUSELAGE LOWER CARGO COMPARTMENT CUTOUT INSPECTION

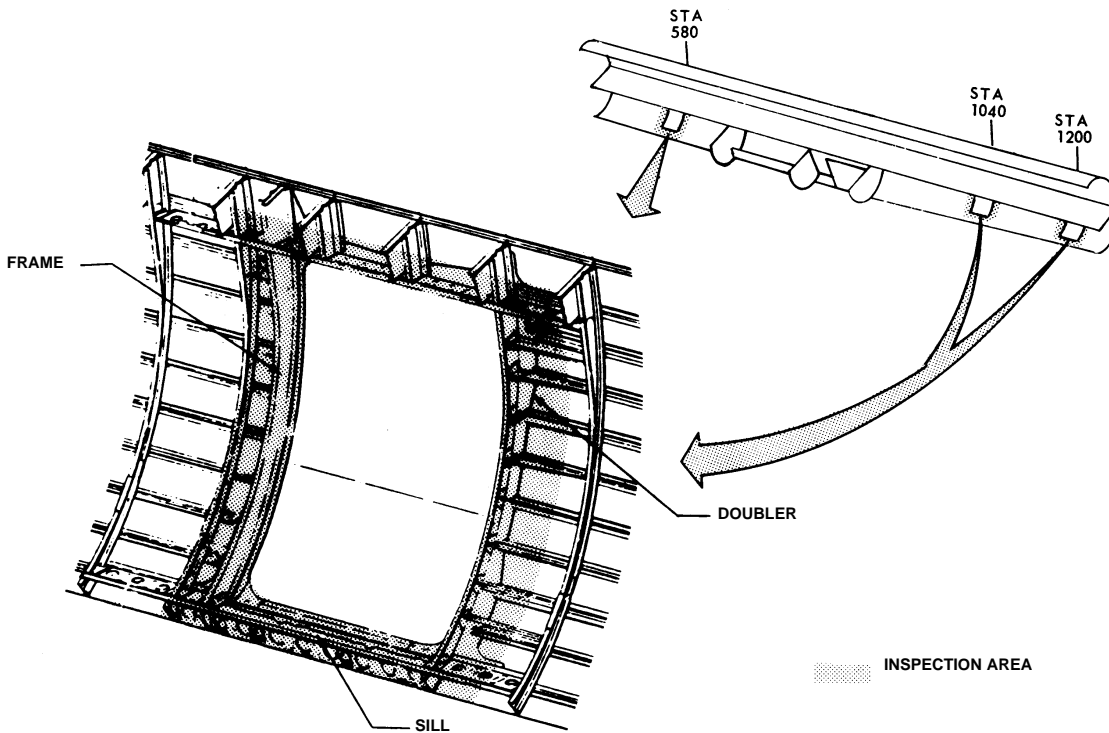
Close visual external inspection of the fwd frame for cracks in fuselage framing, skin, sill, door stop support fittings and doubler around door cutout. Pay particular attention to the cutouts exposed edge and doubler attach fastener areas surrounding the cutout.

FUSELAGE LOWER CARGO COMPARTMENT CUTOUT INSPECTION

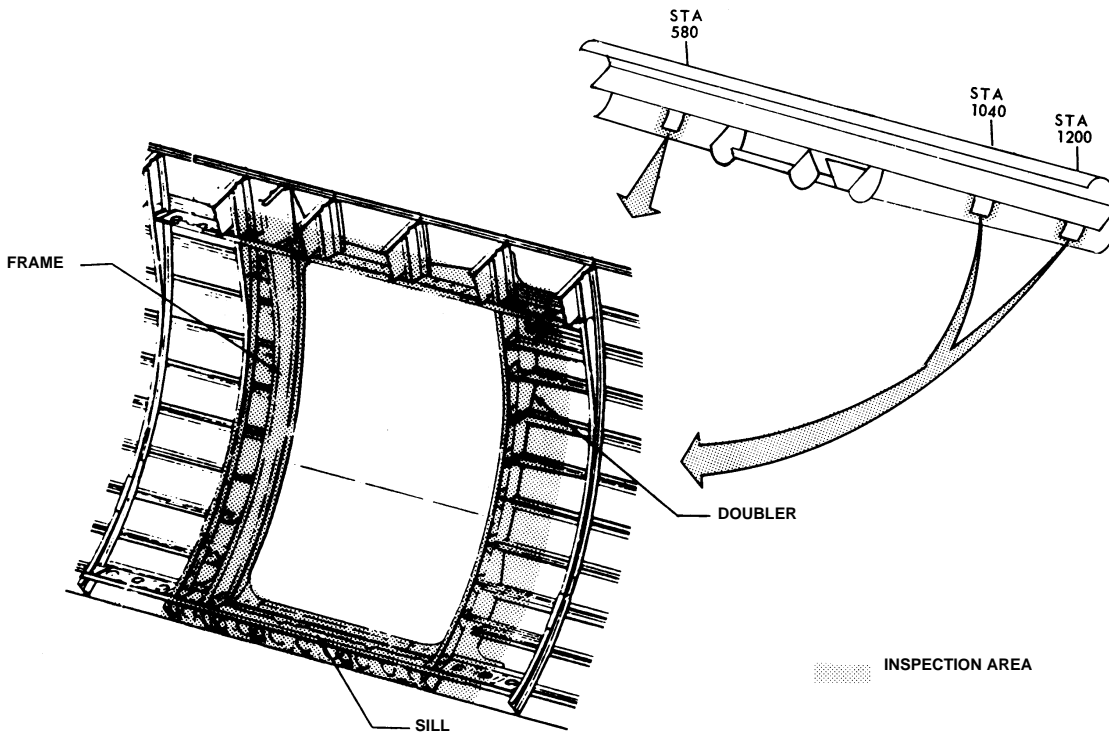
Close visual external inspection of the fwd frame for cracks in fuselage framing, skin, sill, door stop support fittings and doubler around door cutout. Pay particular attention to the cutouts exposed edge and doubler attach fastener areas surrounding the cutout.

FUSELAGE LOWER CARGO COMPARTMENT CUTOUT INSPECTION
