sabena B707	Module: CABIN DOORS	A/C Reg :	Check :

CABIN DOORS ESCAPE SLIDE GIRT STRAP INSPECTION

MAINT	RII/INSP
Nr.	Hardtime	Task	Spec.	Related Documents		
1.			INS	AMM 25-1-29/601 rev NOV 15/08 MMS-328 256003 00100 rev 20/11/08		
Check: B						
Zones: 242, 243, 246, 248						
Access:						
NRC YES <input type="radio"/> NO <input type="radio"/>		IF YES, NUMBER(S):

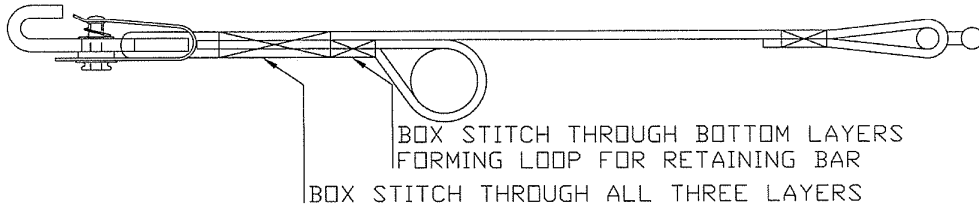
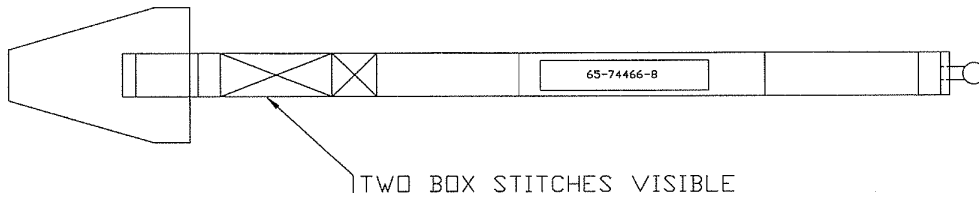
Figure 601. Correct Stitch Pattern for Girt (Floor) Pitting Assembly, Strap End

NOTE
THE STITCHING ON THE RELEASE CABLE BALL END HAS THE SAME BOX X STITCH PATTERN
