sabena [®] B707	Module: PYLON 1	A/C Reg :	Check :

AD 85-12-01 rev . PYLON 1 MID SPAR FTGS INSP

PYLON ENG #1 MID SPAR FITTINGS INSPECTION.

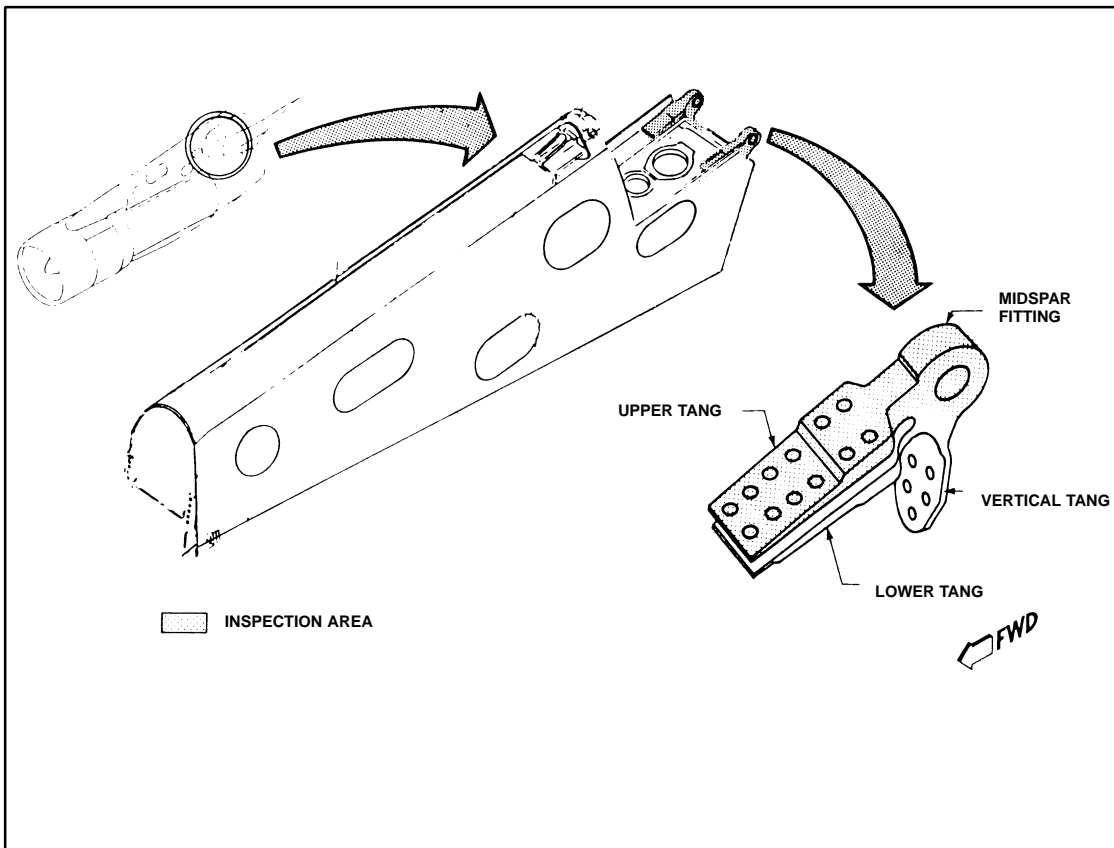
Close visual, internal inspection of both mid spar fittings for cracks in the upper horizontal tang root area and in the fittings lugs.

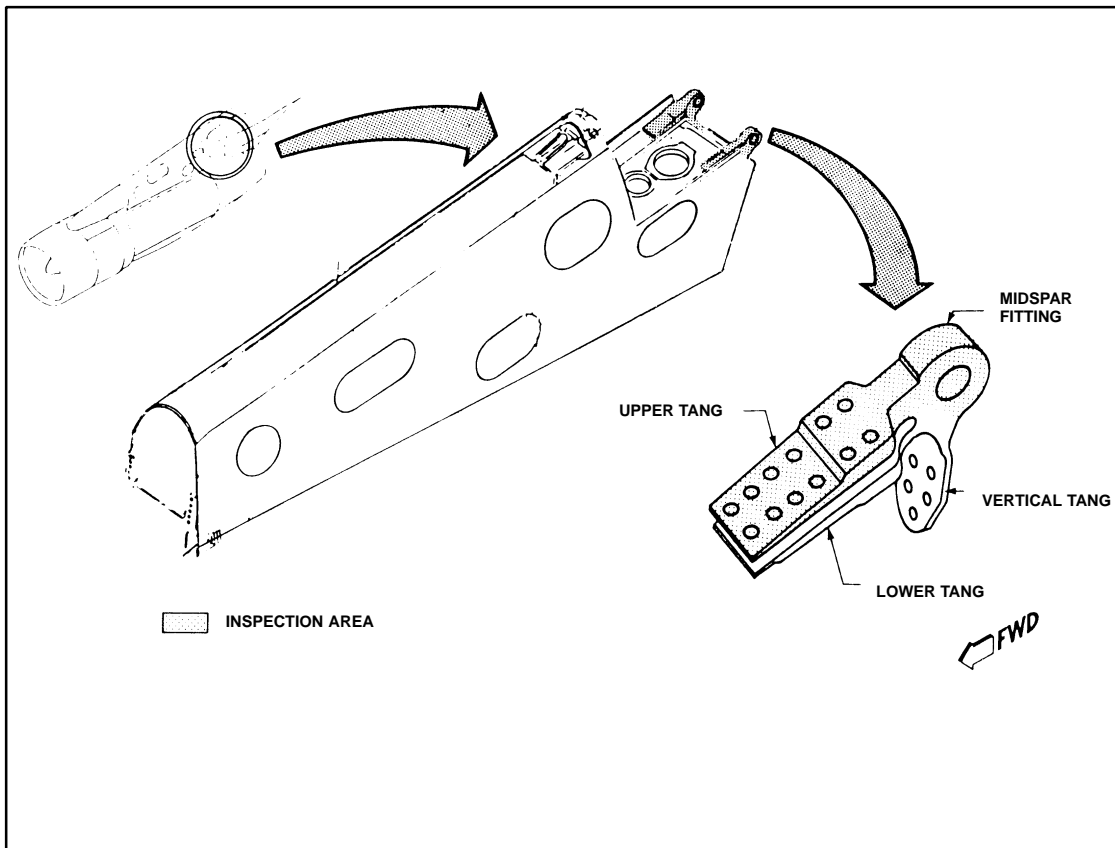
PYLON ENG #1 MID SPAR FITTINGS INSPECTION.

Close visual, internal inspection of both mid spar fittings for cracks in the upper horizontal tang root area and in the fittings lugs.

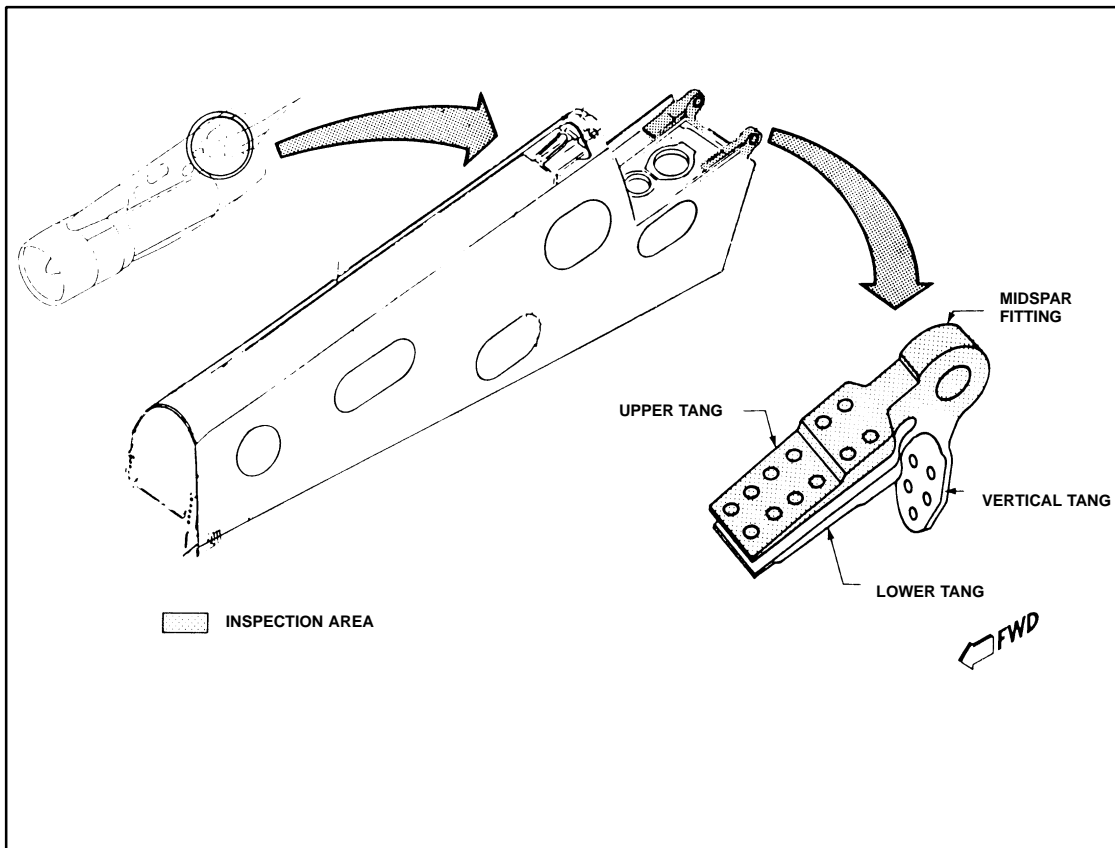
PYLON ENG #1 MID SPAR FITTINGS INSPECTION.

Close visual, internal inspection of both mid spar fittings for cracks in the upper horizontal tang root area and in the fittings lugs.
