sabena [®] B707	Module: PYLON 1	A/C Reg :	Check :

ENG #1 OVERWING SUP FIT NDT INSP

ENGINE #1 OVERWING SUPPORT FITTING INSPECTION.

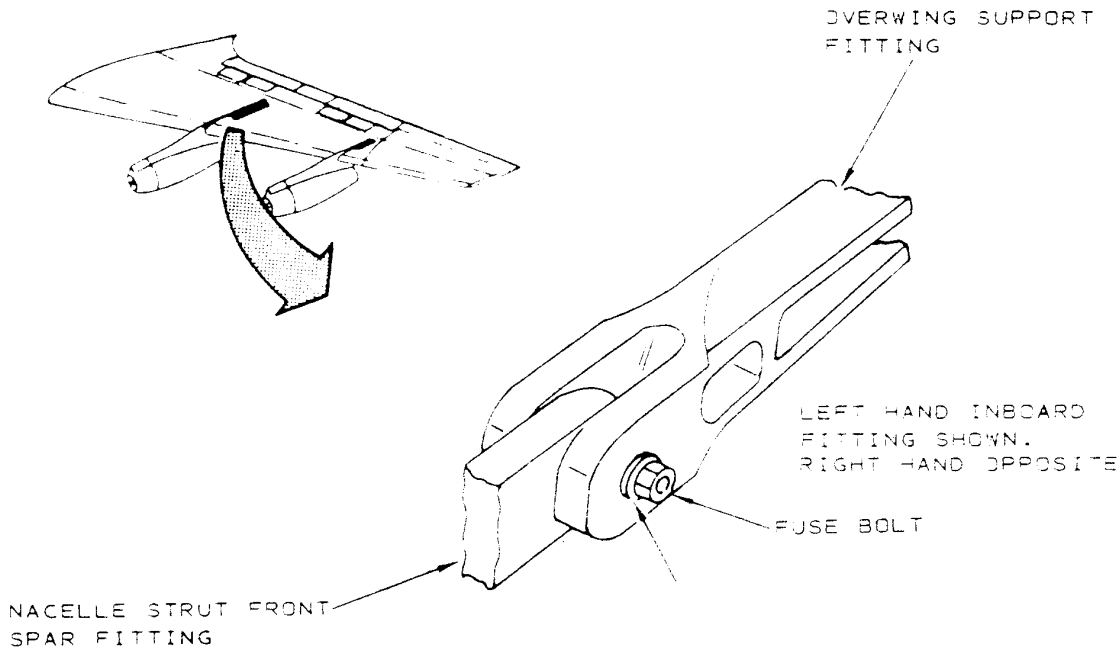
Ultrasonic external inspection of nacelle strut overwing support fitting fuse pin for cracks (DOC D6-48023 part 4, 54-40-07 fig 2).
