sabena [®] B707	Module: PYLON 3	A/C Reg :	Check :

AD 85-12-01 rev . ENG #3 OVERWING SUP FIT CLEV LUG INSP

ENGINE #3 OVERWING SUPPORT FITTING CLEVIS LUGS INSPECTION.

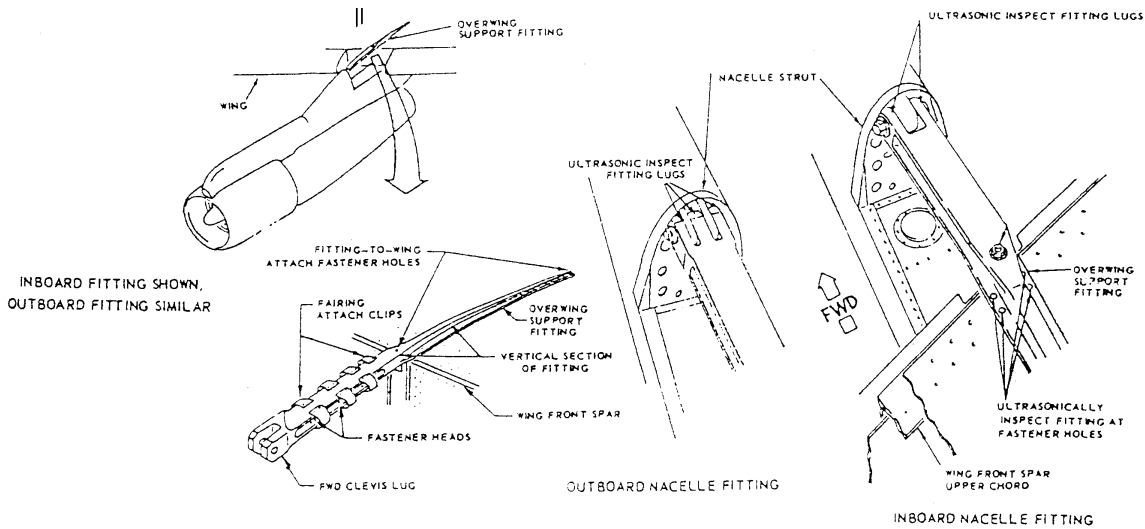
Ultrasonic internal inspection of the overwing support fitting clevis lugs for cracks (DOC D6-48023 part 4, 54-40-07 fig 2).
